## PHOTO REPORT

Job No. : 2270

Date : 17th December 2014  
Location : Tanjung Pelepas Port

No.	Description	
	<b>Subject : <u>Overboard Valve Replacement</u></b>

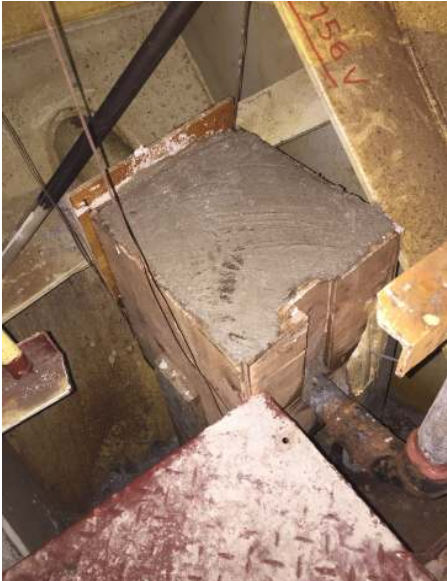
<p>Leaked valve wrapped in cement box</p>

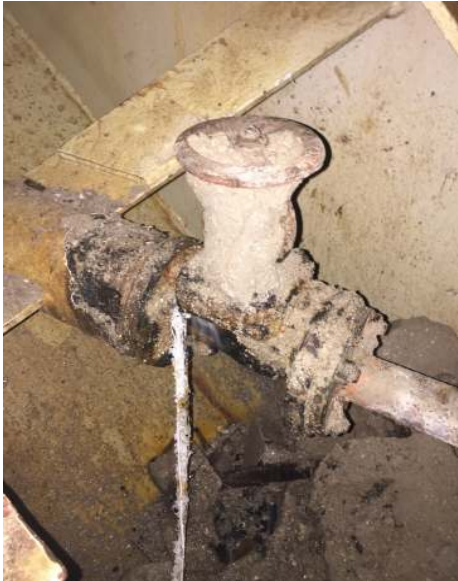
<p>After removal of cement box</p>

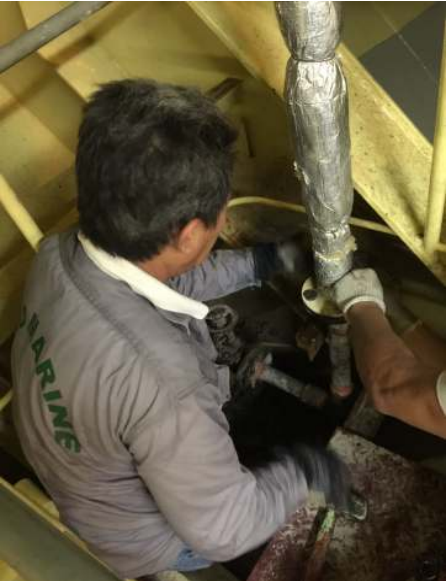
<p>Dismantling connecting steam pipe</p>

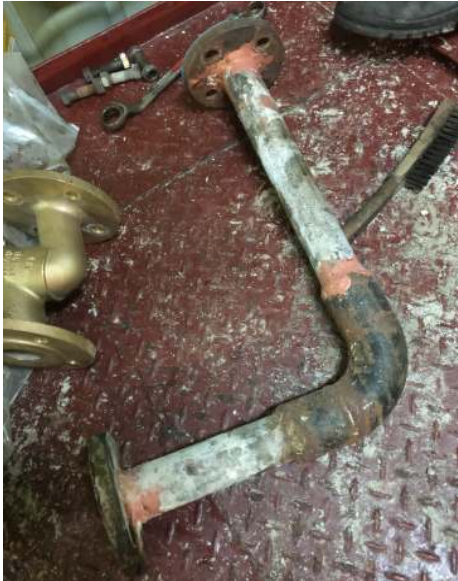
<p>Dismantled steam blow pipe</p>

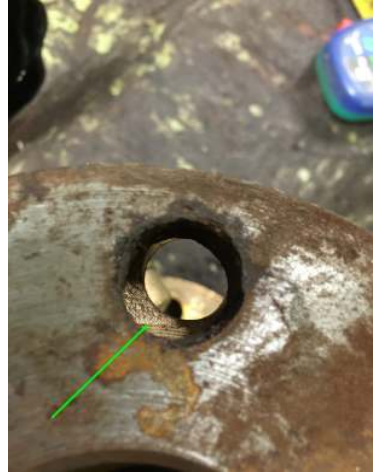
<p data-bbox="1138 835 1287 861">After removal</p>

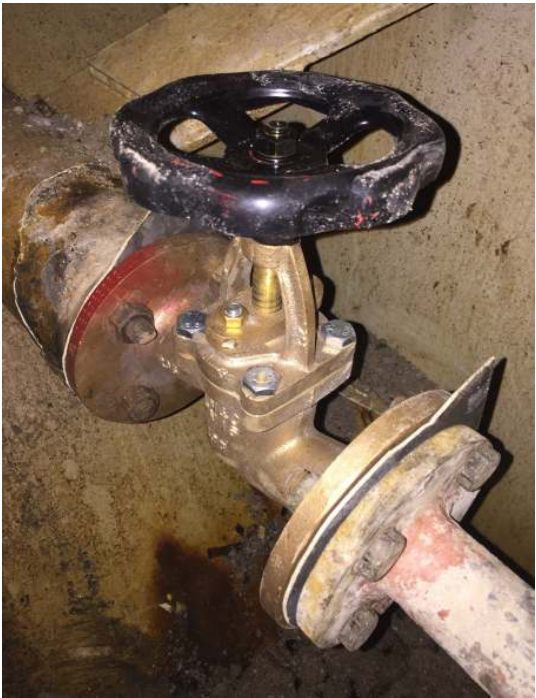
<p data-bbox="812 1728 1344 1770">Diver unplugged and no leakage were found</p>
