# PHOTO REPORT

Job No : 2294

Location : Singapore IPL

No.	Description
<b>Job Scope : Sea Water Pipe Repair</b>	
Work shop fabrication

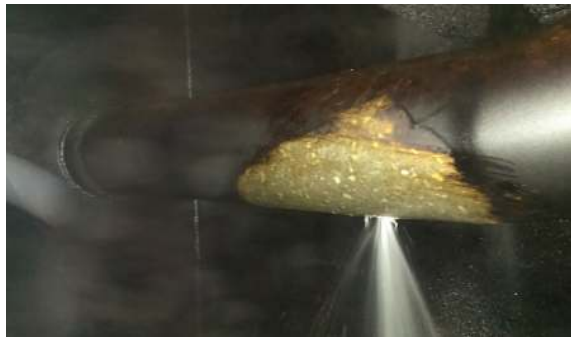
Identified the crack

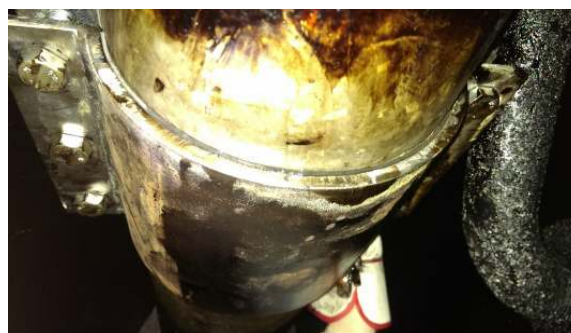
No leak was found

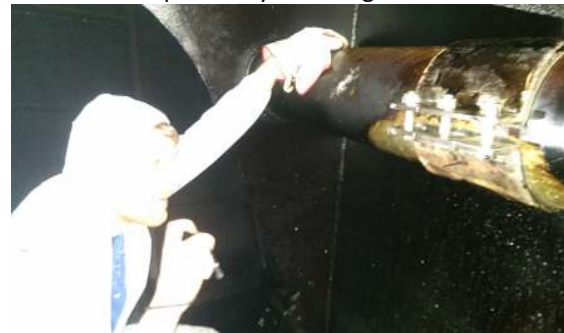
Inspected by chief engineer
