PHOTO REPORT

Job No. : 2295

Date : 02nd Feb 2015

No.	Description
<p><u>Subject : Repair / Servicing of Main Engine's Air Cooler / Model: Hyundai / Dongwa Entec)</u></p>

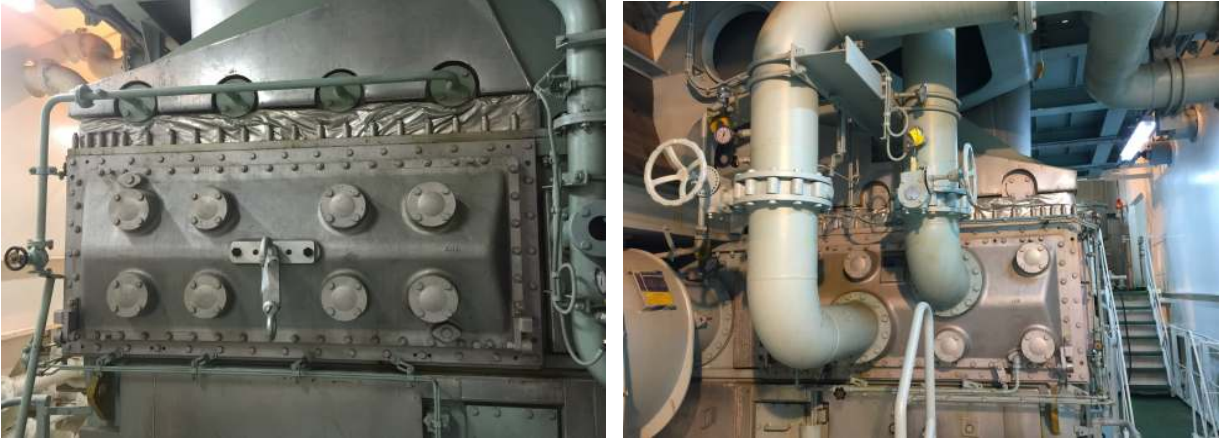
<p>Both End Cover of air cooler unit</p>

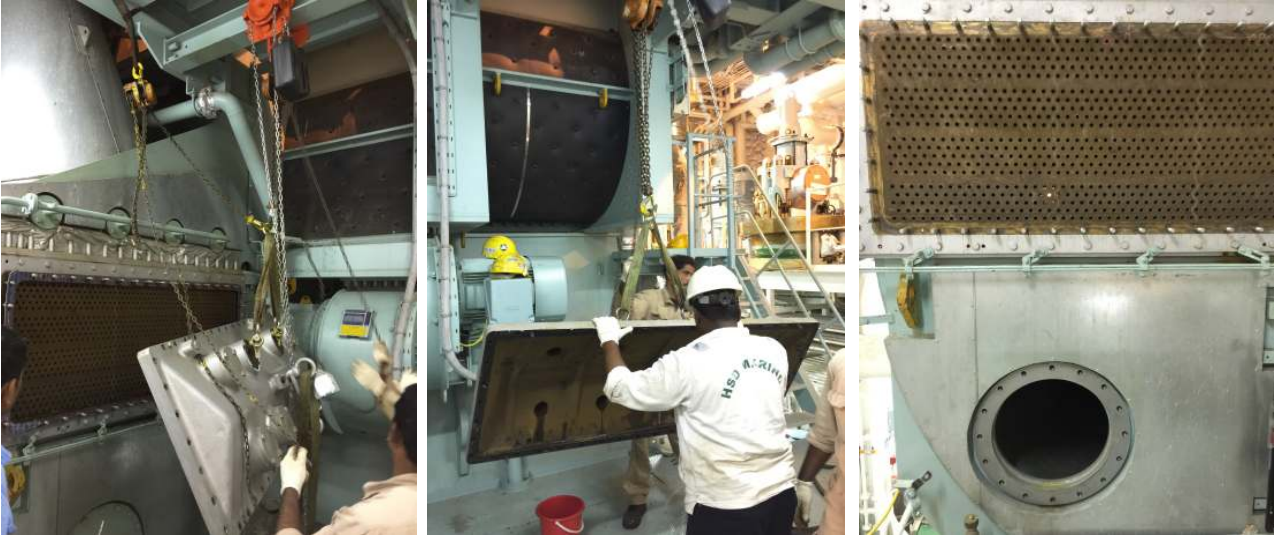
<p>Removed end cover and chamber's manhole</p>

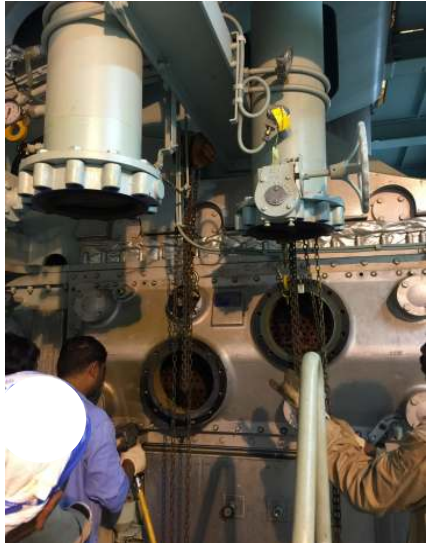
<p>Removed end cover, inlet and outlet pipe connections to end cover</p>

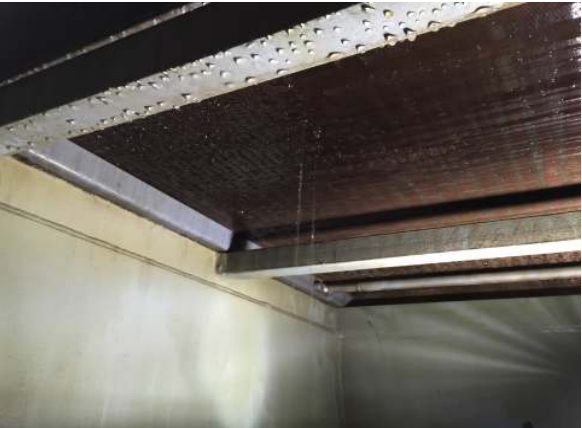
<p>Inspected inner chamber condition and found large amount of water leakage</p>

<p>Cooler unit in built with 1000 tube</p>	<p>Carried out vacuuum air test on each individual tube to identify leakage.</p>
