PHOTO REPORT

Job No : 2320

Date : 14 And 15th March 2015

Subject B : Main Engine Piston Liner Overhauling Unit no10.

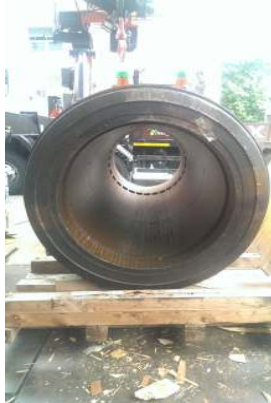
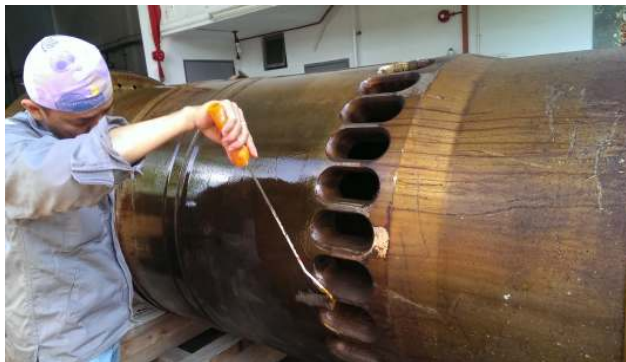
Piston liner in received condition

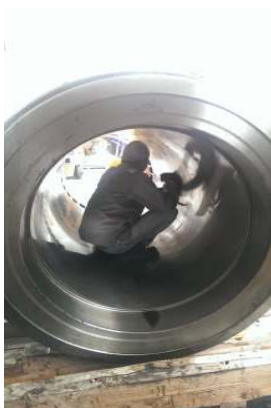
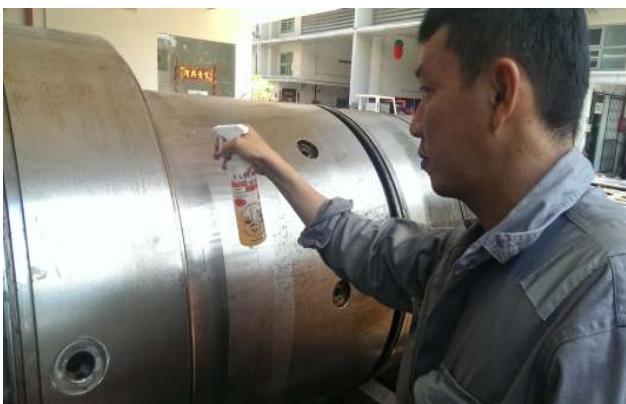
Piston liner in cleaned condition

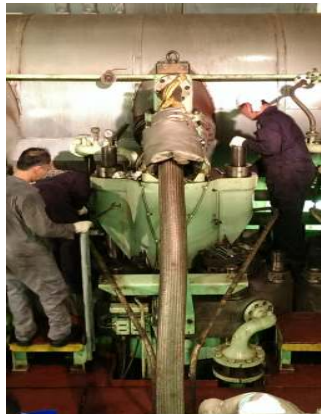
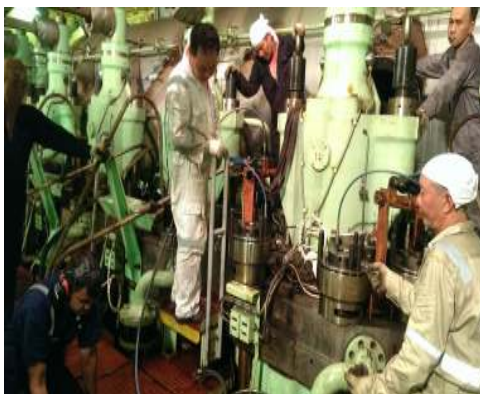
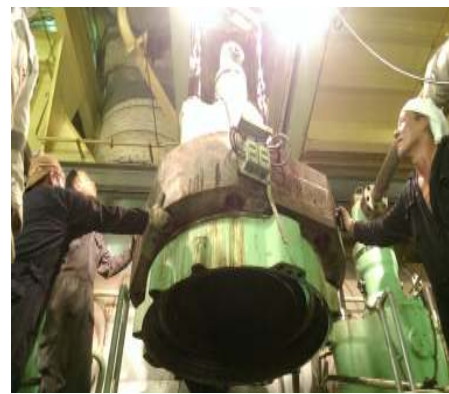
Removed all the connections. Hydraulic tool was installed and loosen the nut and cylinder head dismantled.

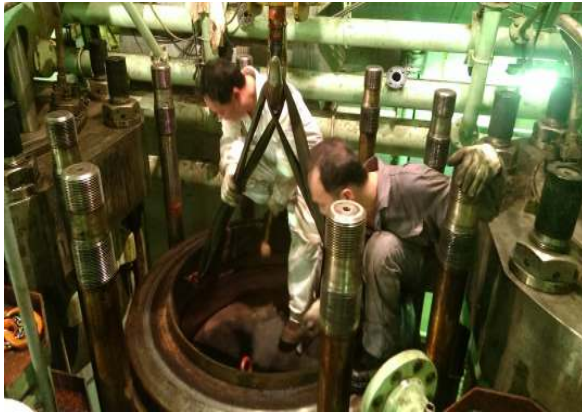
Fire ring removed

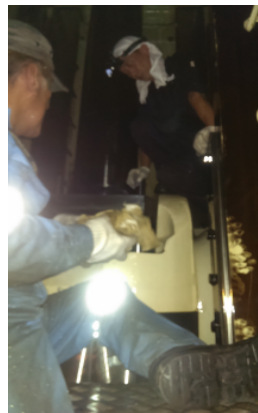
Dismantled lock bolts

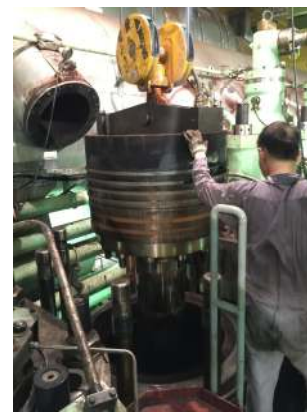
Piston pulled out

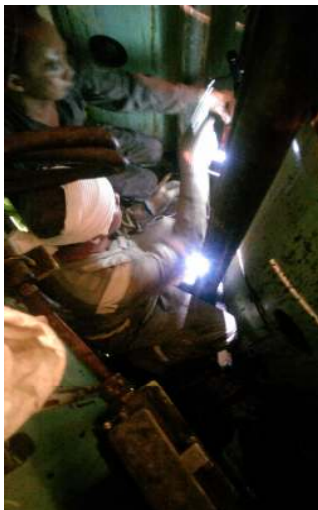
Liner Lubricater Disconncted and two bolts are worn off

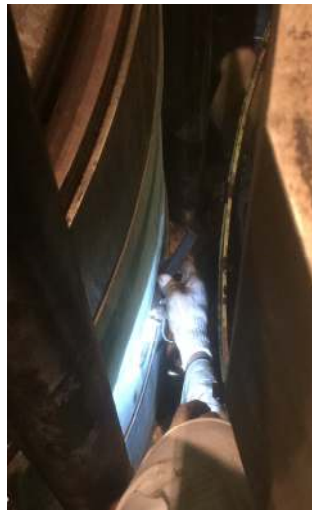
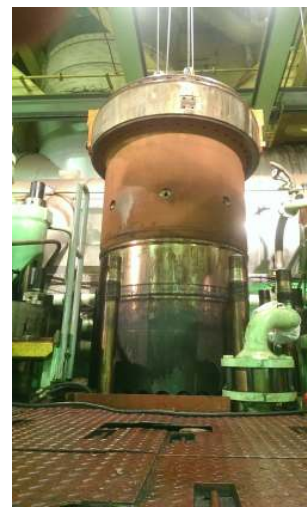
Liner pulled out

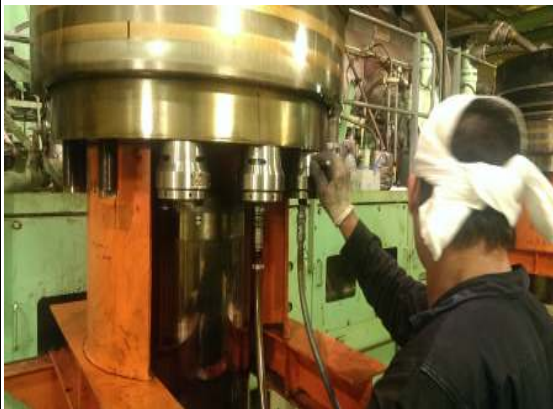
Piston crown nuts are loosen

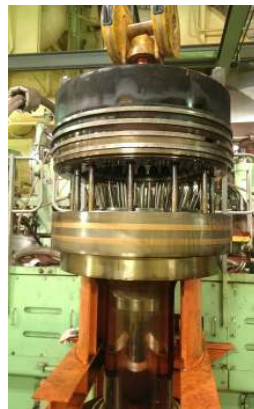
Piston crown removed

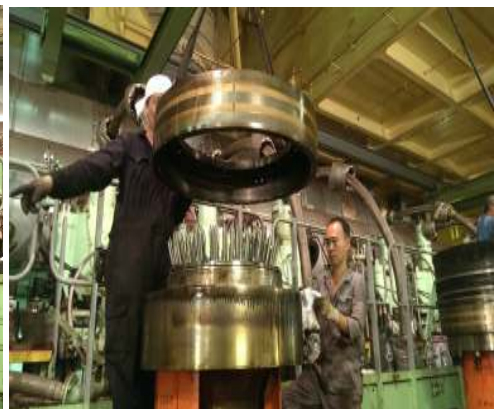
Piston skirt removed

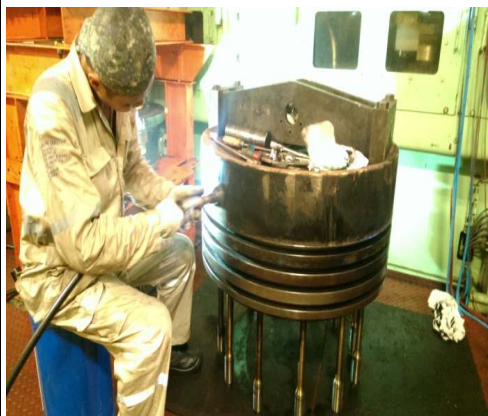
Decarbonized the piston crown

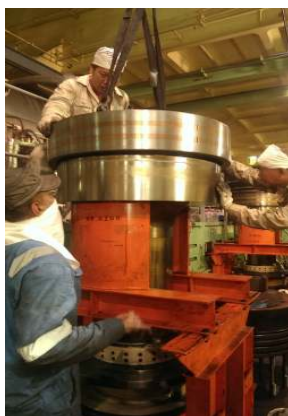
New piston skirt installed

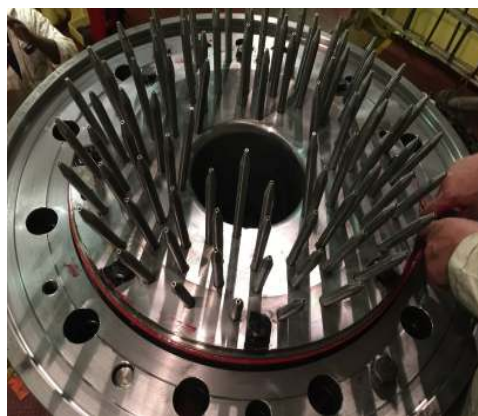
Nozzles cleaned and changed new O rings

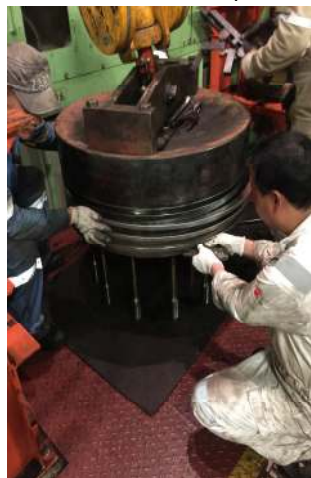
New piston rings were changed and calibrated

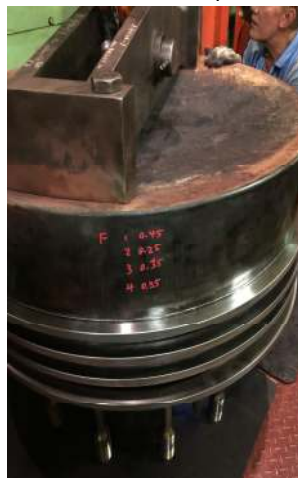
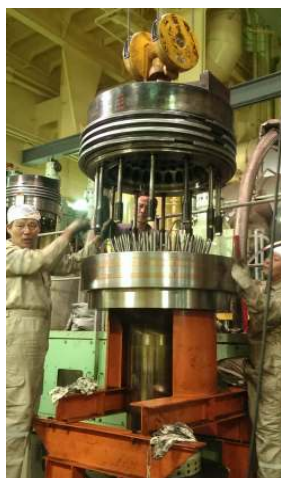
Piston crown mounted back and tighten

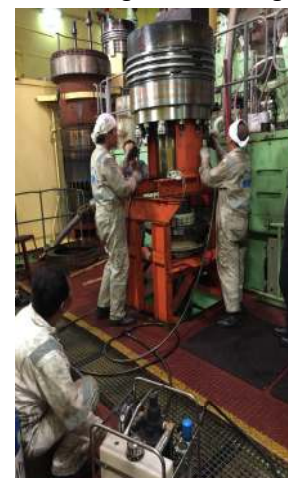
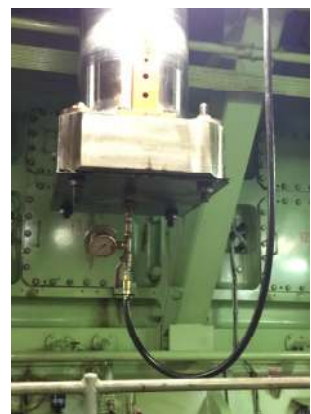
Pressure test performed
No leaking was found

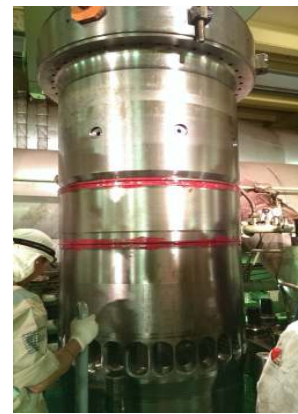
Reconditioned liner was installed with new O ring
and calibrated

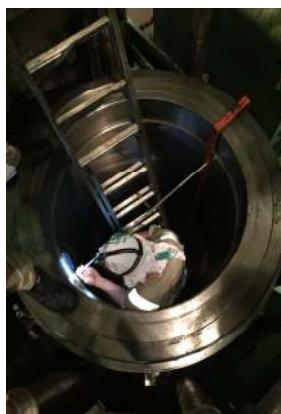
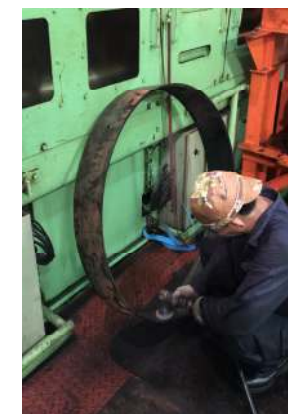
Fire ring decarbonized

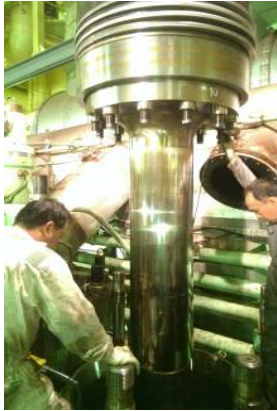
Piston was mounted back and changed new gasket

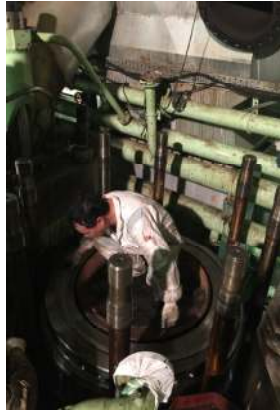
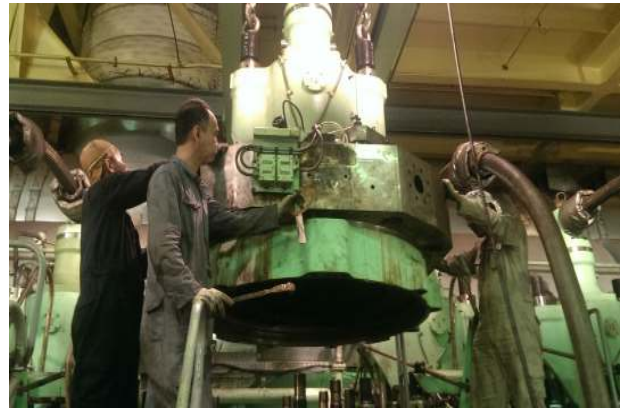
Cylinder head back in placed

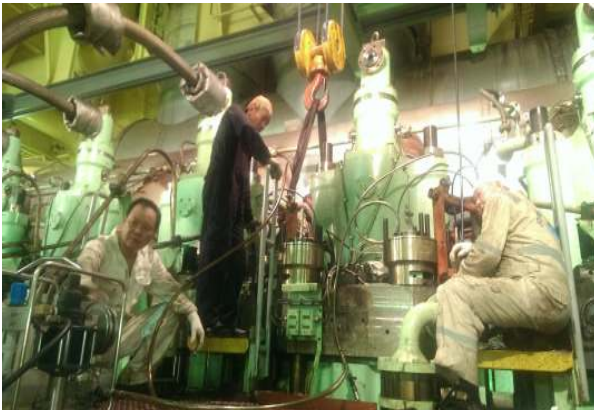
Hydraulic tool was installed and tighten the
Cylinder head nut

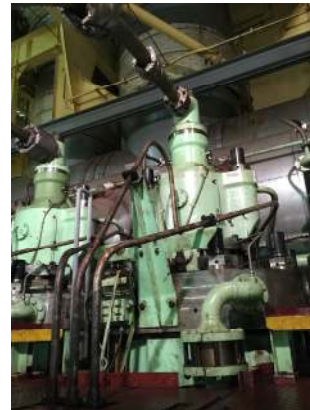
All connections are back in
Place in good order
