PHOTO REPORT

Job No : 2327

Location : Singapore PSA

No.	Description
Subject : Repair on Damaged Bitterend

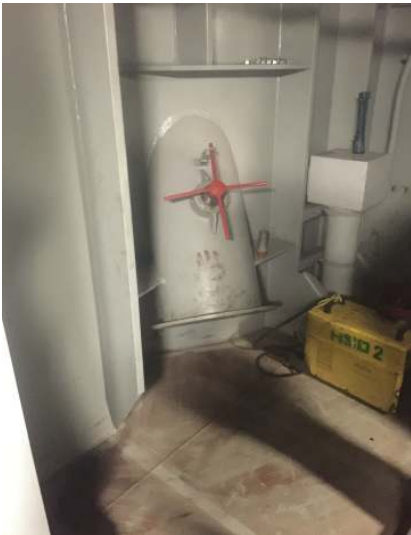
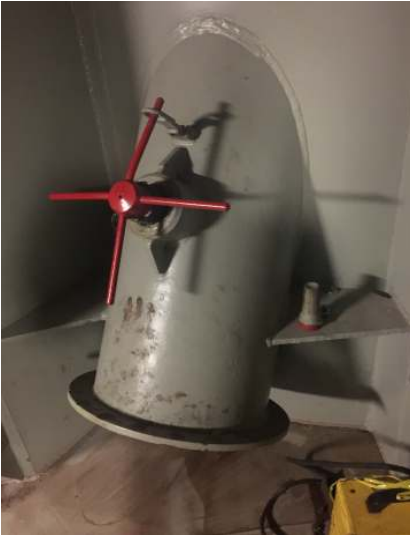
Existing Work Location

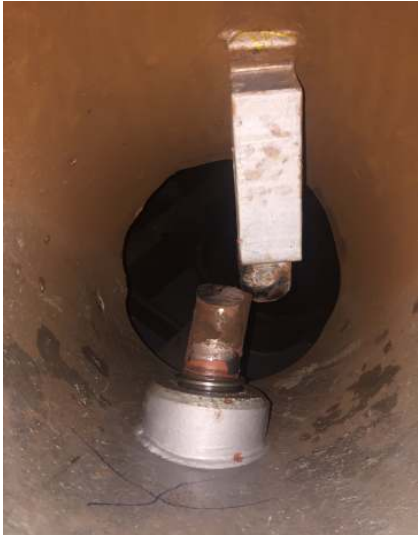
Existing Condition

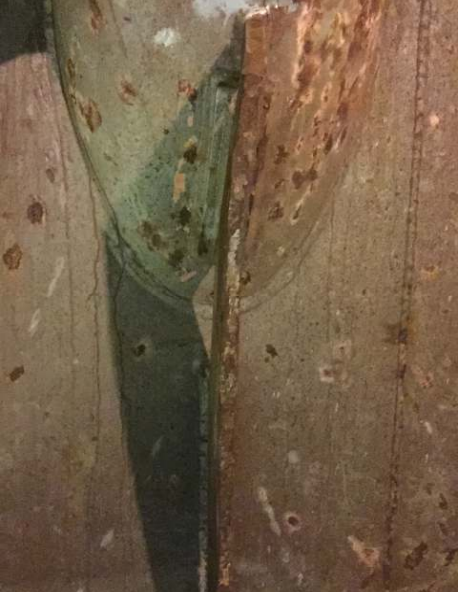
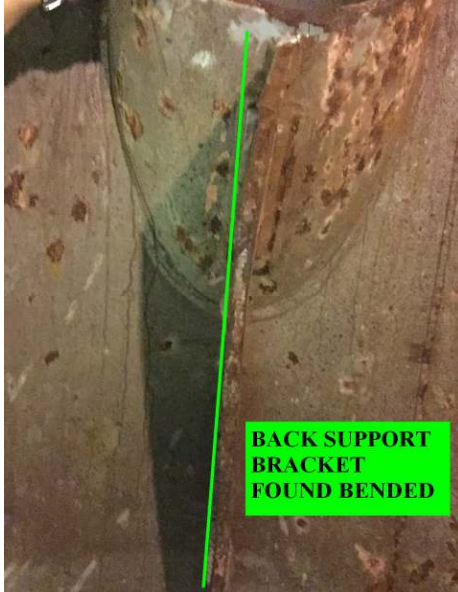
Existing Back support bracket found bended
