# PHOTO REPORT

Job No. : 2365

Location : PSA Singapore

**Subject Workscope : Transformer Room Ducting Modification**

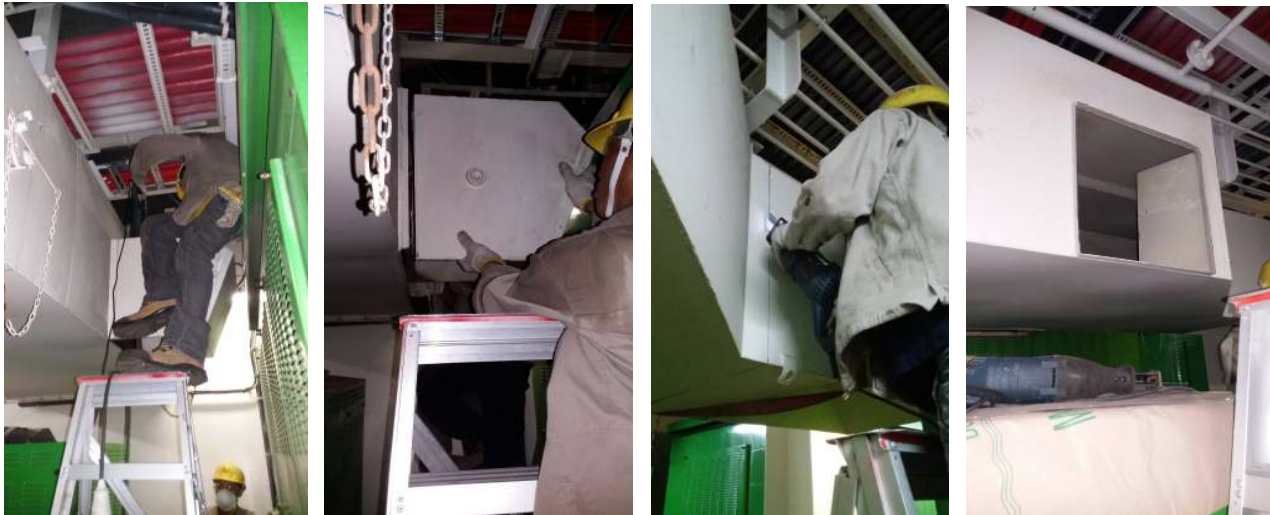
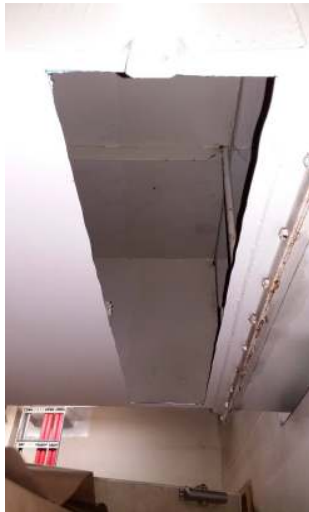
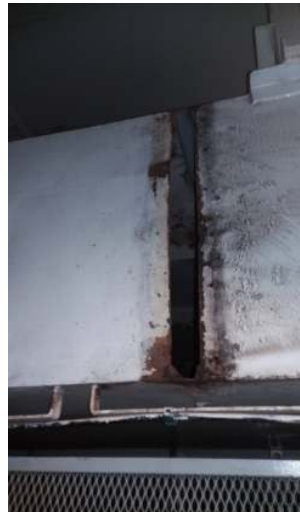
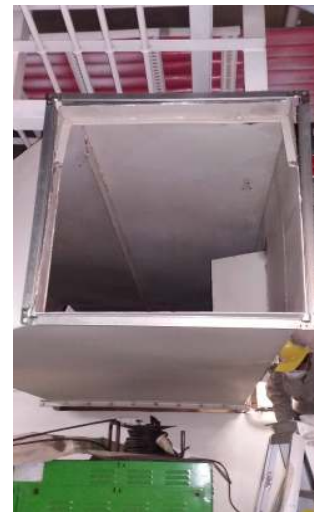
Measured and crop off the existing ducting in order to do the modification.

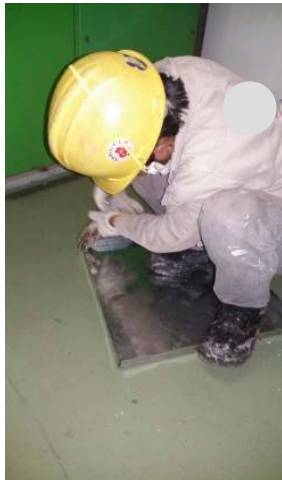
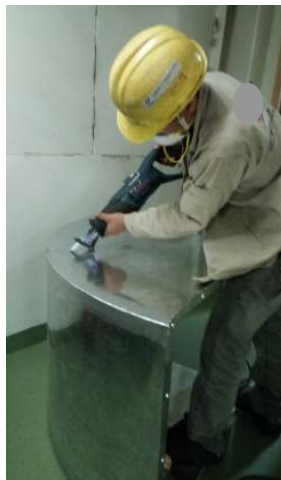
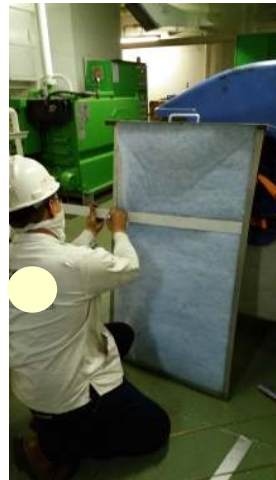
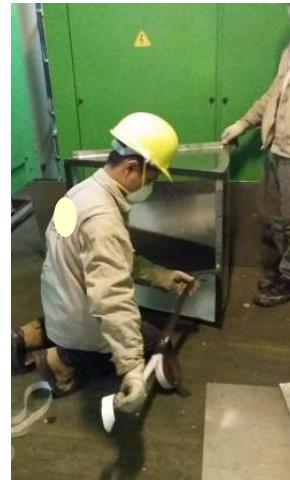
Elbows and End Caps modification, Filter renewal, and Insulation were carried out in situ.

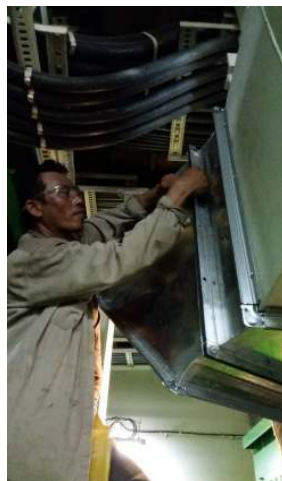
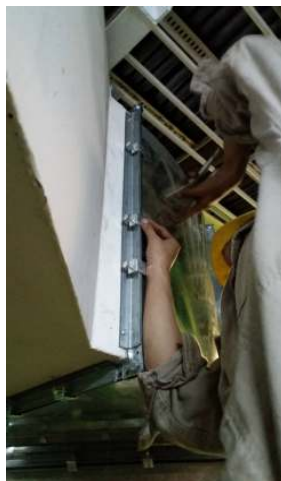
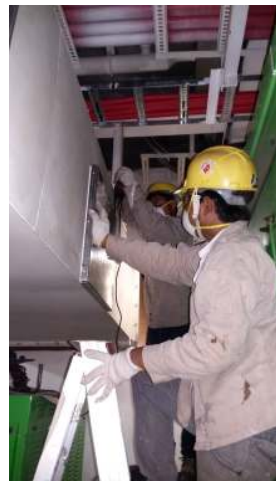
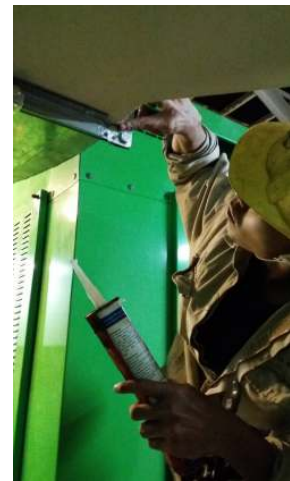
All Elbows Joints and End Caps were fitted accordingly and Silicone paste were applied in all the joint corners.

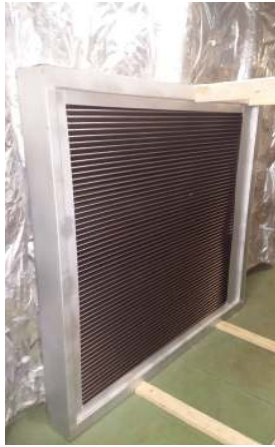
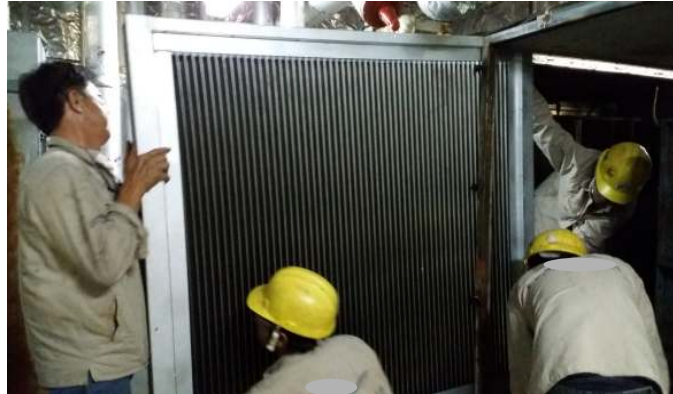
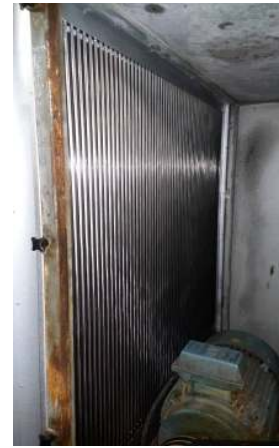
No.	Description
<p><b>Subject / Workscope : No:1 Air Conditioner Unit Water Eliminator Renewal.</b></p>	 
<p>Removed Existing damaged Water Eliminator From the AHU unit no1</p>	 
<p>Removed existing insulation and silicone. And new insulation were fabricated in situ and fixed up.</p>

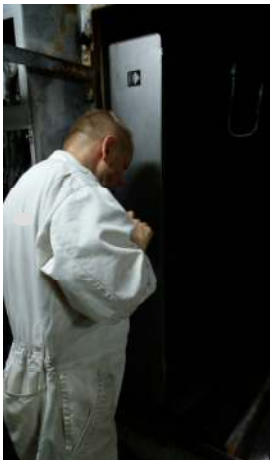
The New Air Conditioner Unit Water Eliminator were installed in place.
