PHOTO REPORT

Job No. : 2372

Location : PSA Singapore

No.	Description	Pg1
Subject/Workscope : High Sea Chest Rubber Coating (port side)

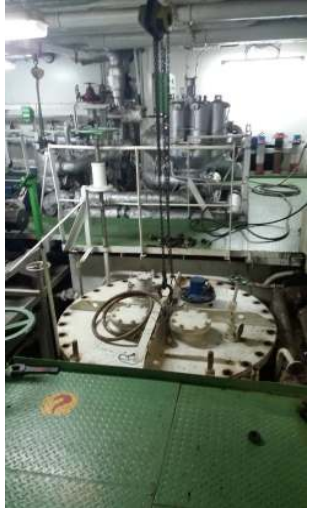
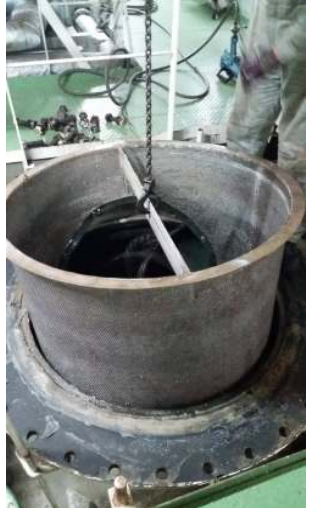
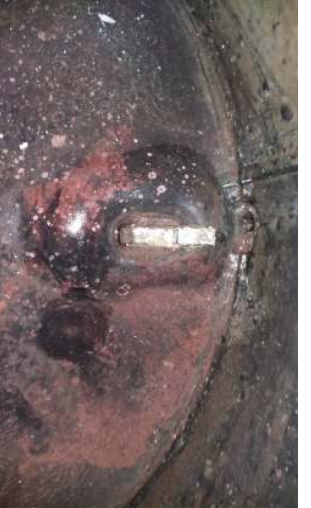
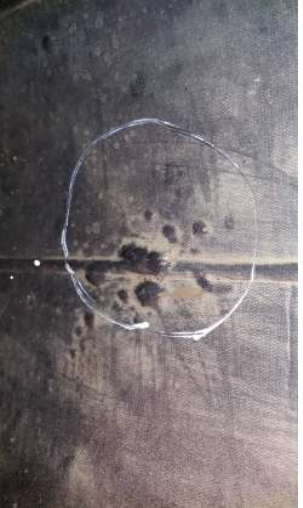
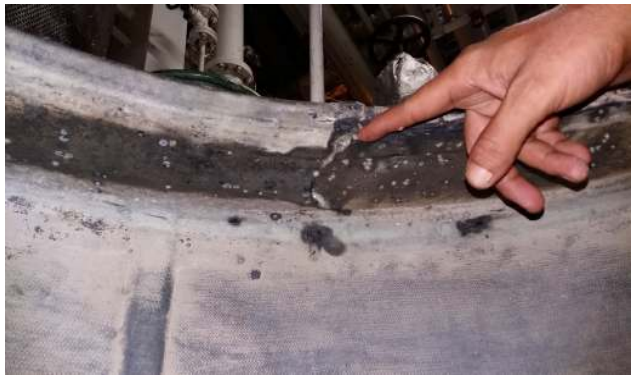
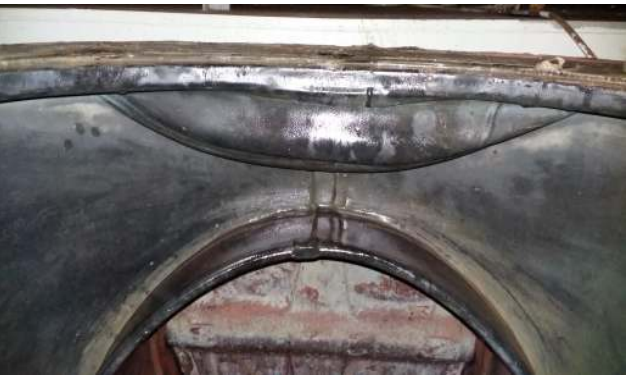
<p>Opened up the High sea chest (Port Side) and extract the filter. Isolated the damages in the sea chest and marked all spots.</p>
