PHOTO REPORT

Job No. : 2379

Location : Singapore IPL

No.	Description	
<p>Subject : Replacement of Exhaust Bellow x 1 unit</p>

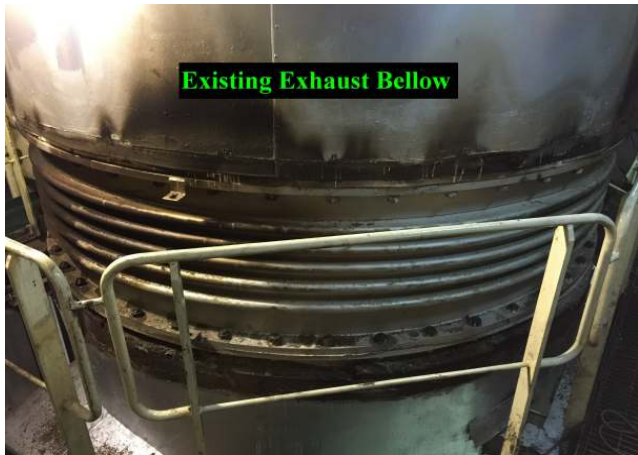
<p style="color: green; font-weight: bold; background-color: black; padding: 2px;">Existing Exhaust Bellow</p>
