PHOTO REPORT

Job No. : 2404

Date : 13 June 2015

No.	Description	Pg1
<p>Subject/Workscope : Wire Sheave Replacement of Jib Head Assembly for Crane No.1</p>

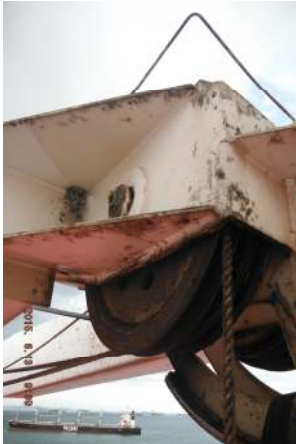
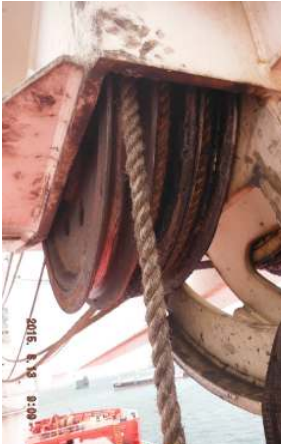
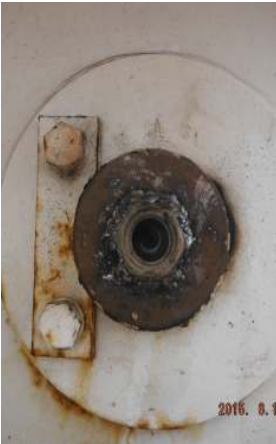
<p>Ship crew removed the hoisting wire and welded M30 nut on the pin.</p>

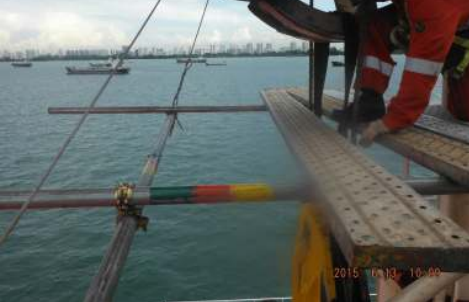
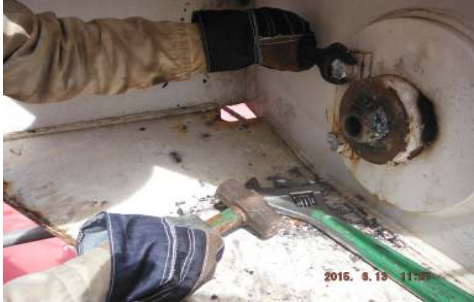
<p>Scaffolding were erected</p>		<p>key plate removed</p>

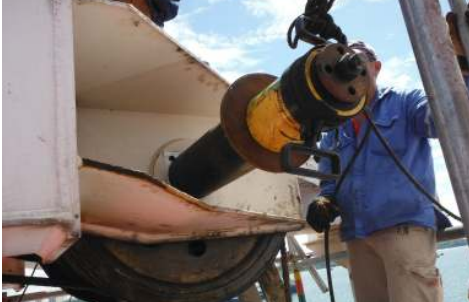
<p>Hydraulic tool were installed in order to extract the pin</p>

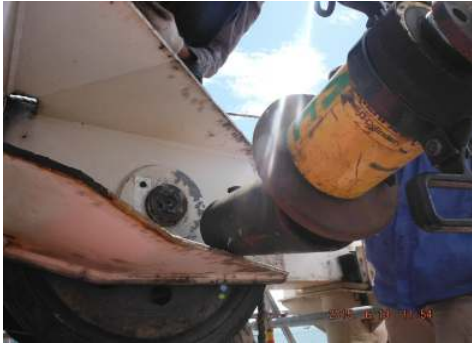
During the extraction nut were cracked and fall off

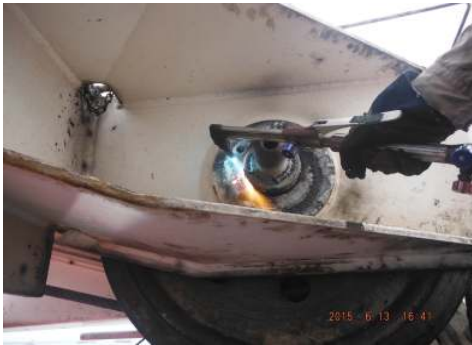
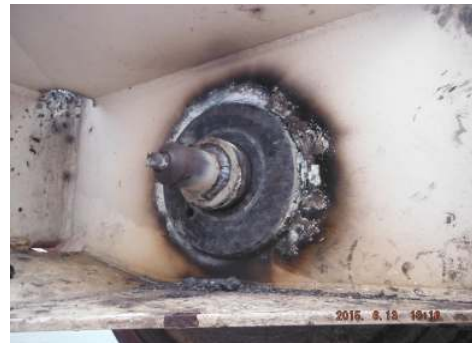
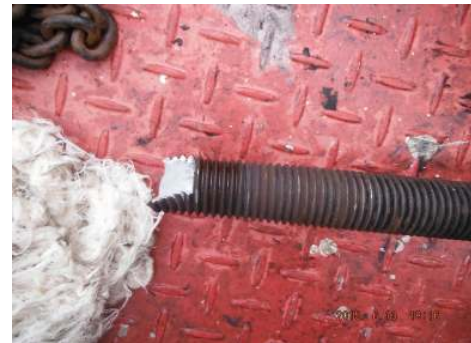
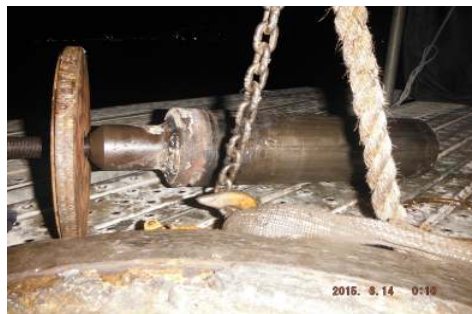
Continued extraction with hydraulic tools at 1000BAR pressure threaded stud broken and nut cracked fall off after Keep trying extraction the Sheave Pin were out.

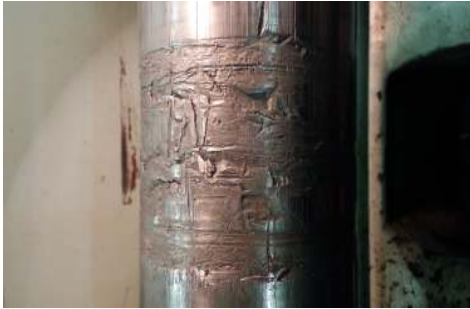
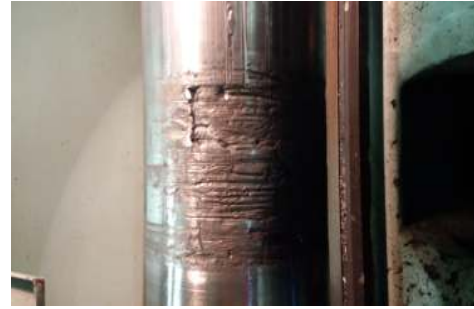
Pin were found with several damages and Chief Engineer advised bring to shore and machine a new pin.

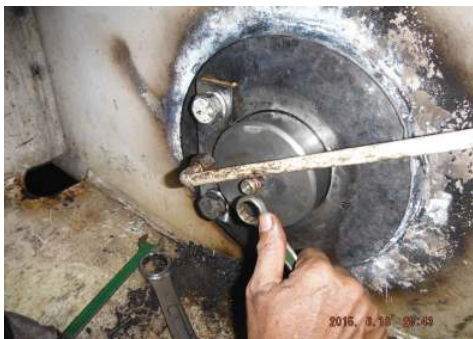
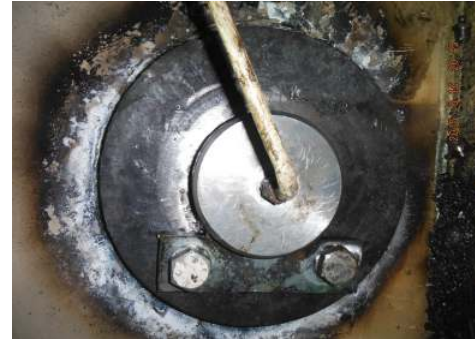
Chief Engineer inspected and carried out operational hoisting test and found in good working condition.
