PHOTO REPORT

Date : 14th Sept 2015
Location : Thailand Anchorage

Subject : Reconstruction of Damaged Poop Deck (Stbd side)(Fr.29 to Fr.33)

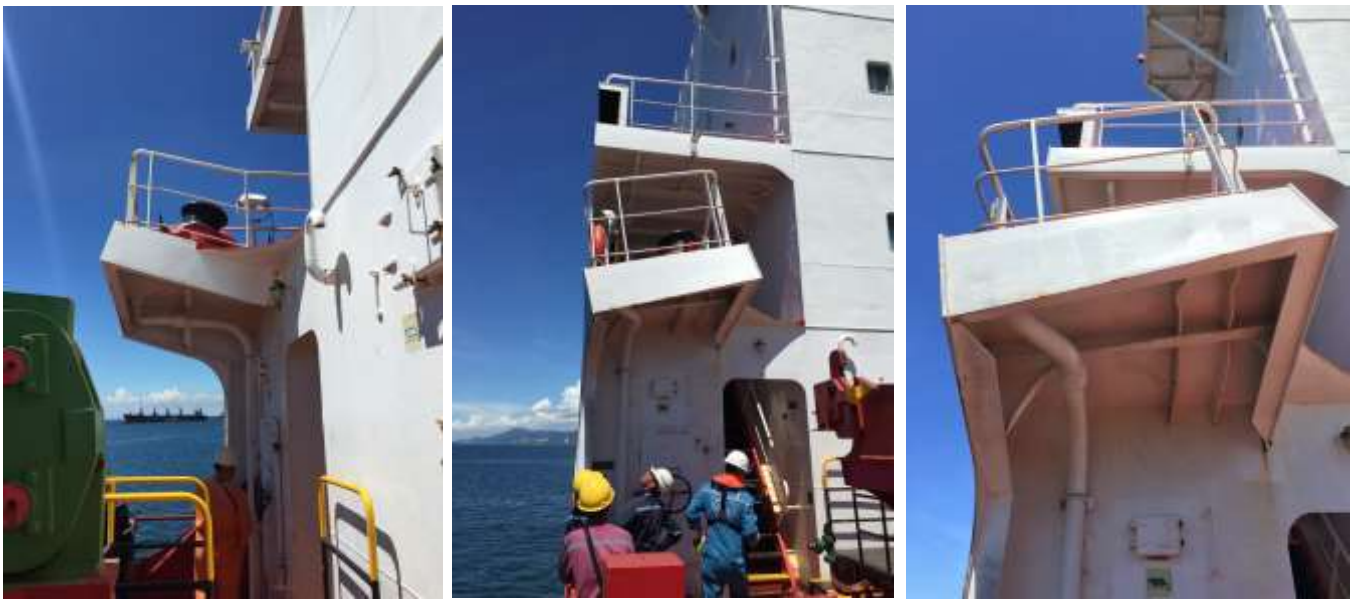
Inspected damaged location with Surveyor & discussed through repair procedure

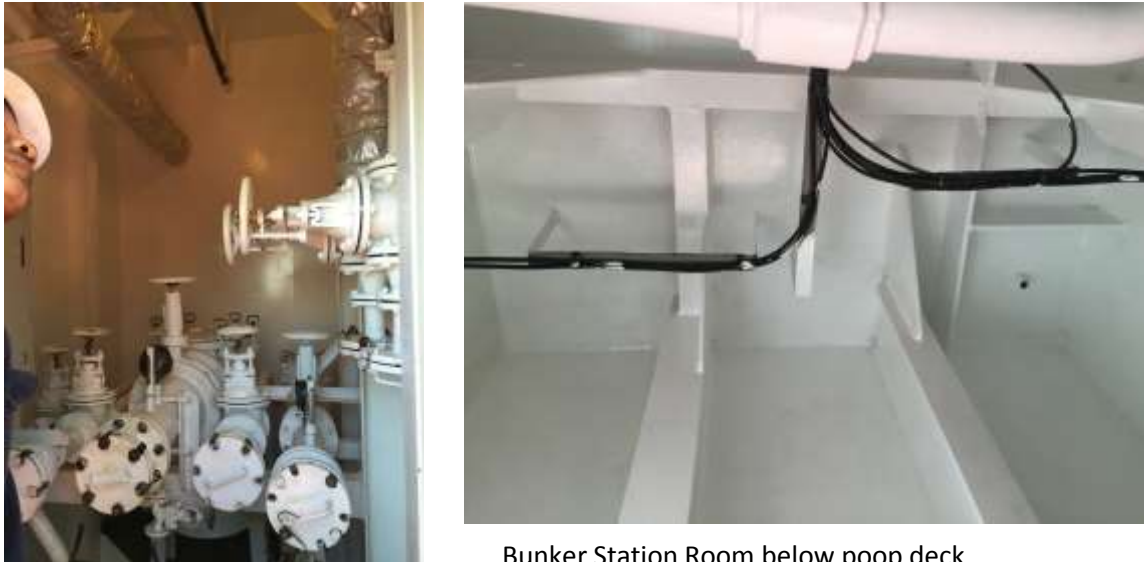
<p data-bbox="651 891 1120 929">Bunker Station Room below poop deck</p>

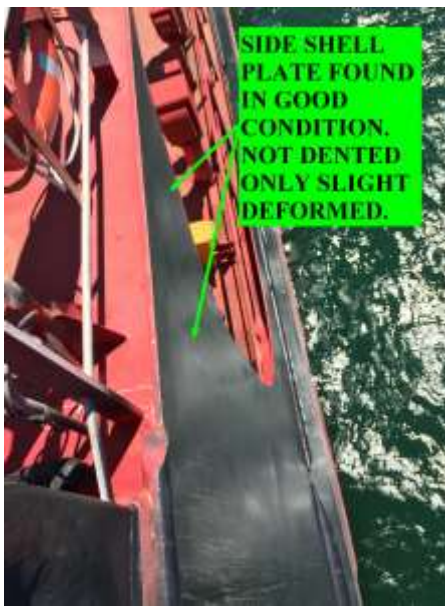
<p data-bbox="1220 1467 1412 1668">SIDE SHELL PLATE FOUND IN GOOD CONDITION. NOT DENTED ONLY SLIGHT DEFORMED.</p>
