PHOTO REPORT

Job No. : 2493

Subject / Workscope 502 Bilge Holding Tank Repair

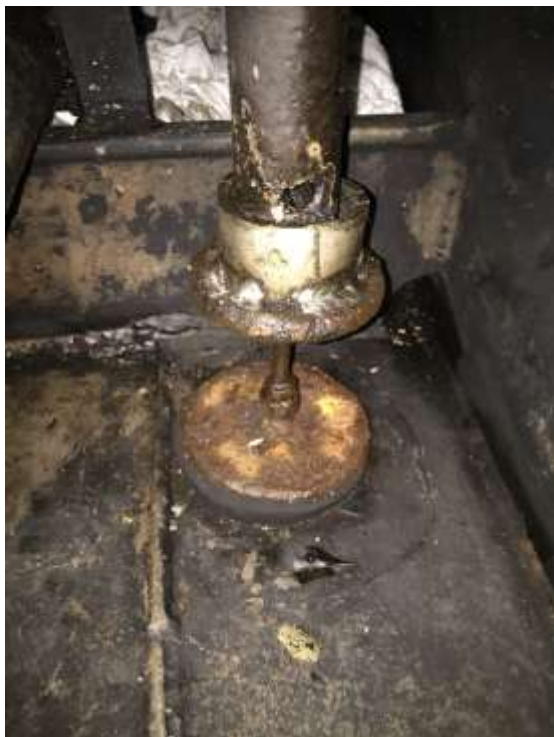
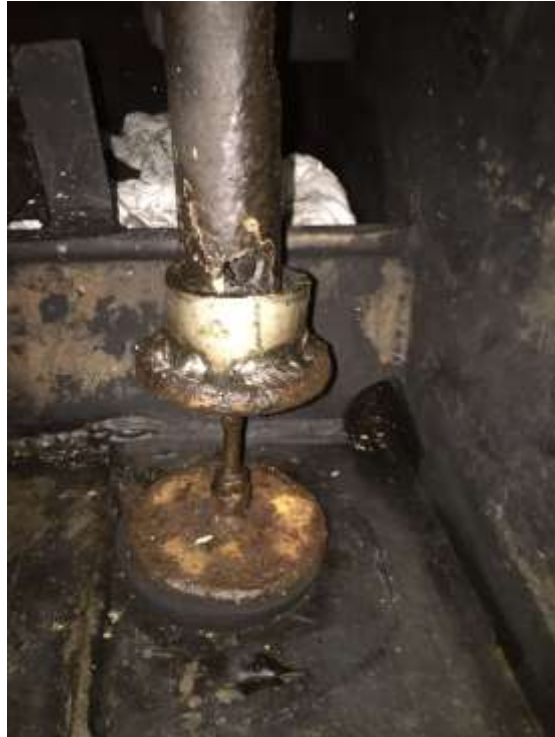
Existing plug previously installed by crew

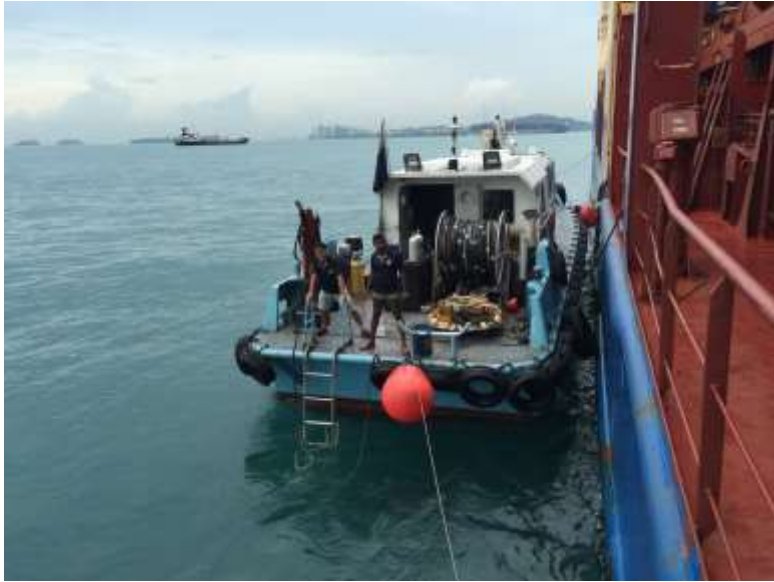
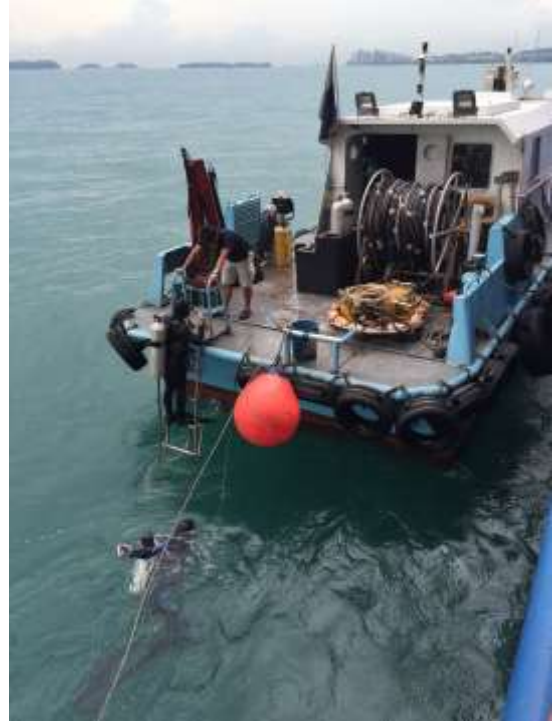
Divers in operation for underwater blanking

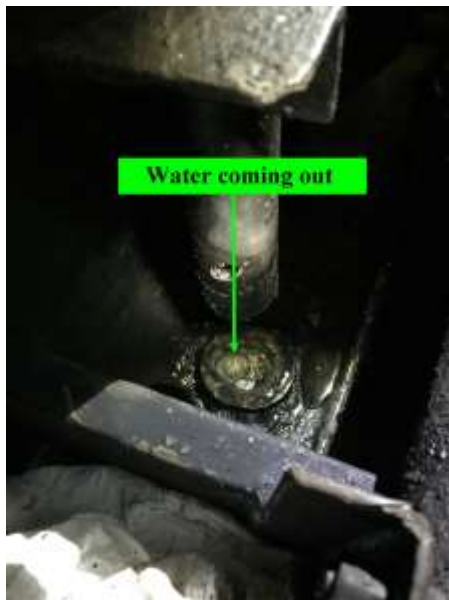
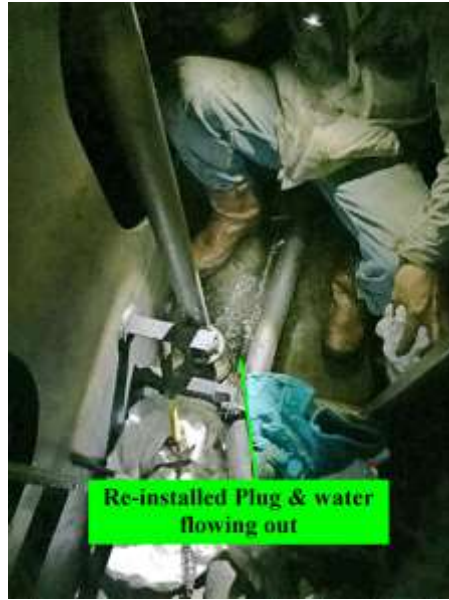
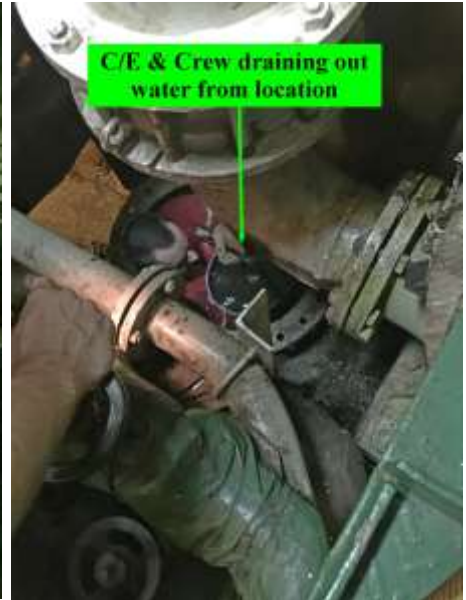
<p>Removal of existing sounding plug base in progress</p>

<p>Fractured hole revealed Install fabricated doubler plate</p>

<p>Carried out 6 rounds welding on bottom doubler plate and 1 round welding on top plate</p>
