## PHOTO REPORT

Job No. : 2538  
Attendance : 30th Dec 2015

No.	Description	Pg1
<b><u>Subject / Workscope Replacement of Sheave Bearing for Deck Crane No.4 Jib Head Assembly</u></b>

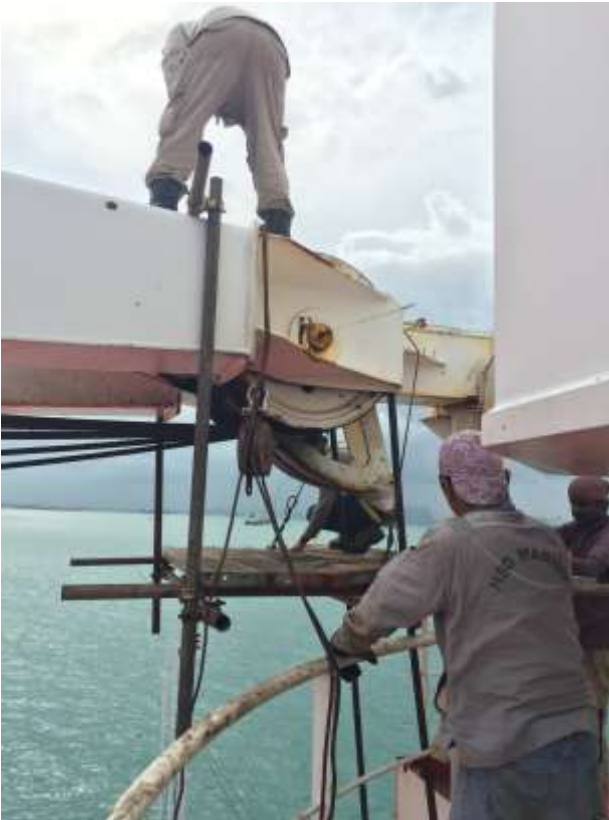
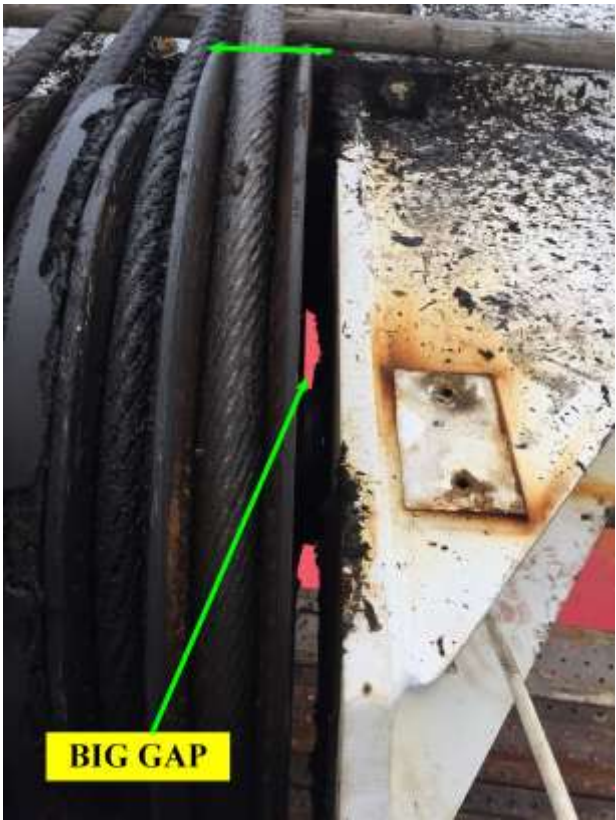
Constructed staging in place	End roller sheave found misaligned with big gap

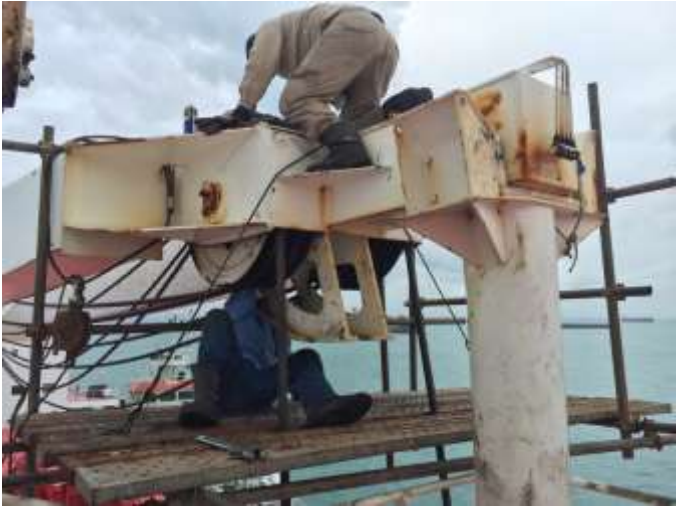
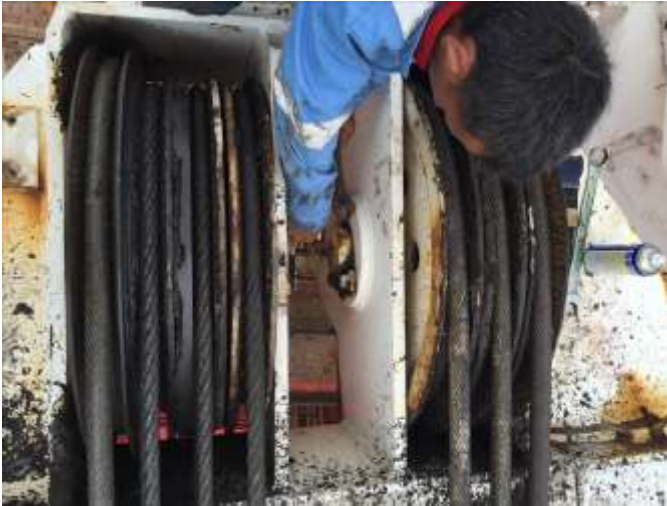
Commenced dismantling works	Removing supply line fittings.

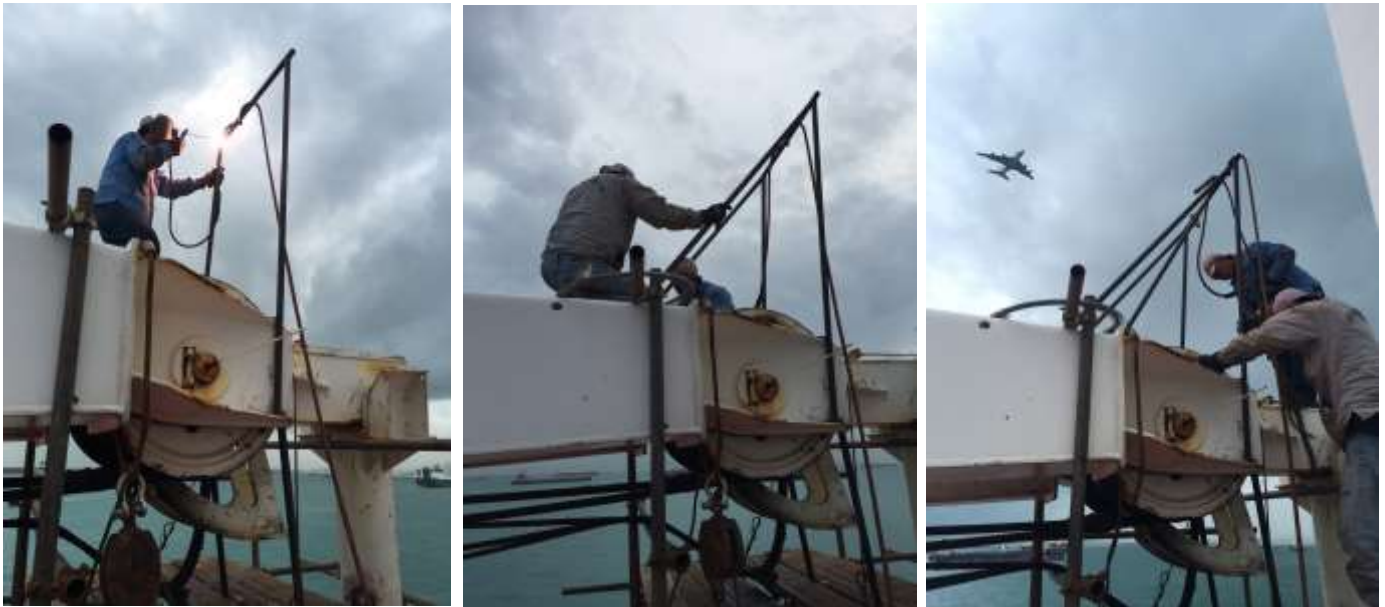
Fabricated lifting frame in situ & installed on top side of crane jib head

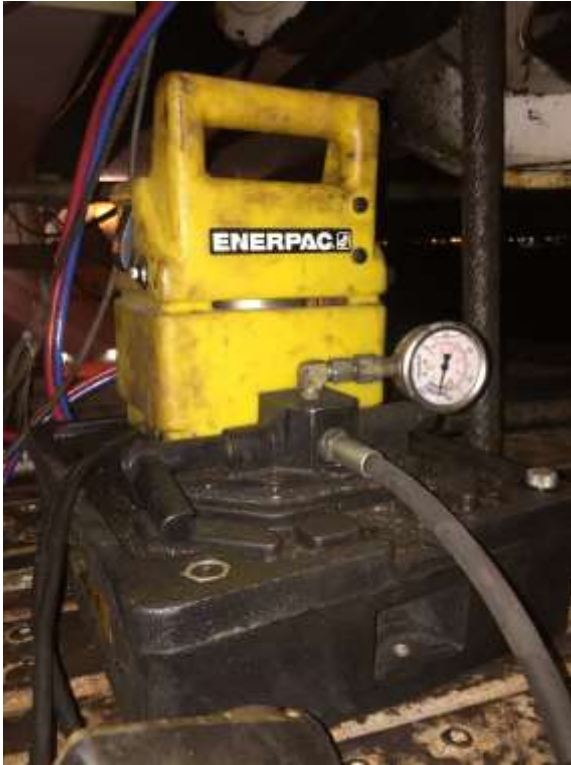
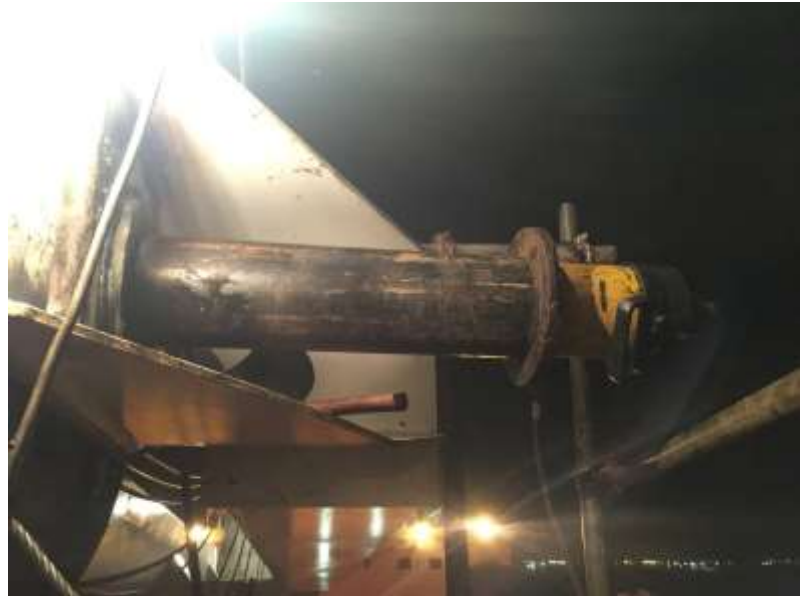
Attempted several times to extract intermediate pin, not successful.

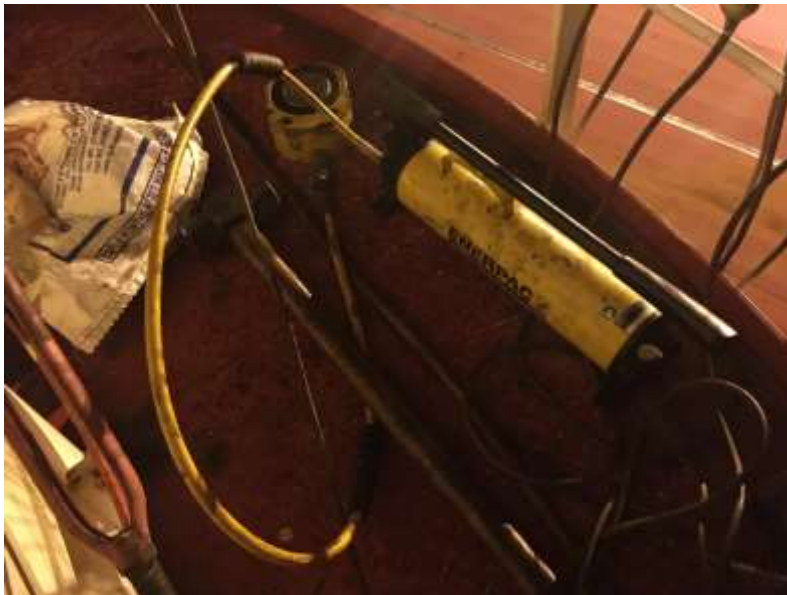
Mobilized additional set of hydraulic jack tools from shore workshop to vessel.

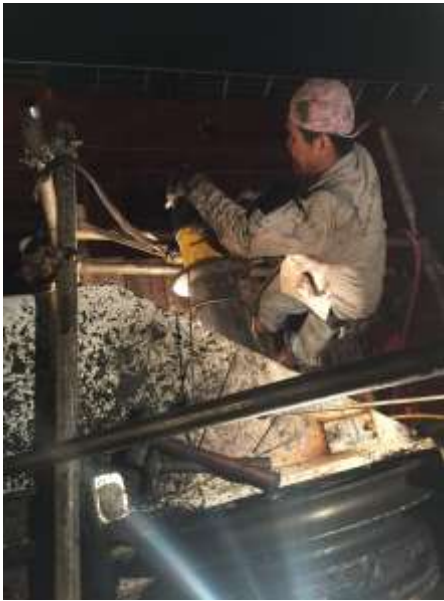
Re-attempt pin extraction

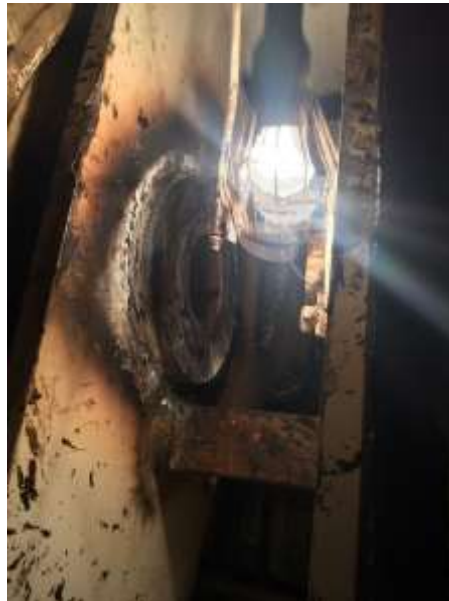
Pin extracted 50%

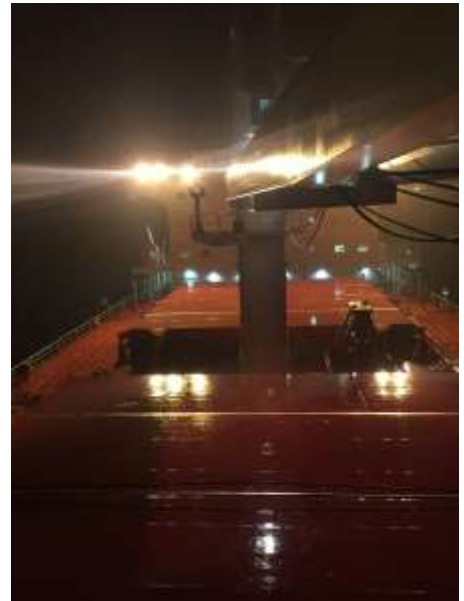
Work stopped due to rains

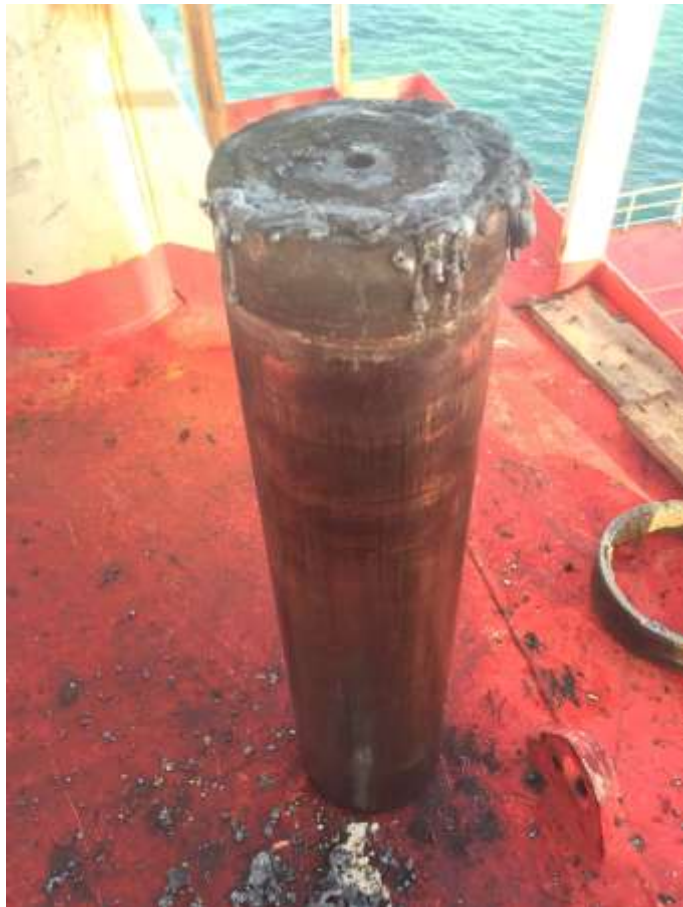
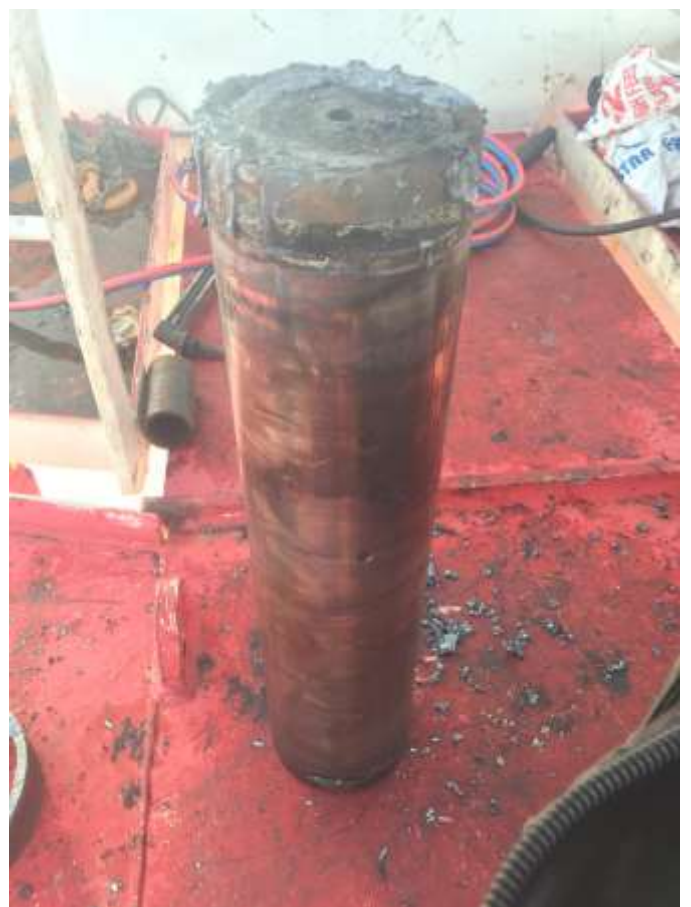
Extracted pin found in good condition

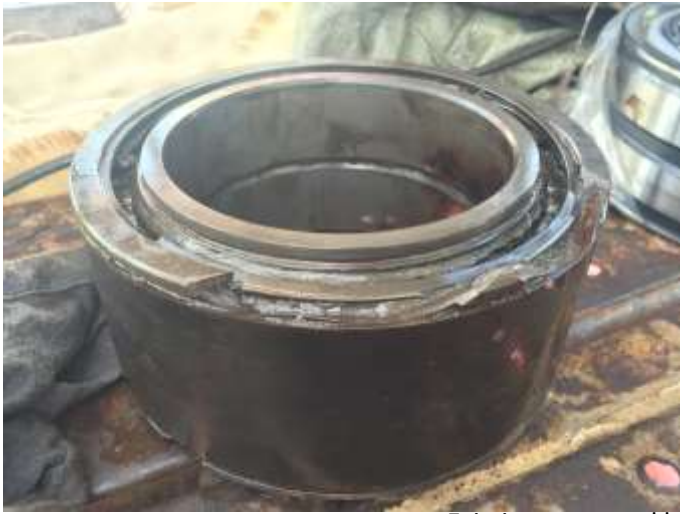
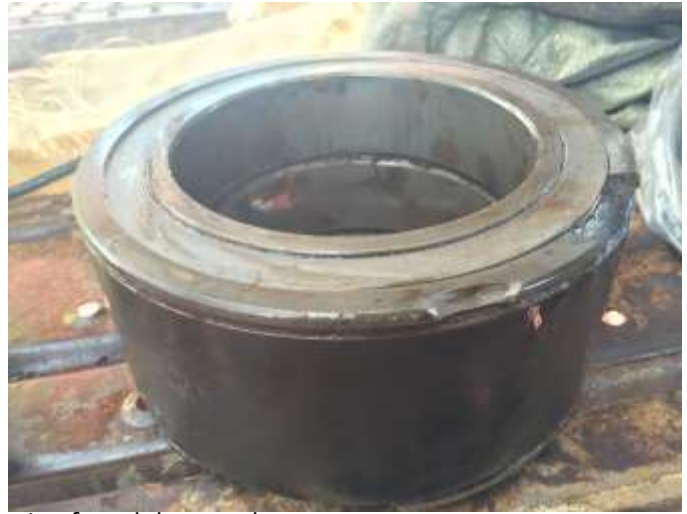
Existing extracted bearing found damaged

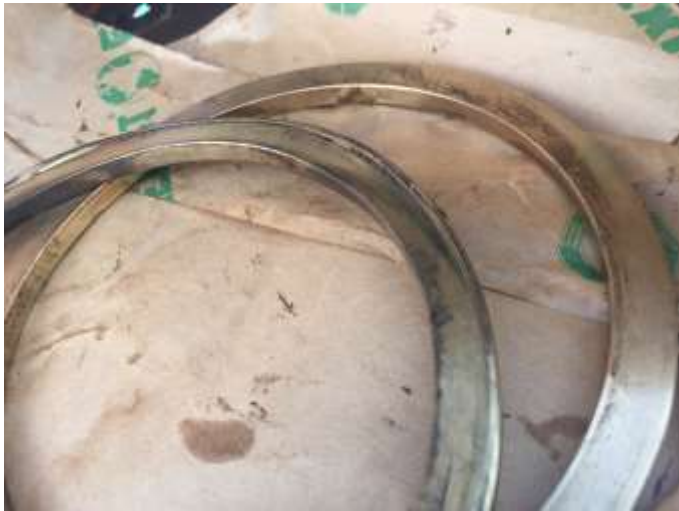
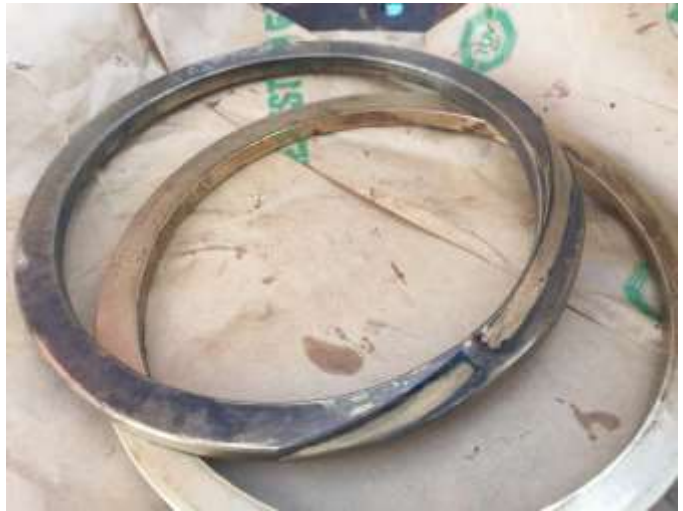
Existing collar plate found worn off
