PHOTO REPORT

Job No. : 2632

No.	Description	Pg1
<p><u>Subject (A) : Starboard Damaged Fender Repair @ OPL</u></p> <p>Scope : Removal of damaged fender & to Blank off cropped ends. (Temporary repair as requested by owner)</p> <div style="text-align: center;">

No.	Description	Pg1
<u>Subject (B) : Temporary Hull structural Repair In Steering Gear Room.(Transom Plate) @ OPL</u>

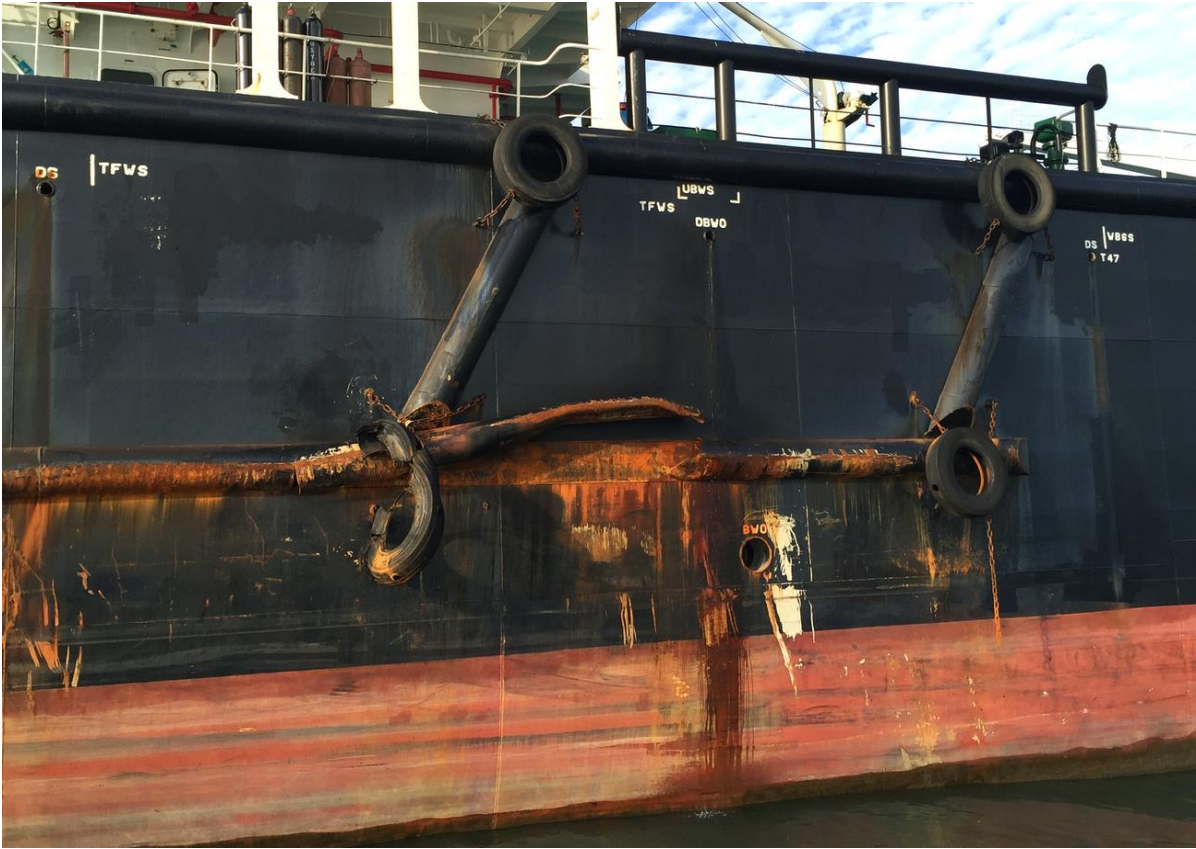
</div> <p style="text-align: center;"><u>Partial starboard fender damaged.</u></p>
