PHOTO REPORT

Job No. : 2633
Date : 06th May 2016
Location : Singapore IPL Anchorage

Description	Pg1
<p><u>Subject : Transportation, Relocation & Positioning of Shaft Generator</u></p>

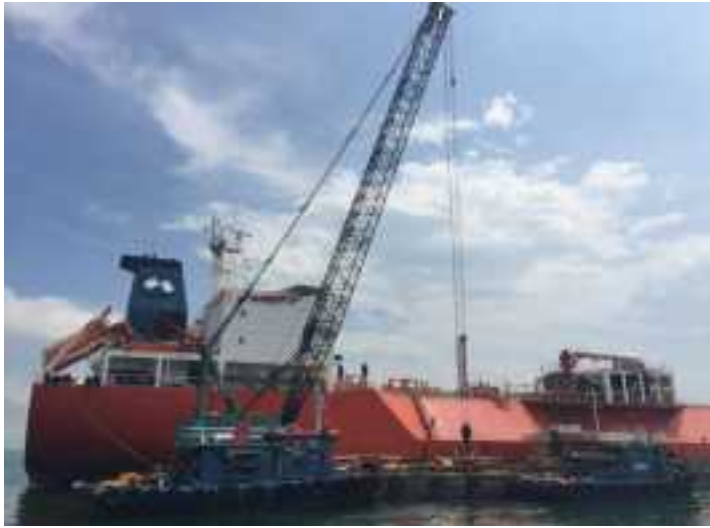
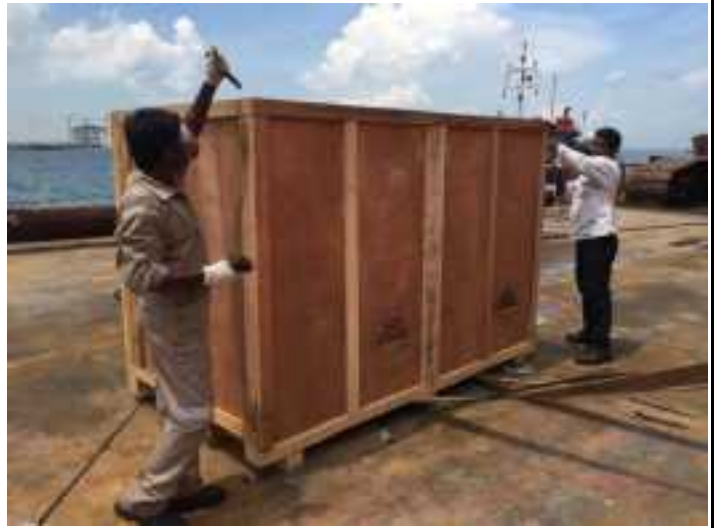
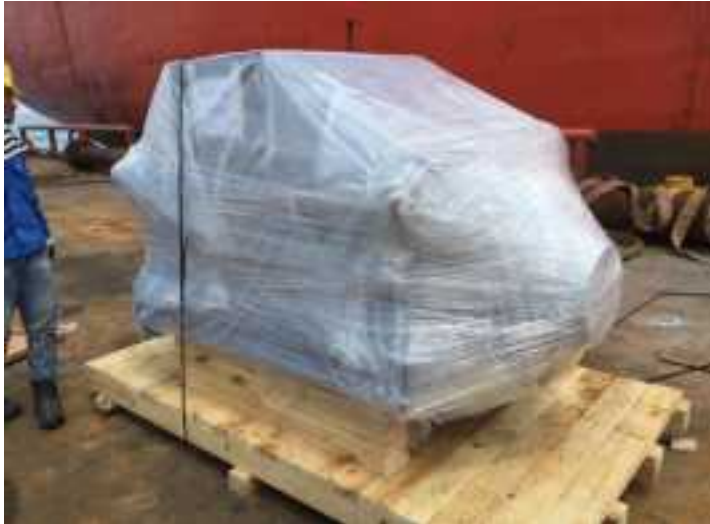
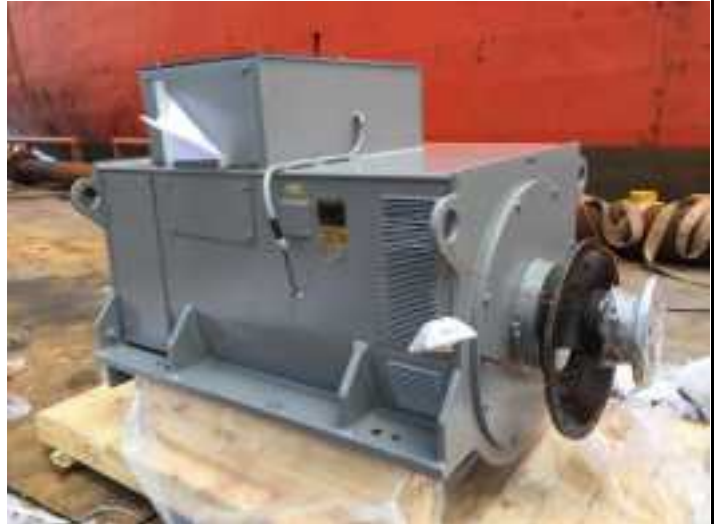
Removal of Wooden Crate Packaging

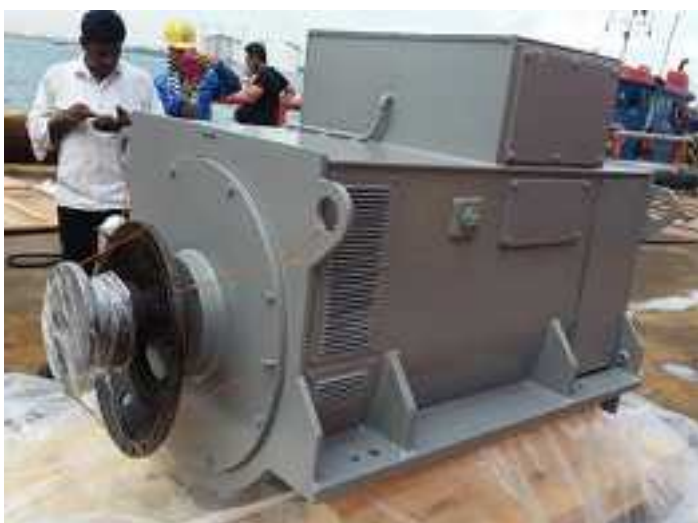
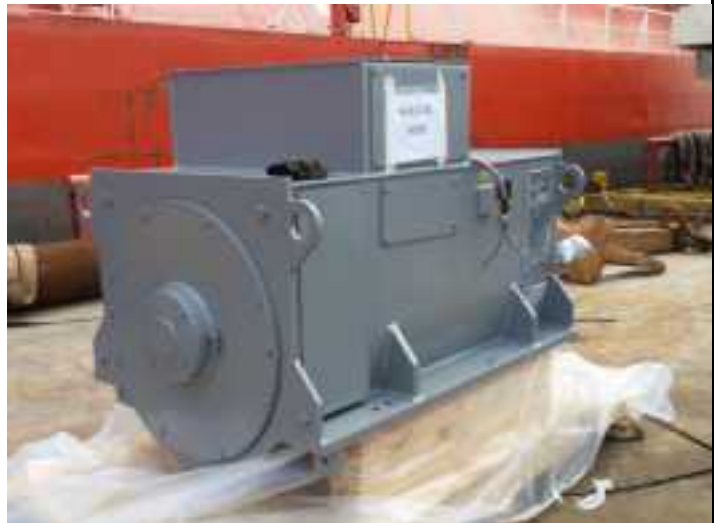
Shifting Route of Shaft Generator

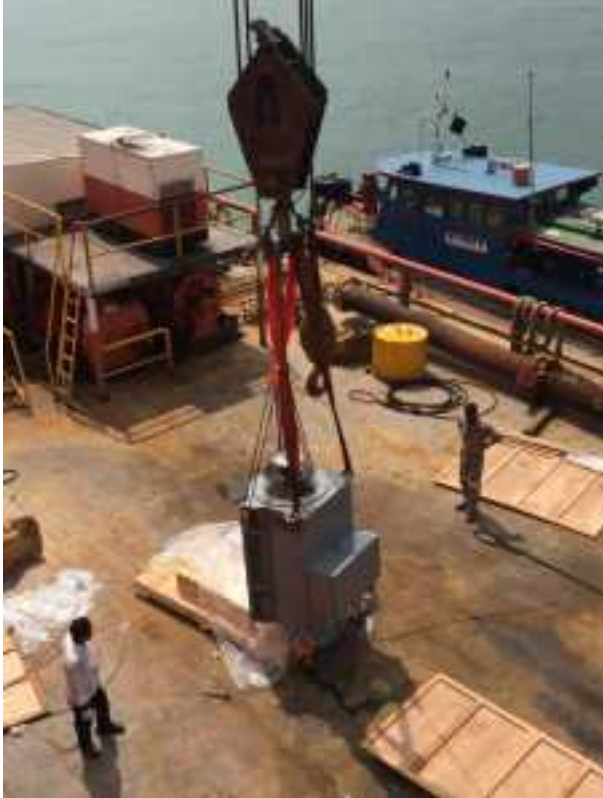
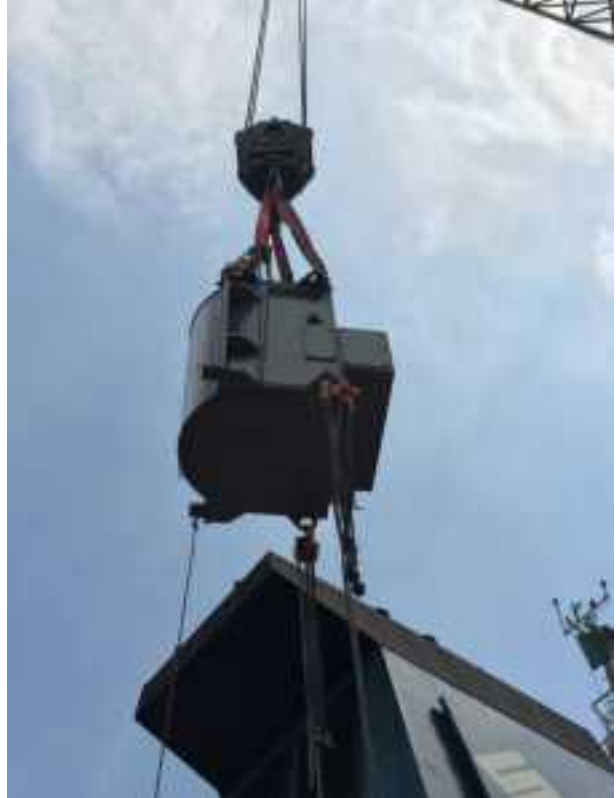
Shaft Generator lifted in vertical position due to insufficient clearance of sky light for entry

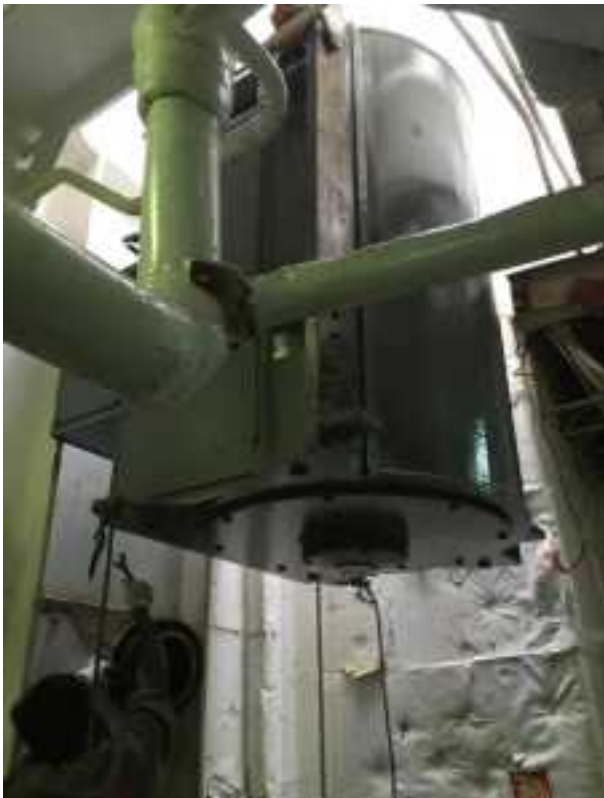
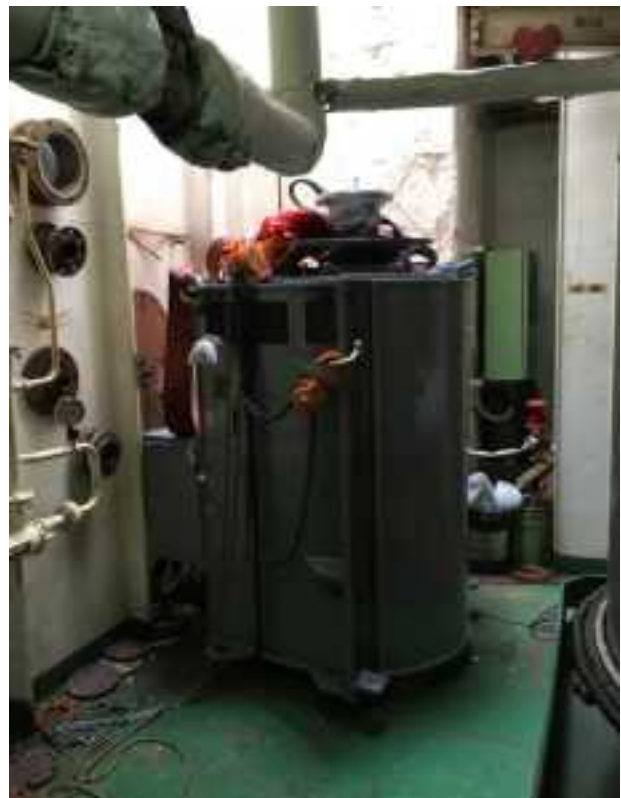
Removal of obstacle in way of Shaft Generator Shifting

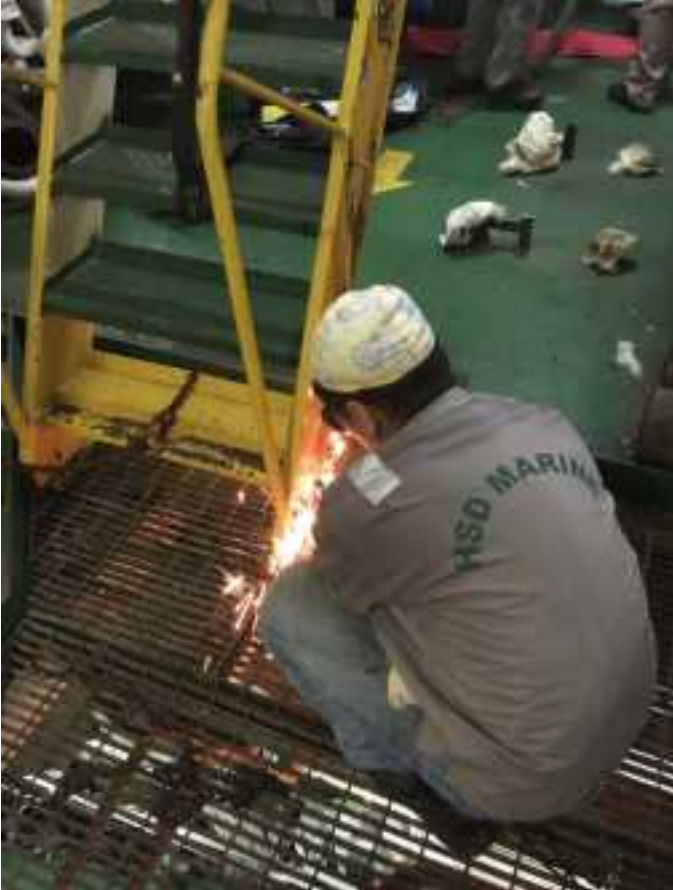
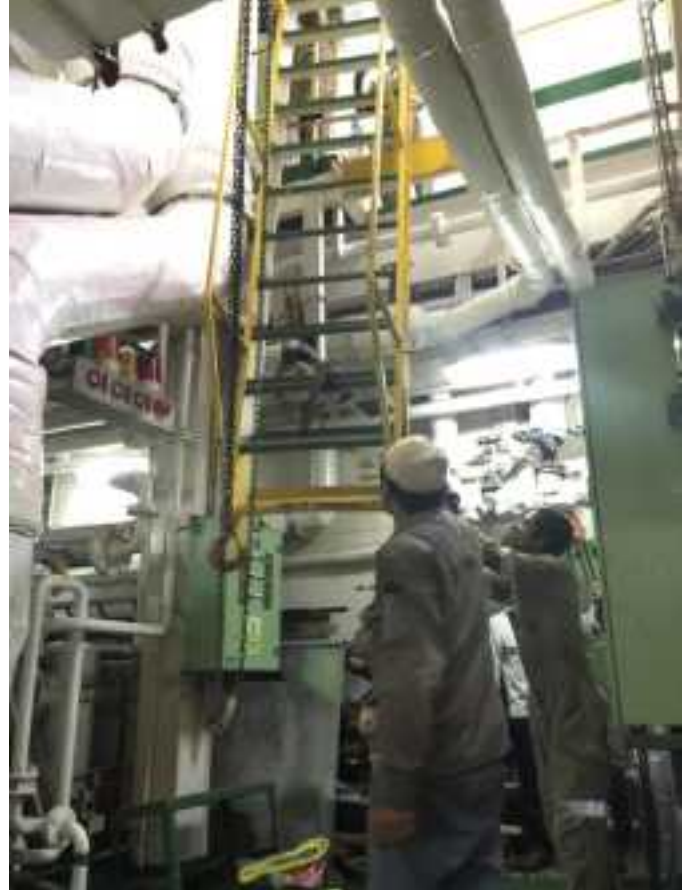
Removal of tween deck's ladder

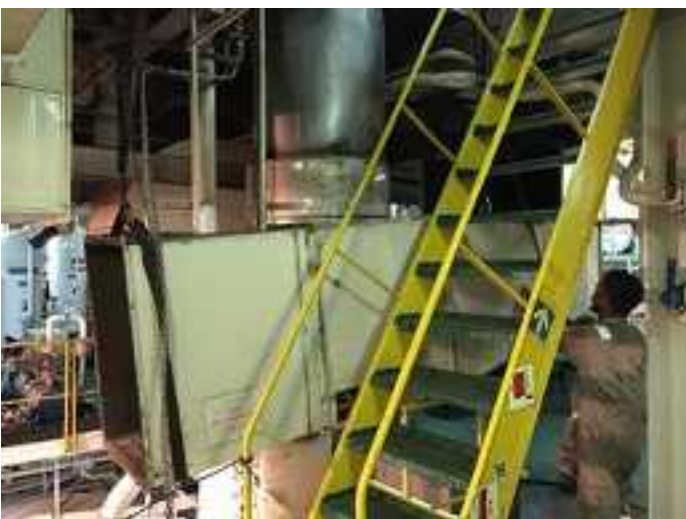
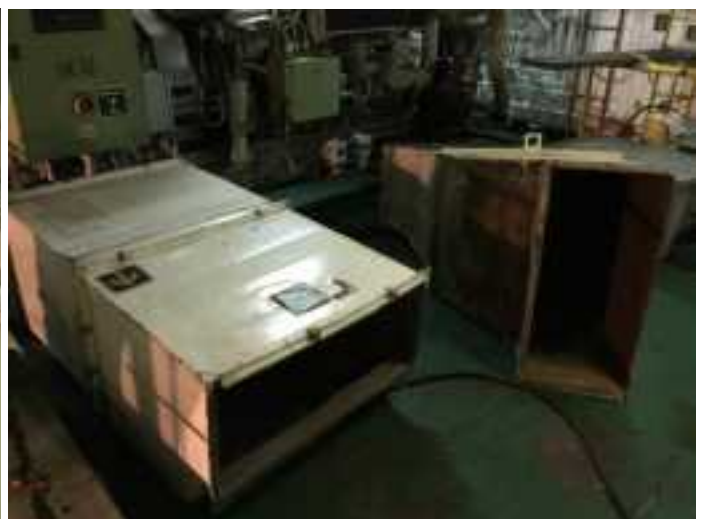
Removal of top level air ducting section to give way to shaft generator

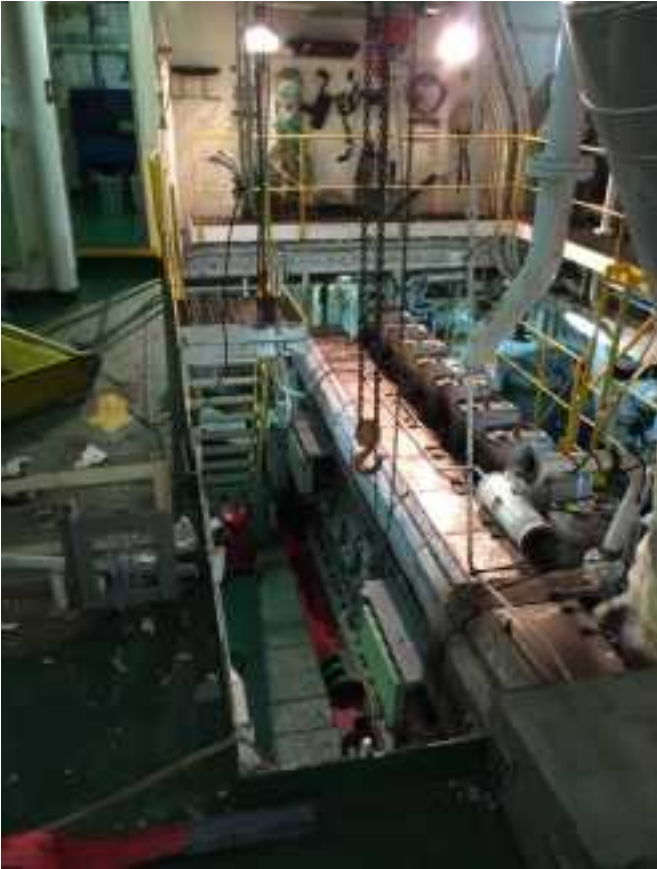
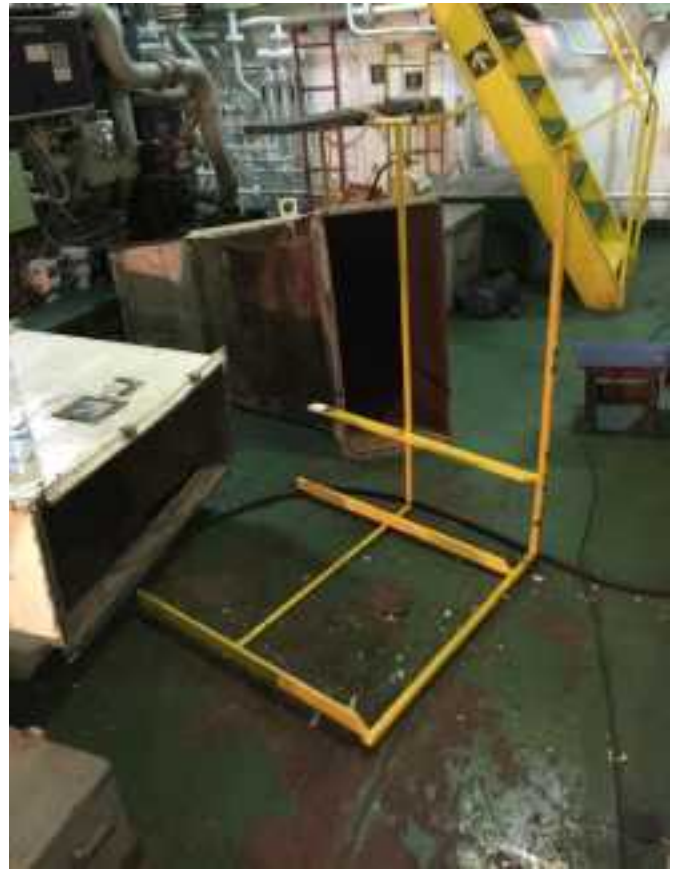
Removal of Railing in Engine room

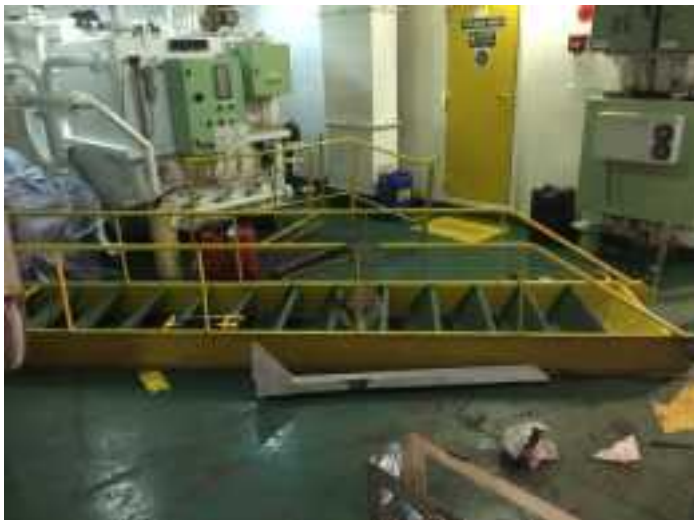
Removal of E/R access ladder

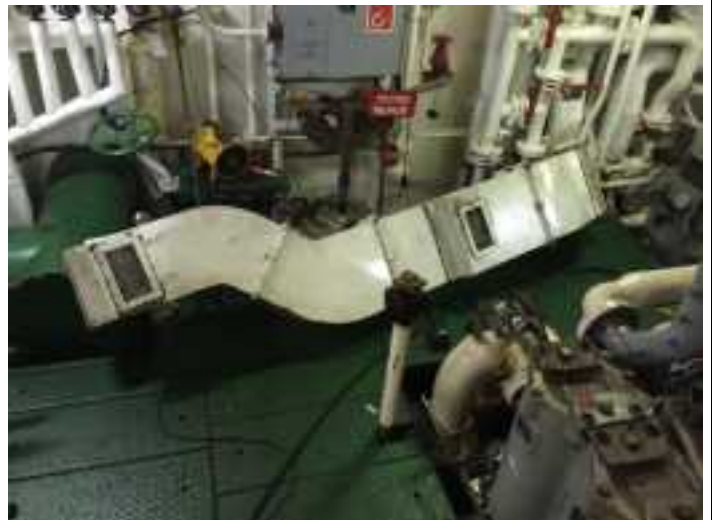
Removal of E/R air duct section

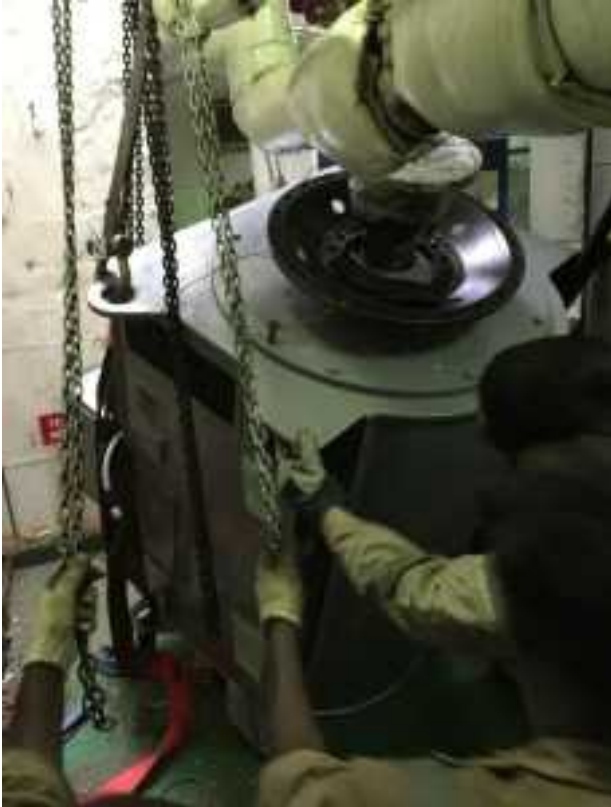
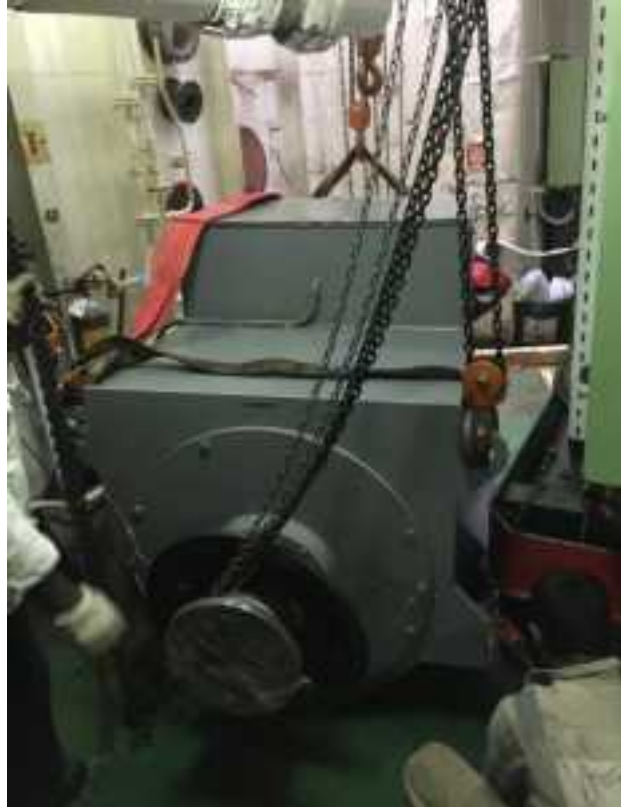
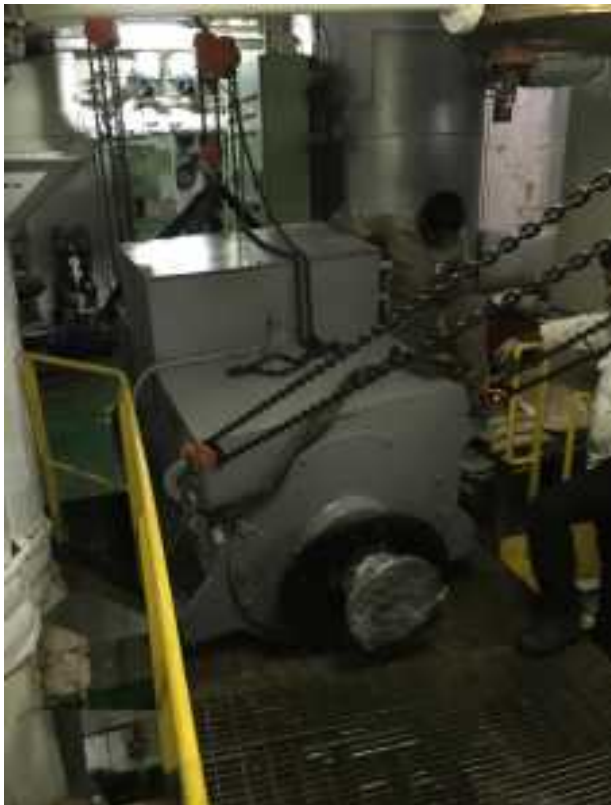
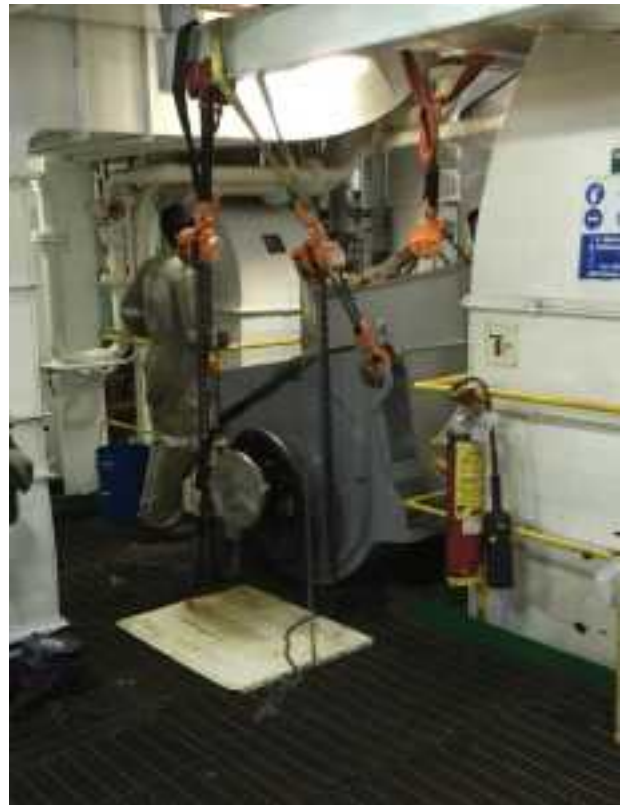
Shifting & Lifting of Shaft Generator down to Engine Room

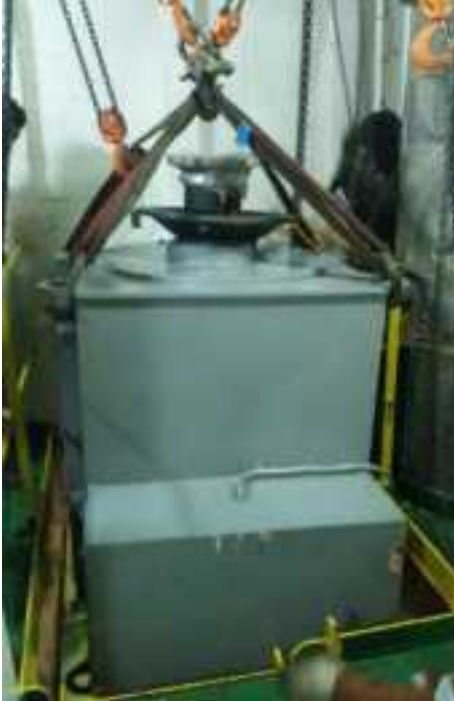
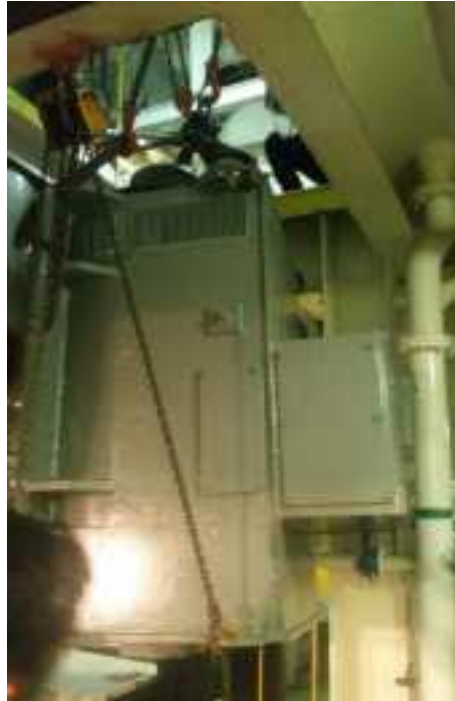
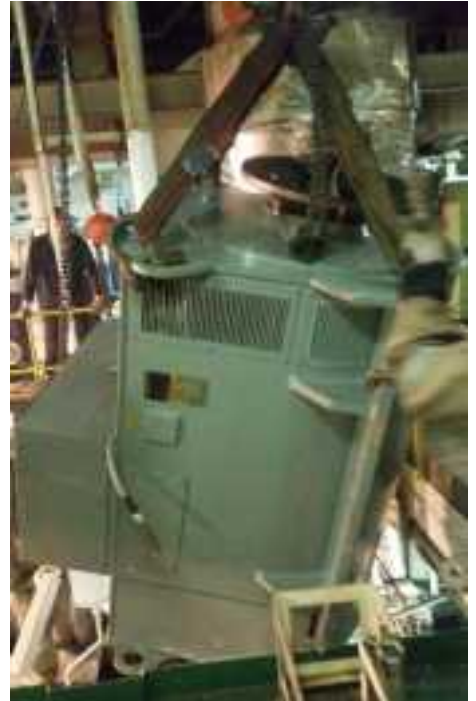
Shaft Generator were stuck due to insufficient clearance for going through

From 2300hrs to 0300hrs, further removal of pipes, brackets, phone booth & air duct then resume shifting

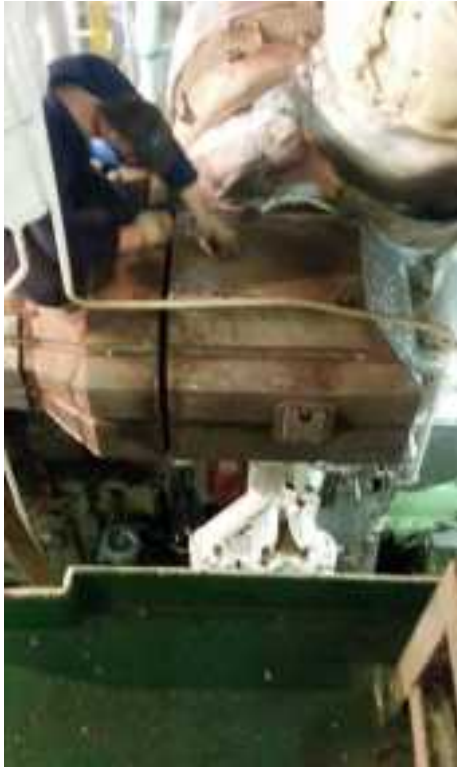
Removal of Engine Parts

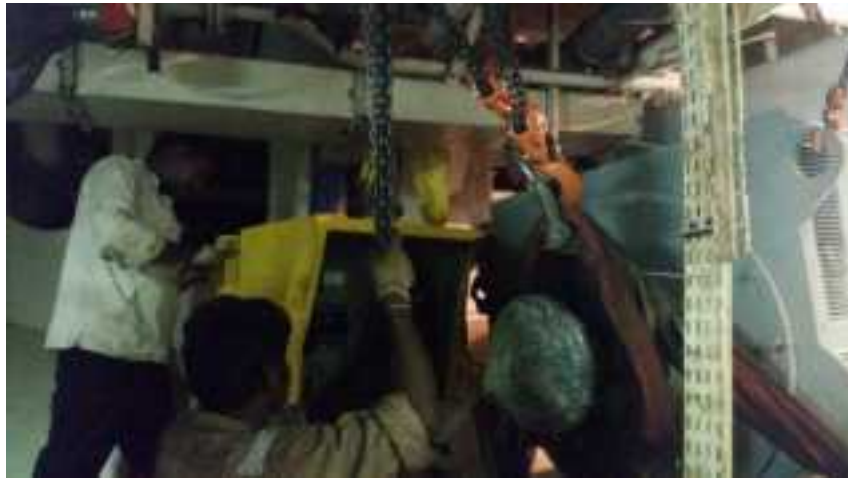
Removal of communication booth

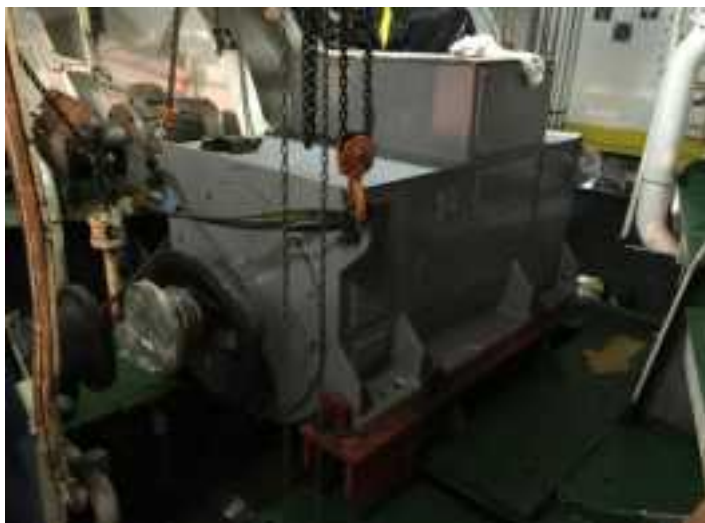
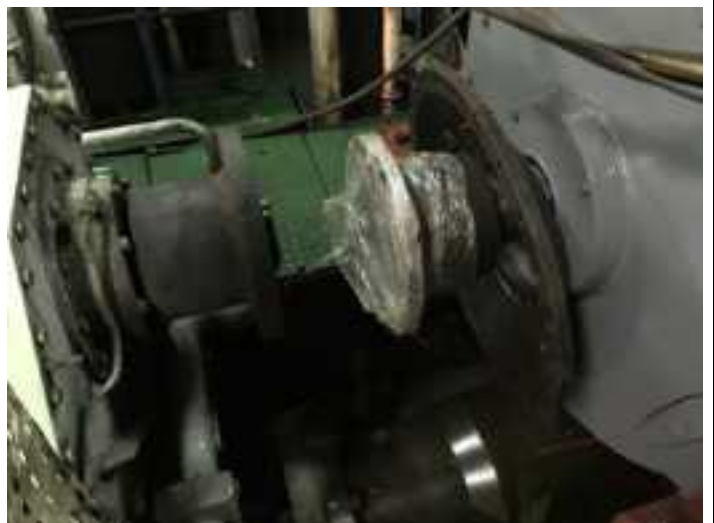
Shaft Generator were shifted into position at 0430hrs

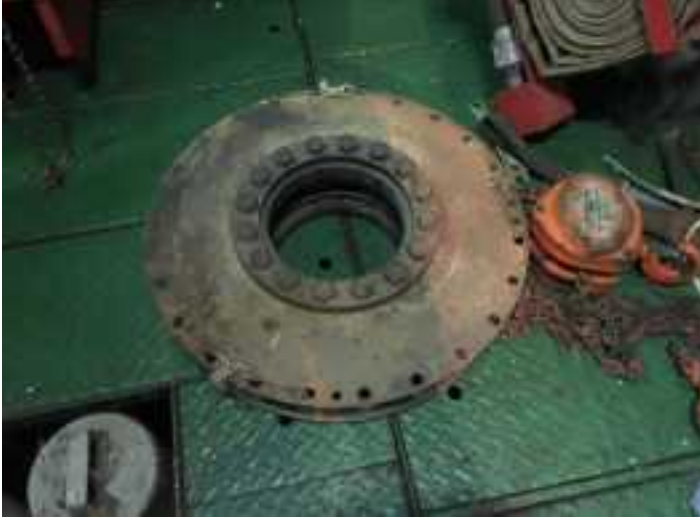
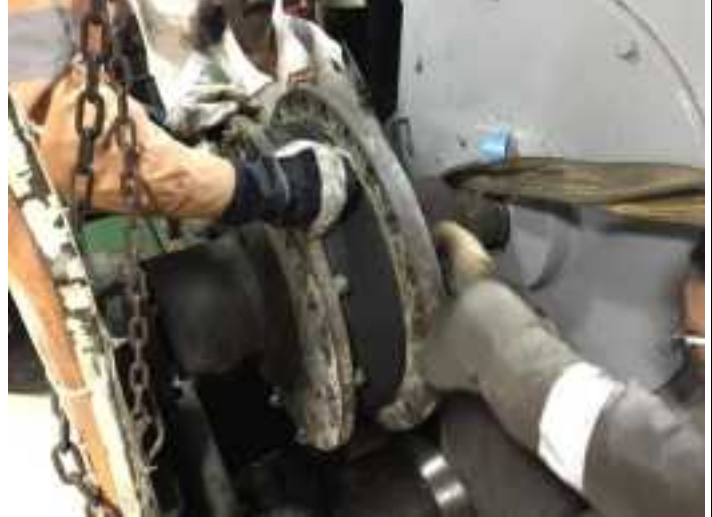
Assembled vulkan coupling connecting to shaft of generator

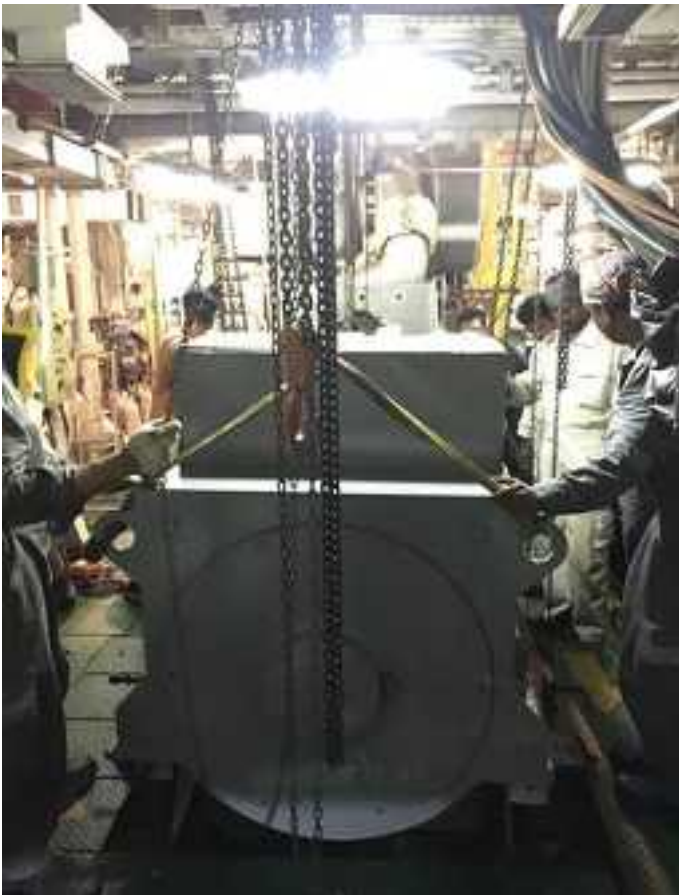
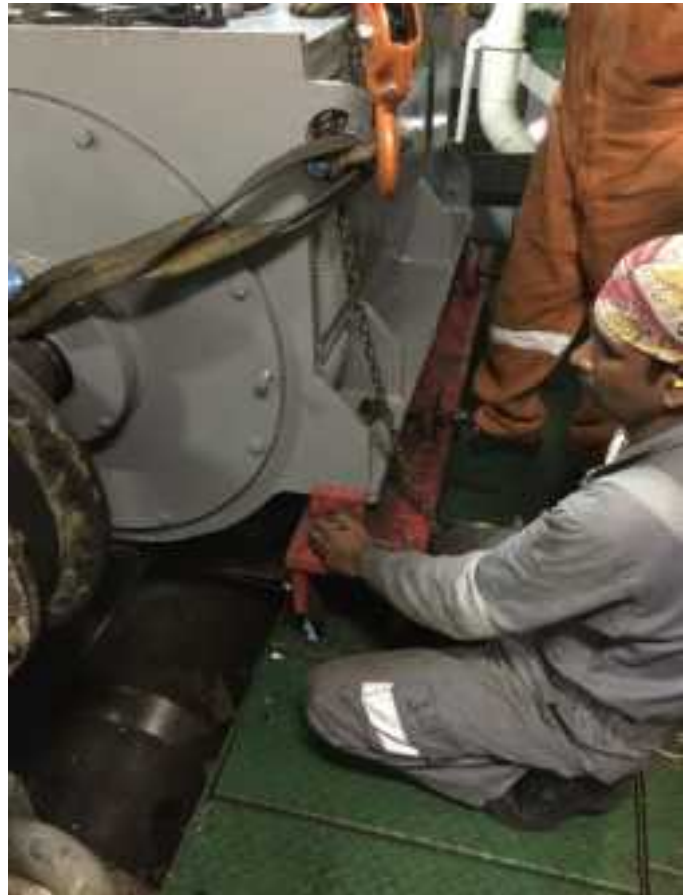
Adjusting alignment of generator & jacking bolts of foundation

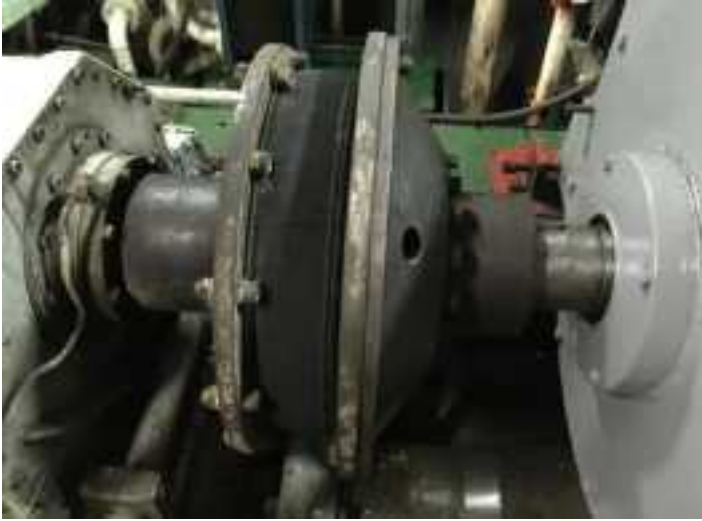
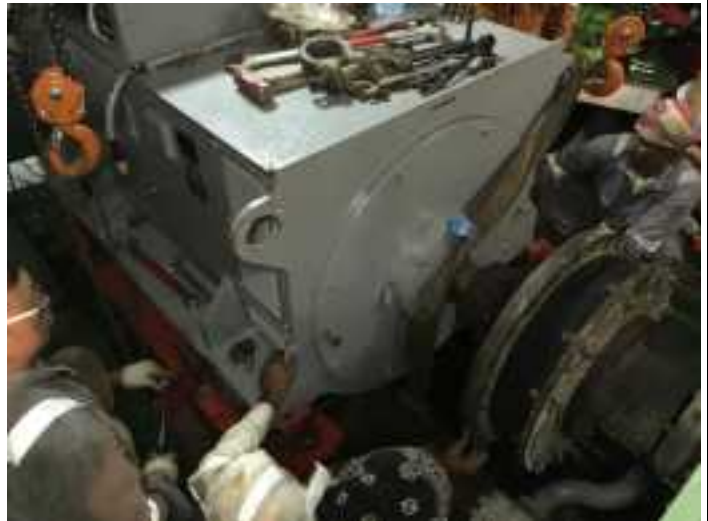
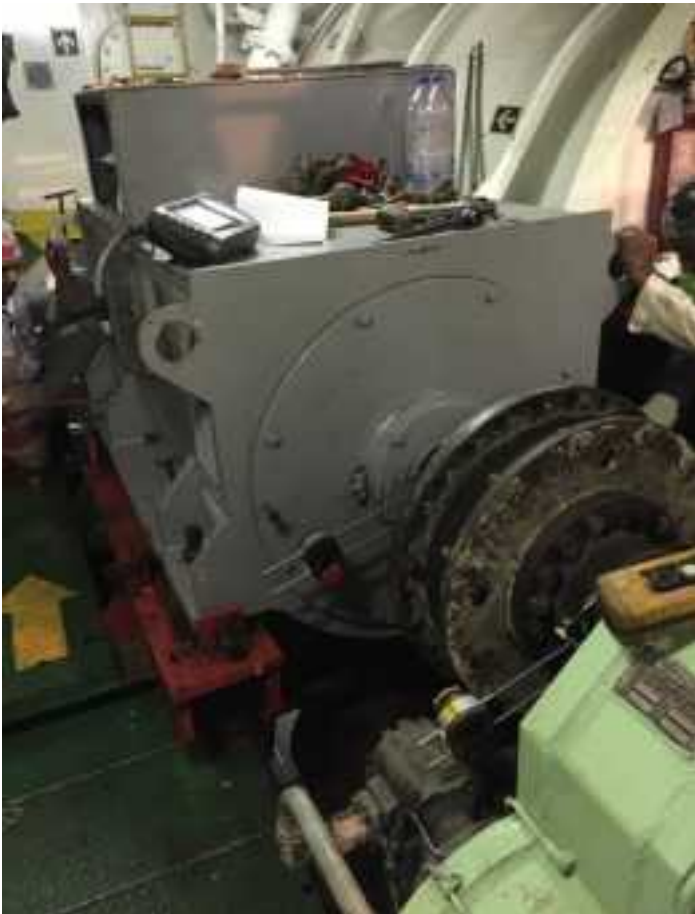
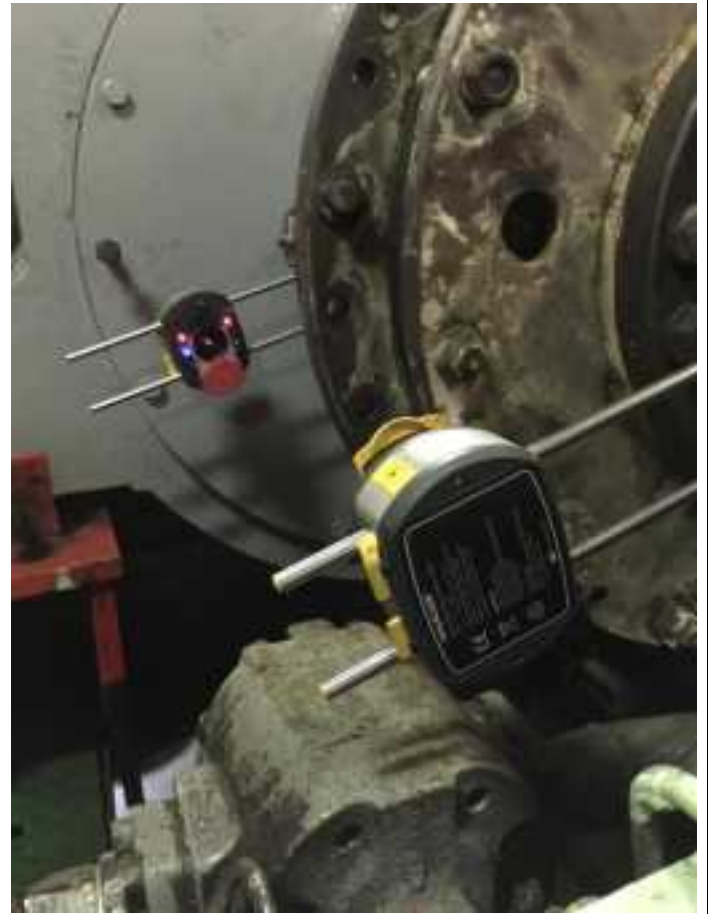
Laser alignment in progress

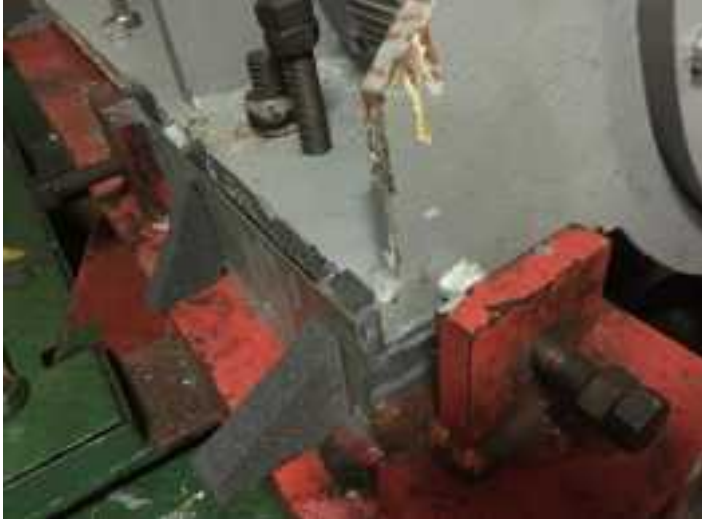
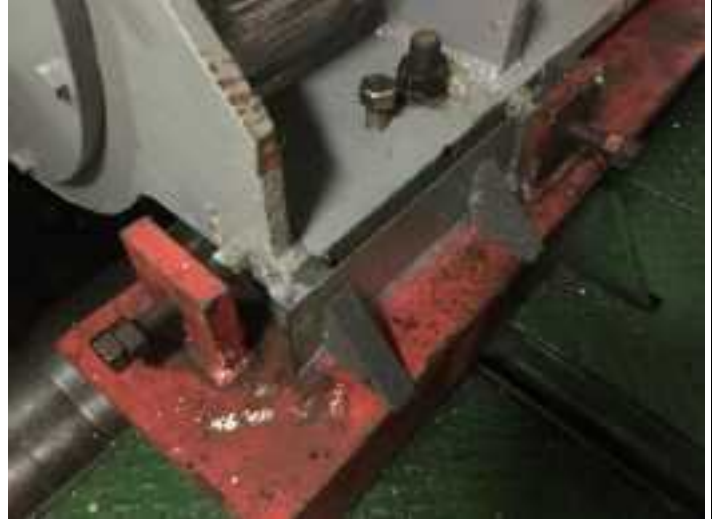
Constructed coaming for chockfast material

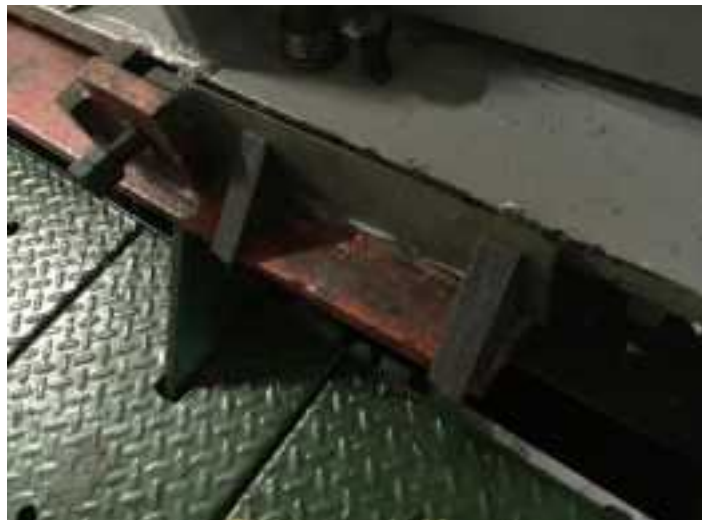
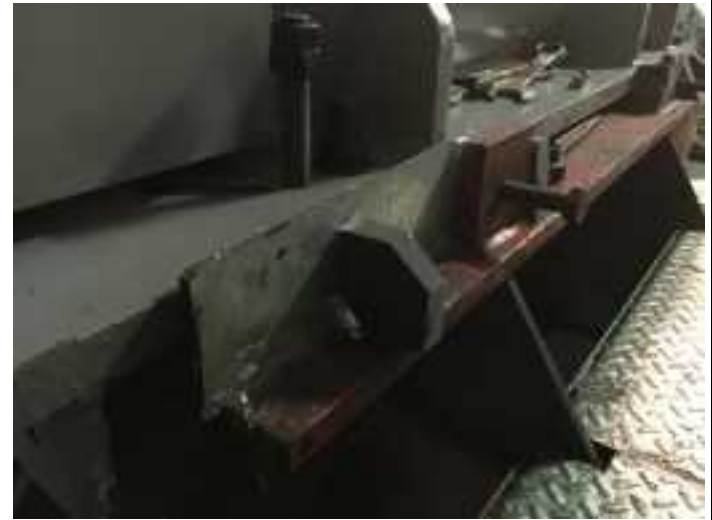
After constructed coaming for chockfast material, waited for 1hr for curing time

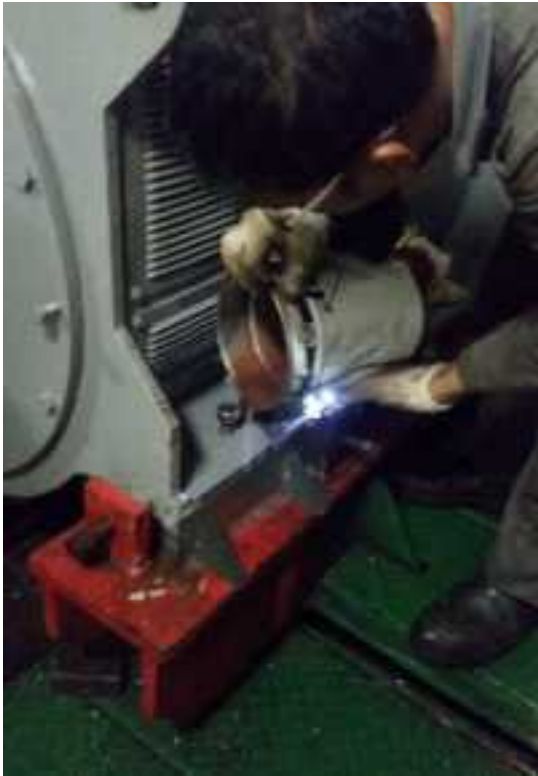
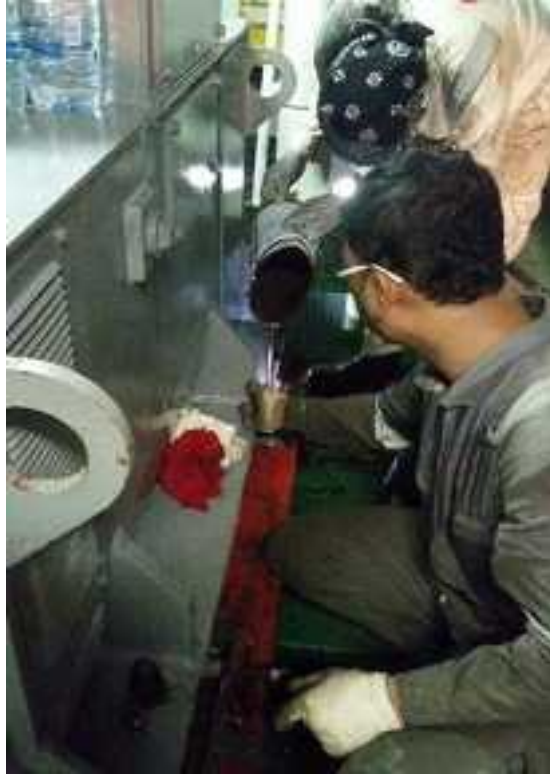
Chockfast material were then poured into coaming, as per photos shown below.

Chockfast hardening requires 18 to 24 hours, team to re-attend next day for final inspection, and final round of laser alignment.

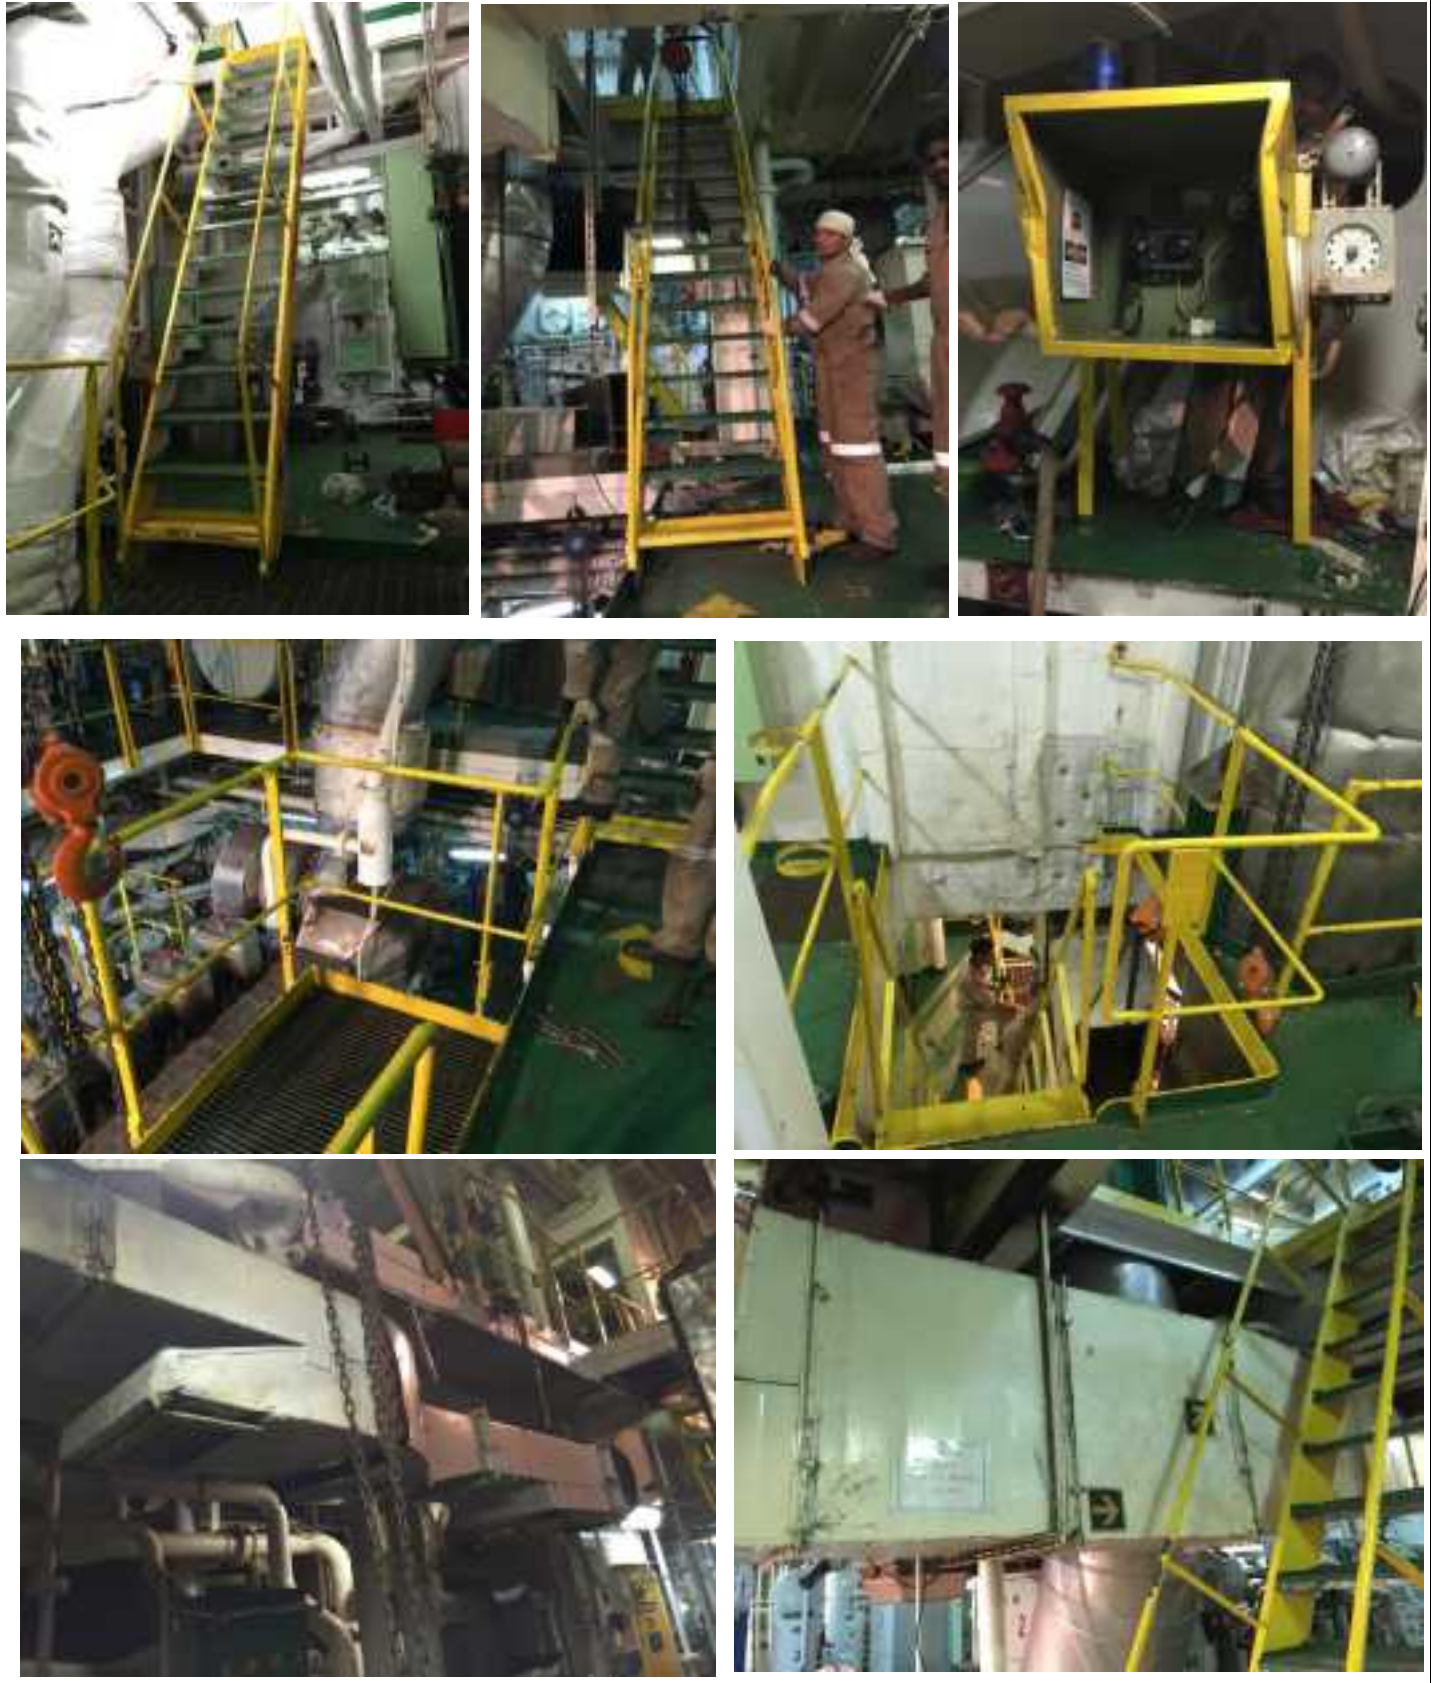
Reassembling of ladders, air ducts, pipes & railing
