PHOTO REPORT

Job No. : 2633
Date : 06th May 2016
Location : Singapore IPL Anchorage

Description	Pg1
<p><u>Subject : Transportation, Relocation & Positioning of Shaft Generator</u></p>

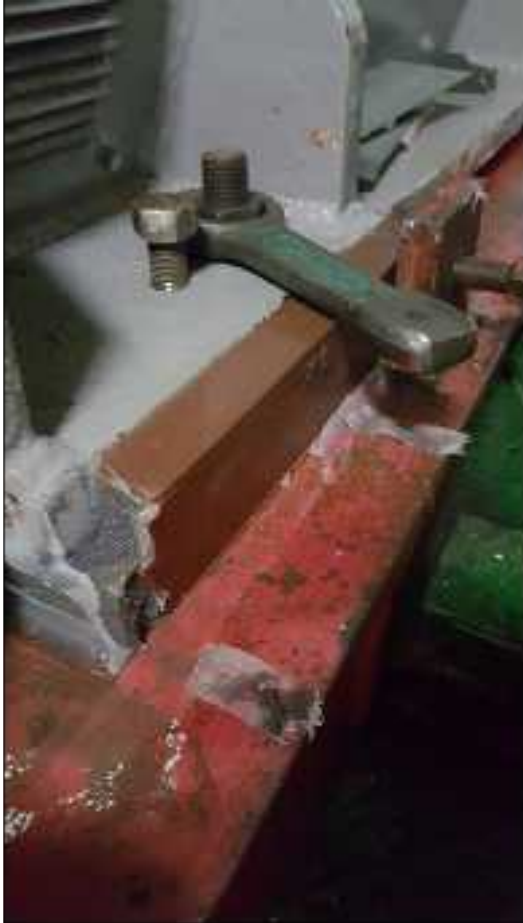
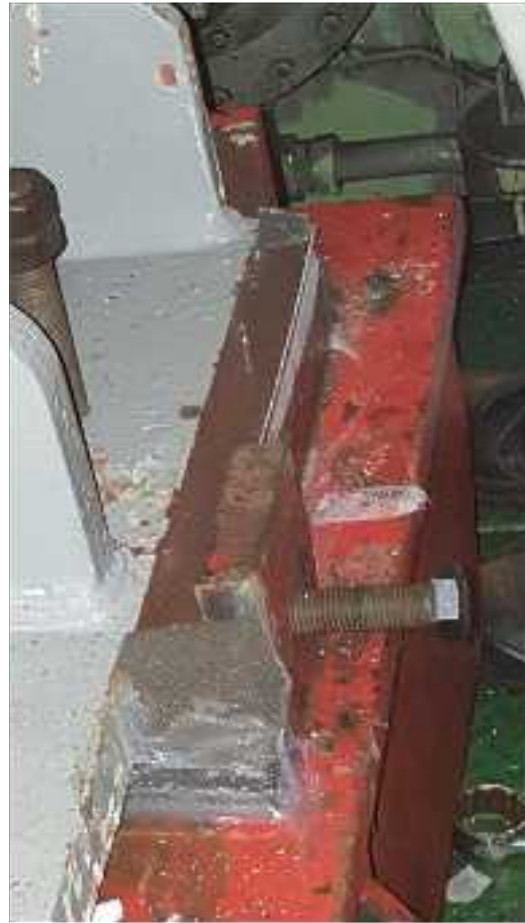
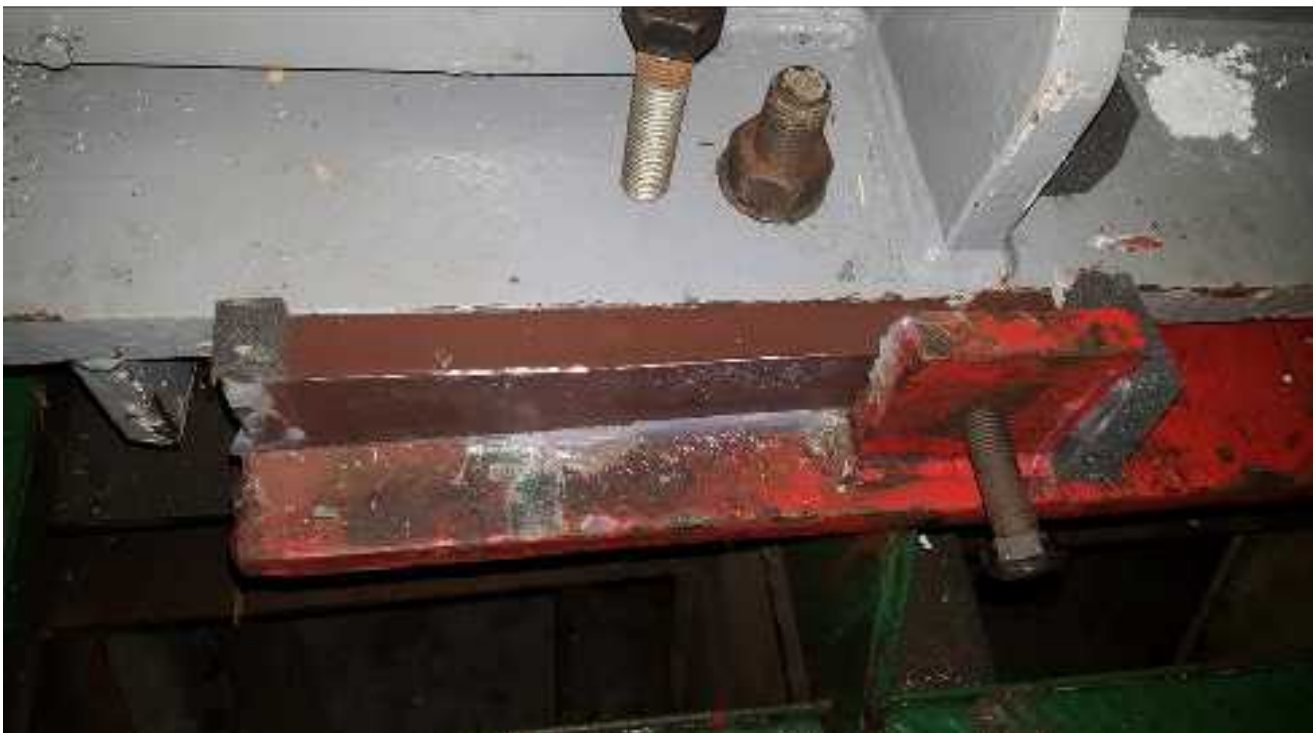
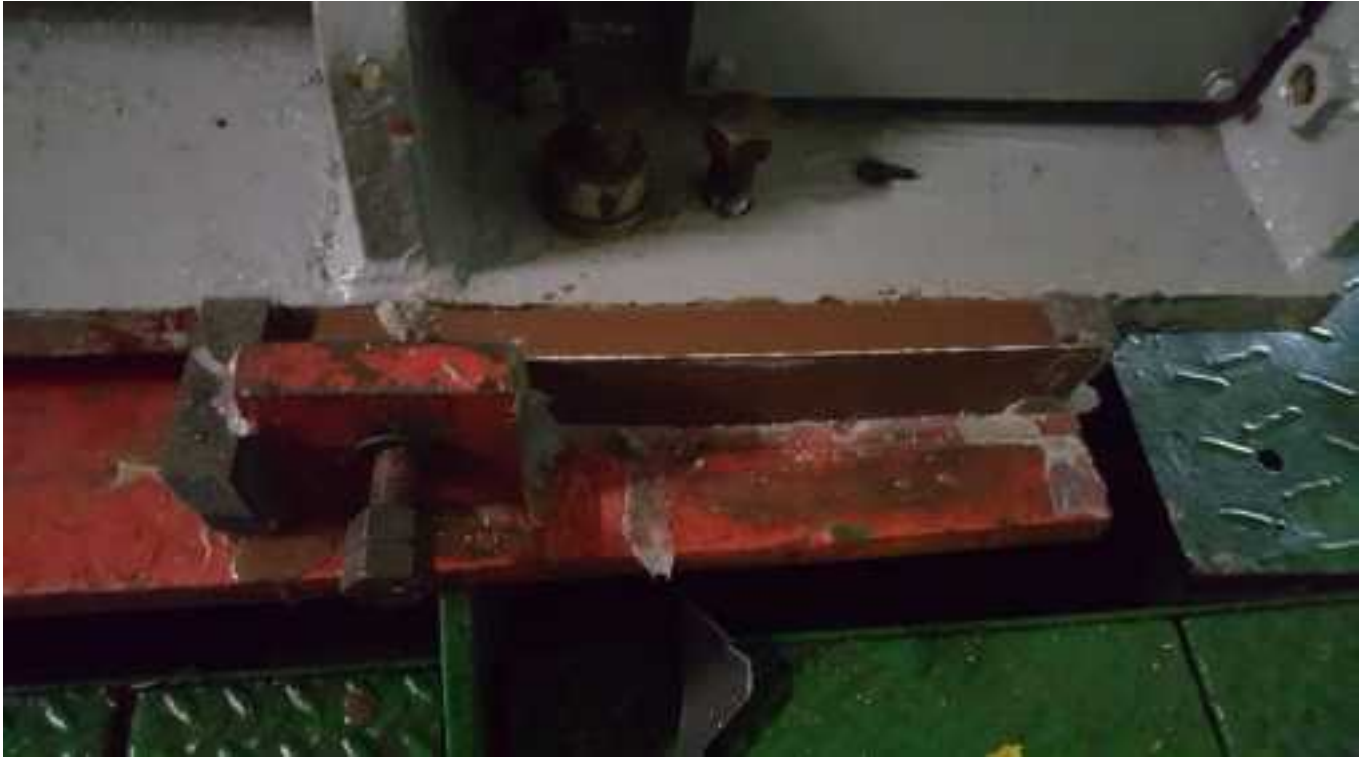
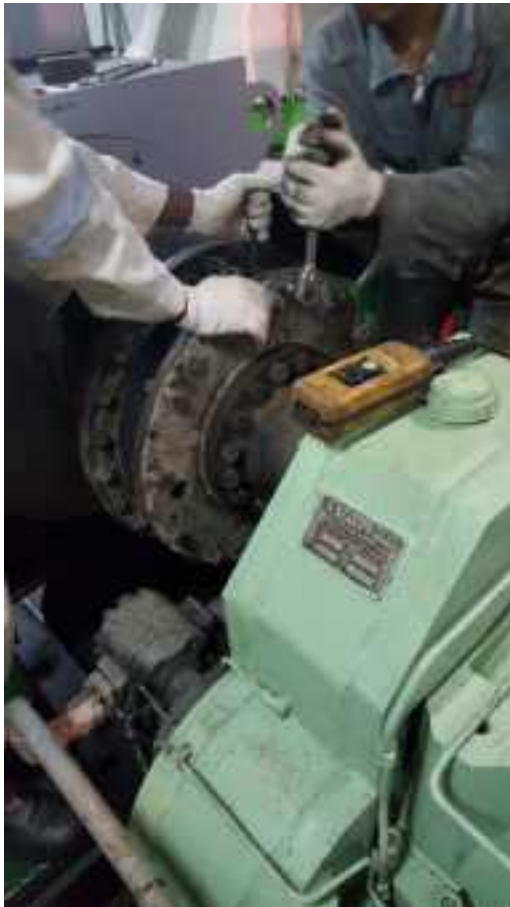
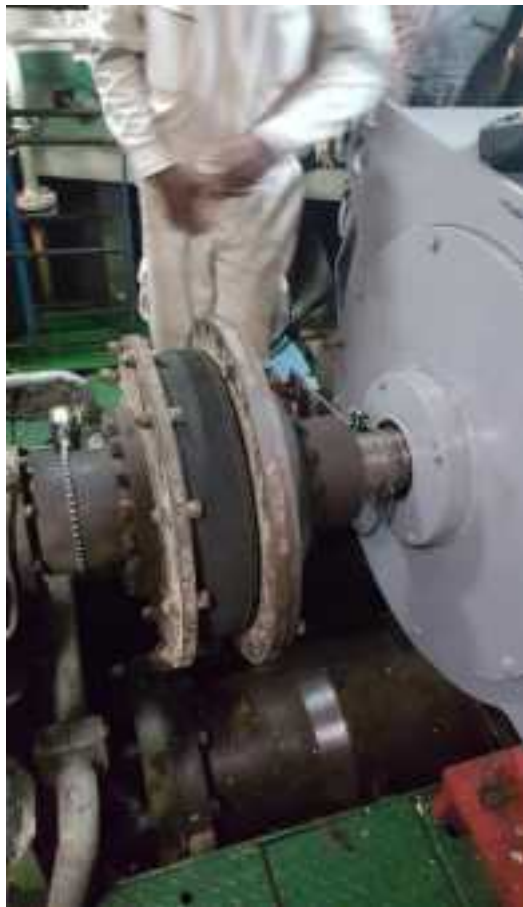
Chockfast Hardened & Final Laser Alignment

Carried out final adjustment & conducted laser alignment, results found satisfactory

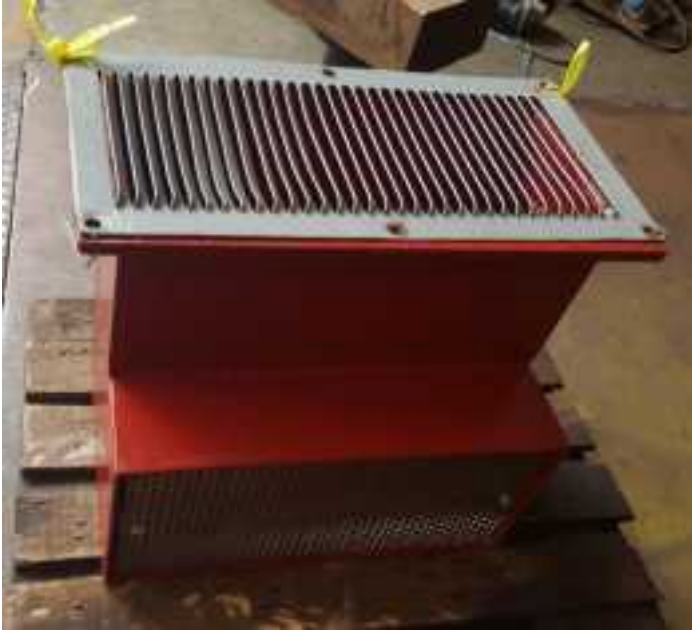
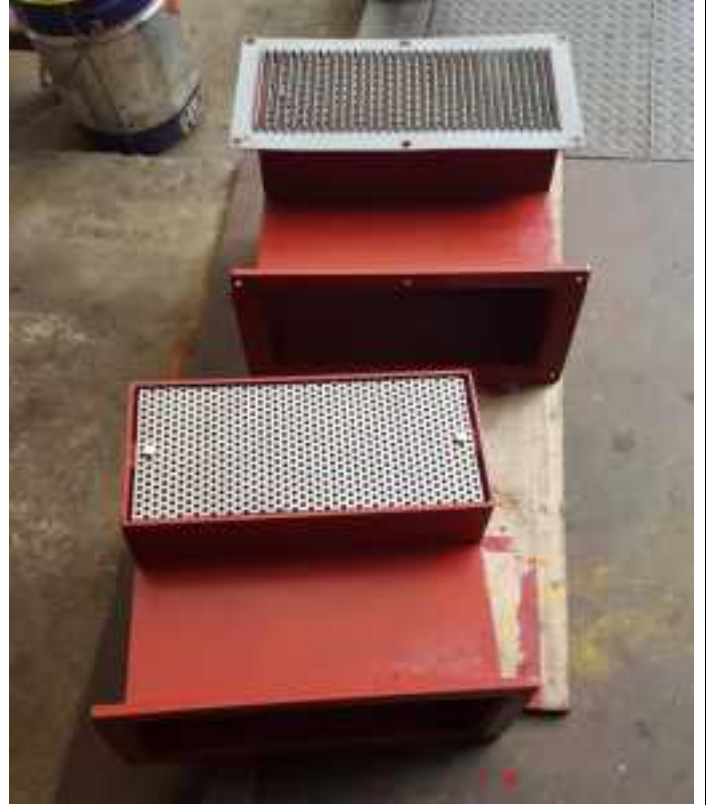
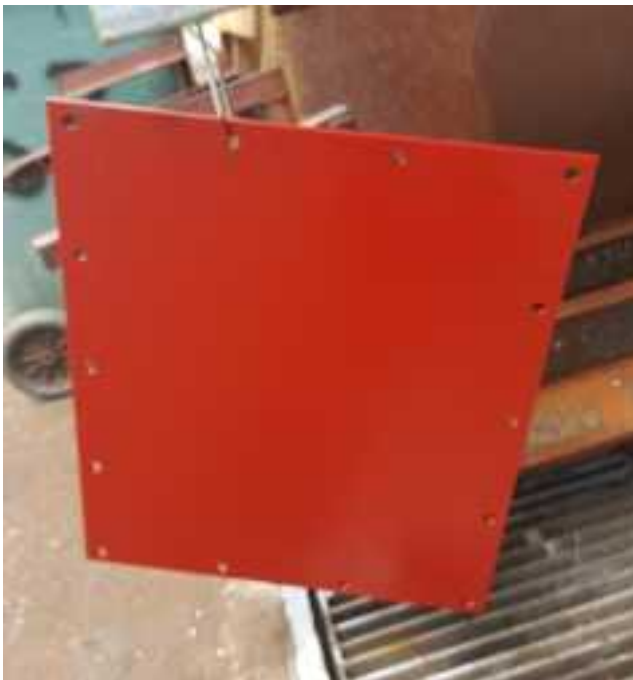
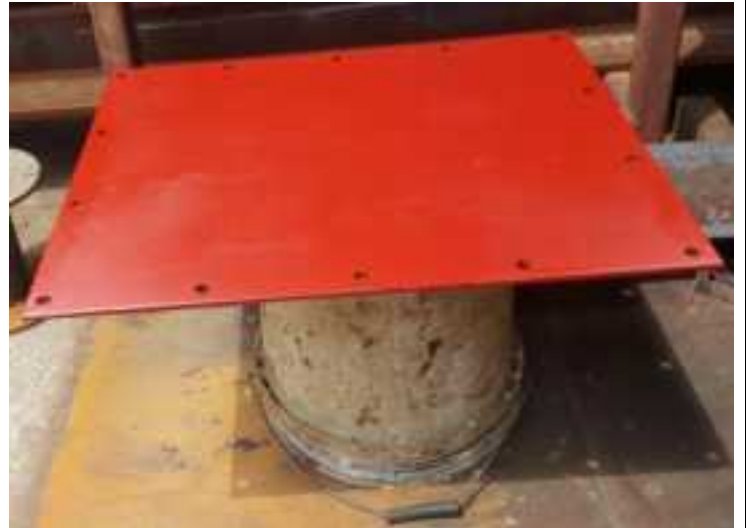
Fabrication & Supply of Alternator's top cover x 2pcs & side air vent duct x 2pcs
