PHOTO REPORT

Job No.: **2638**

Location: **Waigaoqiao Terminal,
Shanghai, China**

Subject: Renewal of damaged cell guide iwo Bay 38 Row 11

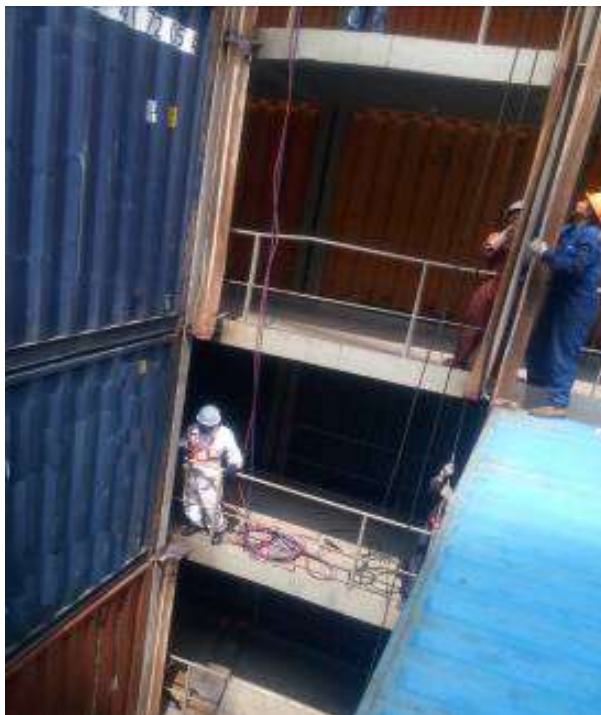
The following is the damaged cell guide

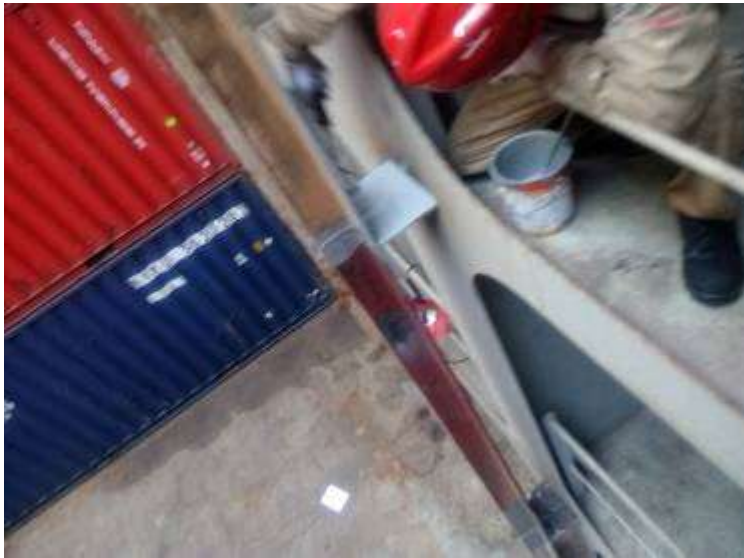
3. After job completed and container loading test had been carried out, the container was smoothly moving up and down.
