# PHOTO REPORT

Job No. : 2895

Date : 13th May 2017

**Subject : Fabrication and Installation of Ropeguard in Underwater at IPL**

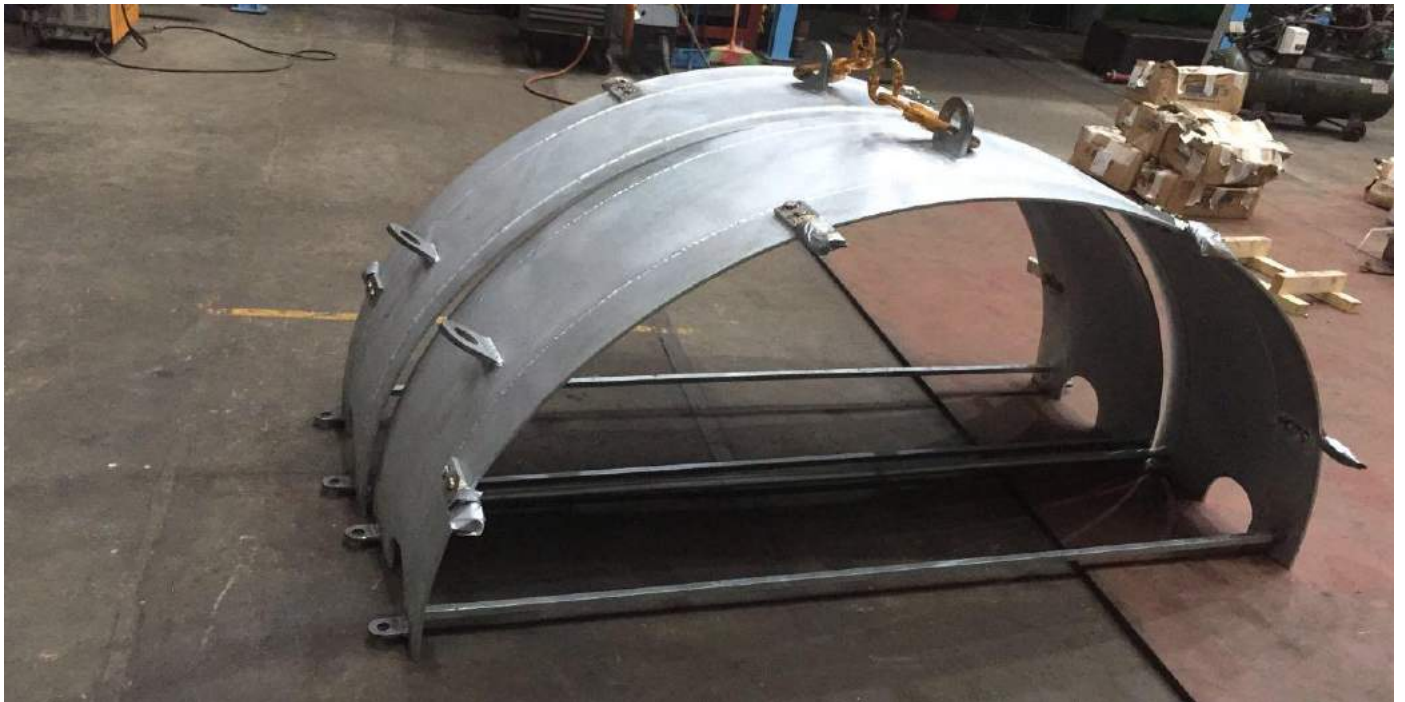
↑ Pre-fabricated Rope Guard in HSD Workshop

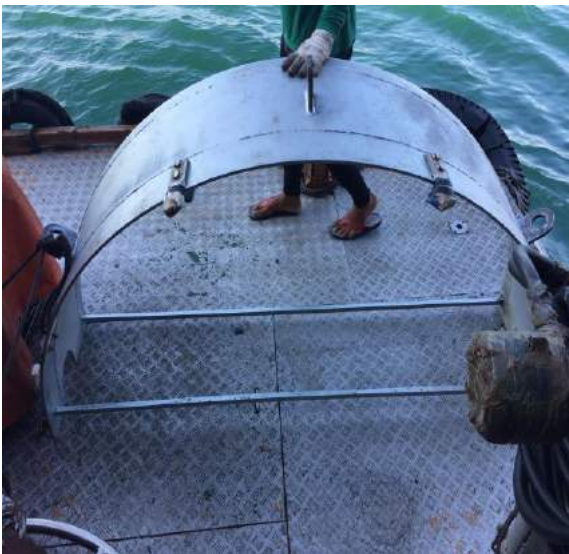
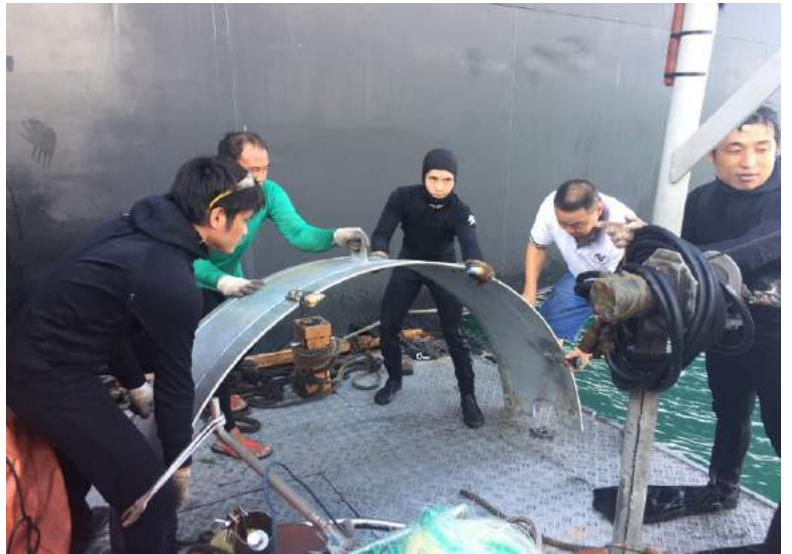
↓ New Rope Guard loaded on boat

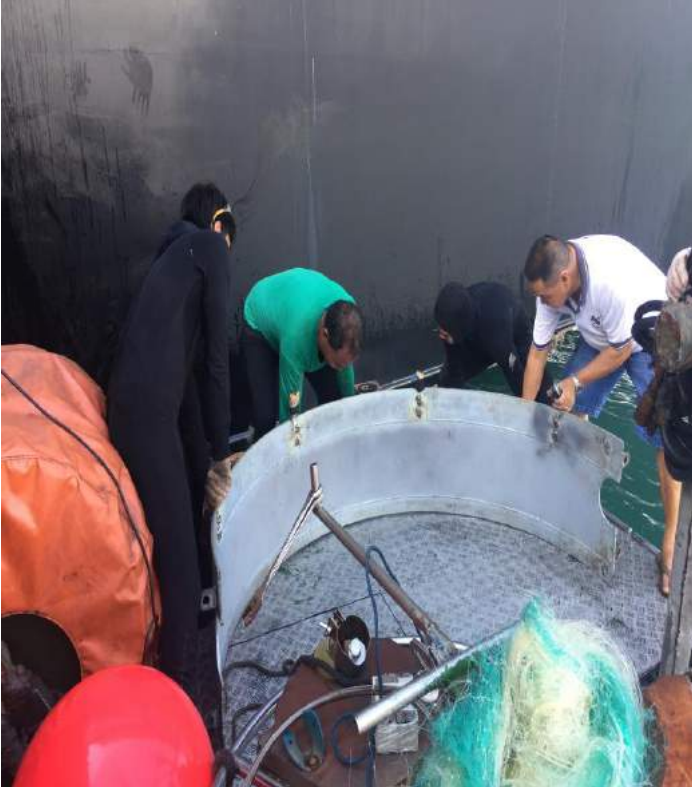
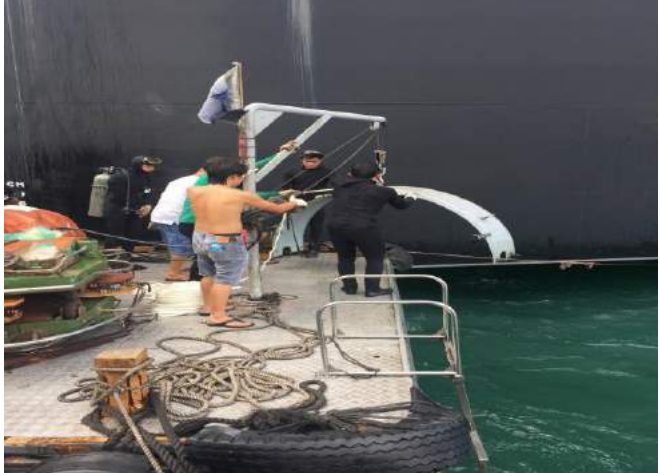
<p>↑ New Rope Guard released into water</p>

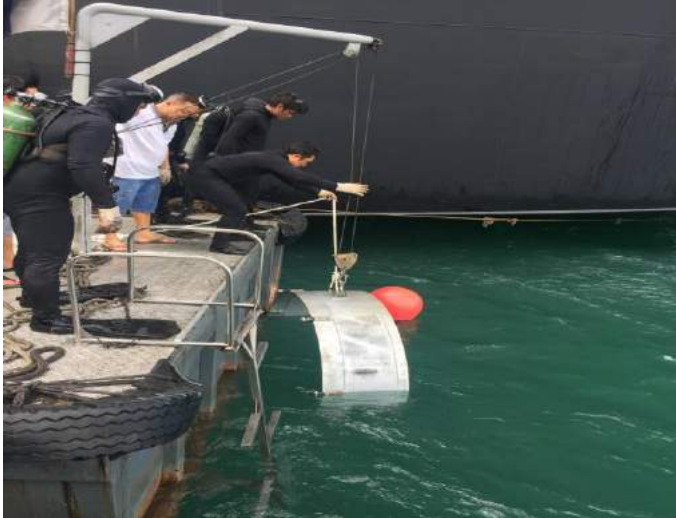
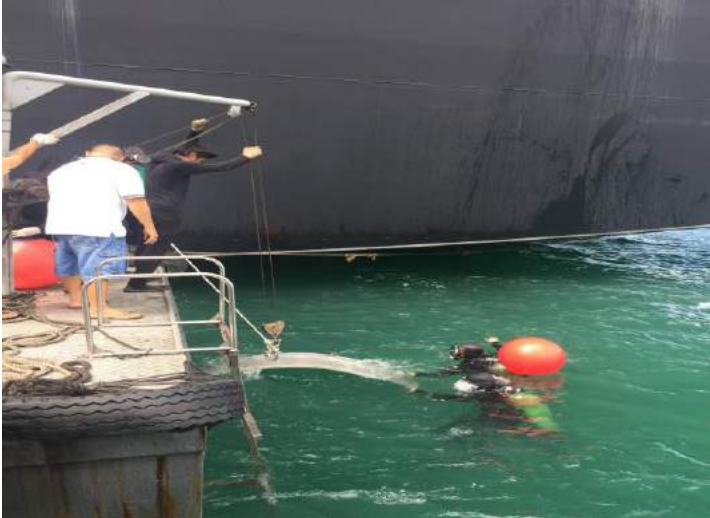
<p>↖ Removal of temporary support From new Rope Guard</p>
<p>Upon releasing of Rope Guard into water, Diver team assisted to position Rope Guard for installation underwater.</p>

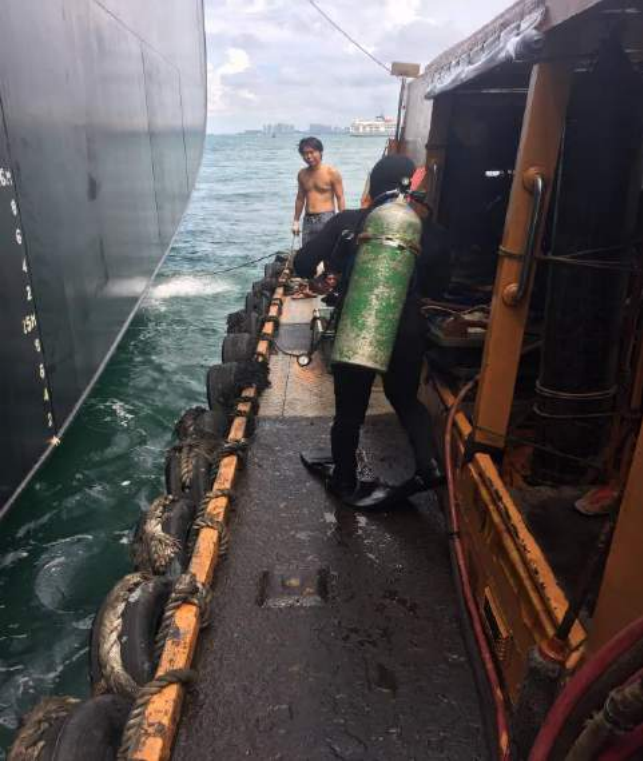
↑	Diver team began operation underwater	↑ Entanglement observed around propeller

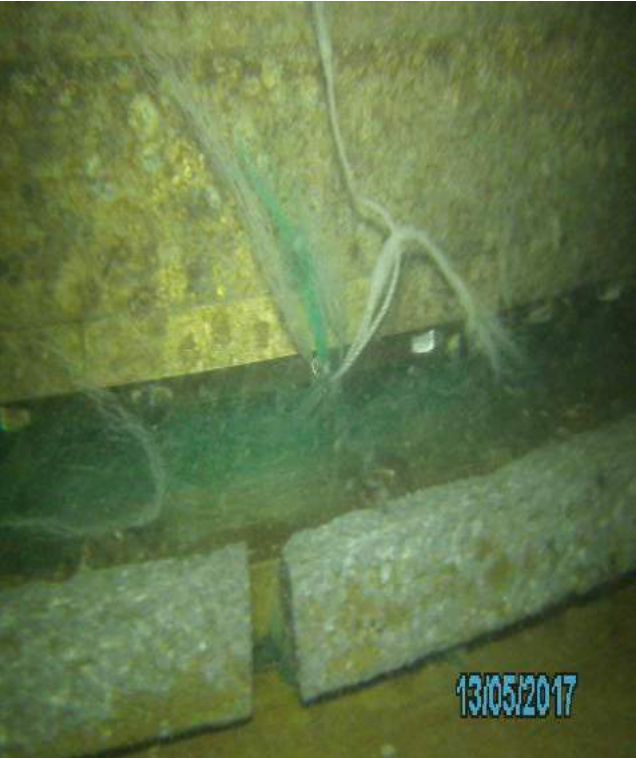
↑	Entanglement observed	↑ Entanglement removed and brought to surface

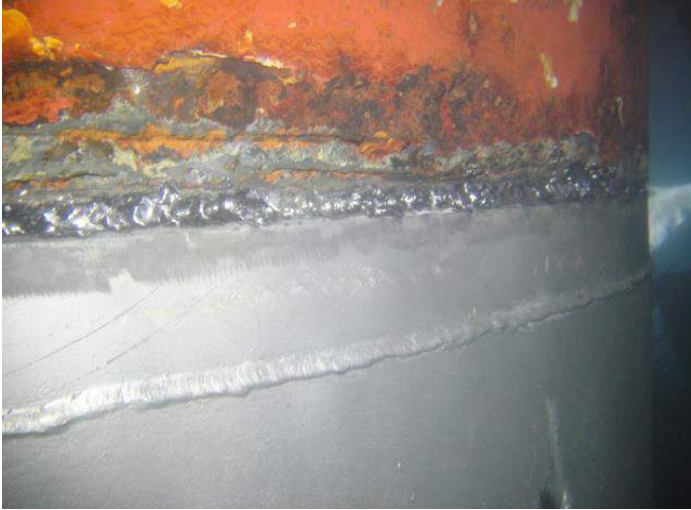
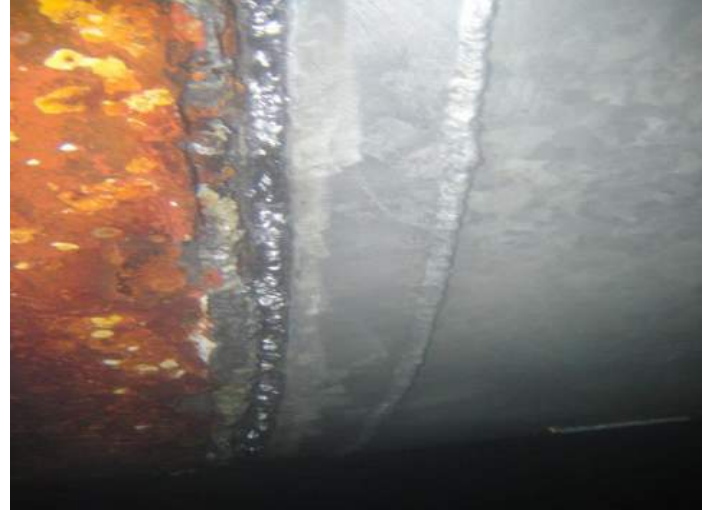
Position of new Rope Guard well secured and carried out full welding

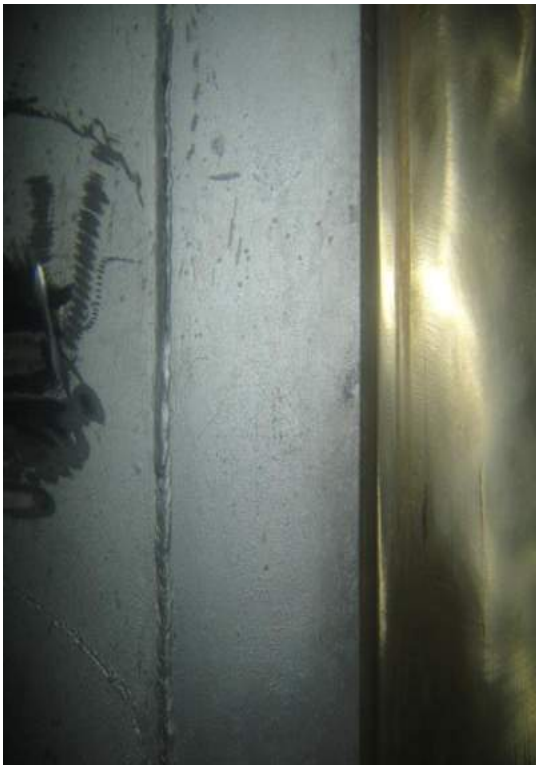
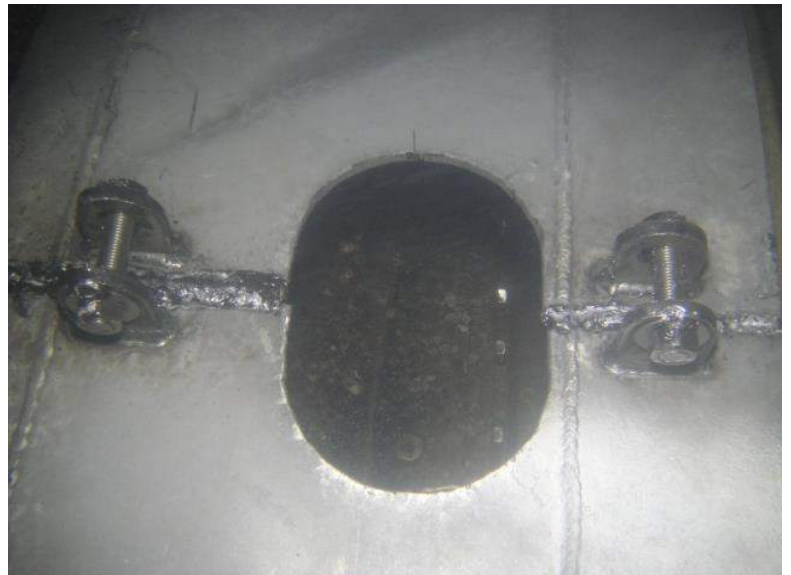
Upon completion of full welding securing Rope Guard, Operation photos and videos were submitted to Chief Officer/Master and acknowledged work to be satisfactory.
