PHOTO REPORT

Job No. : 2916

No.	Description	Pg1
Subject : <u>Aft Mooring Winch Support Crack Repair</u>

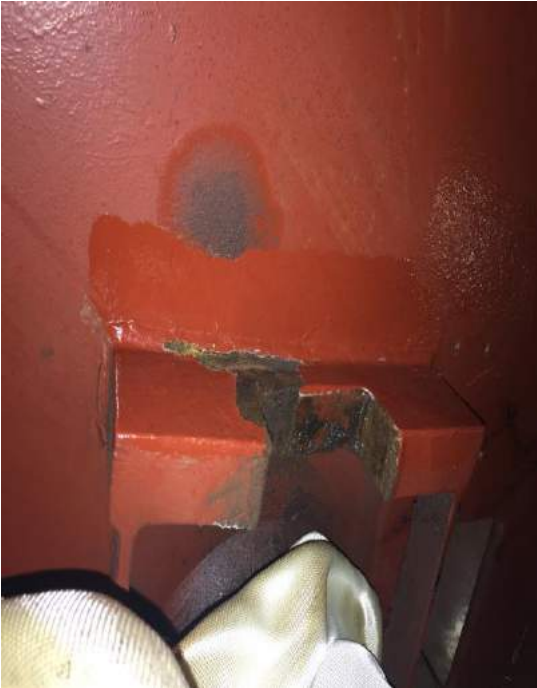
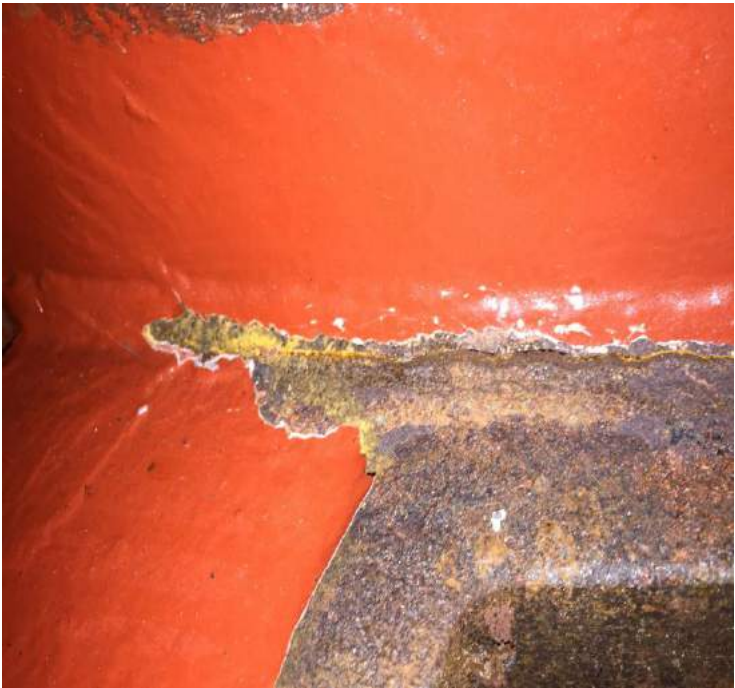
Existing condition reflects cracks and bends		
Mooring winch support at current location

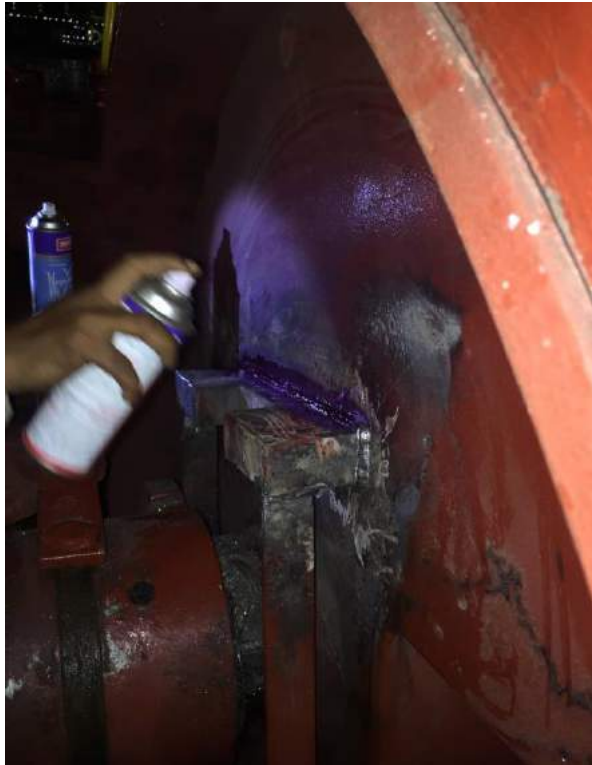
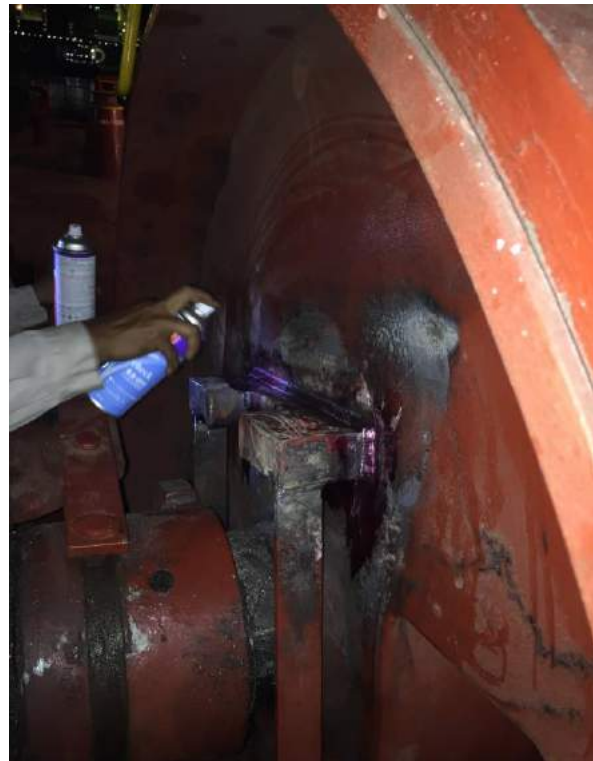
Carried out NDT dye penetrant test on weldment and found results satisfactory, with no defects.

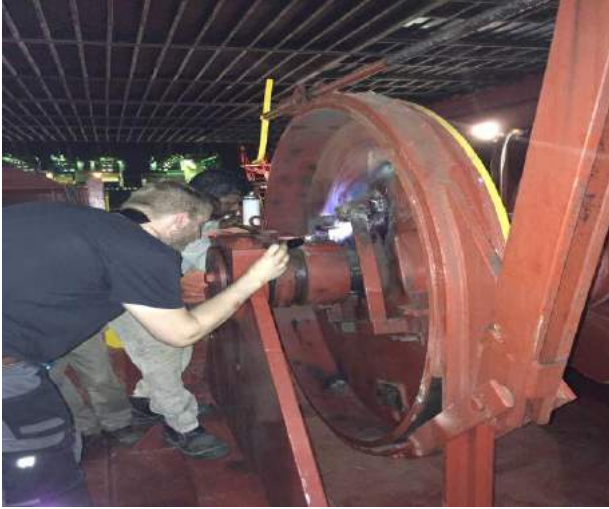
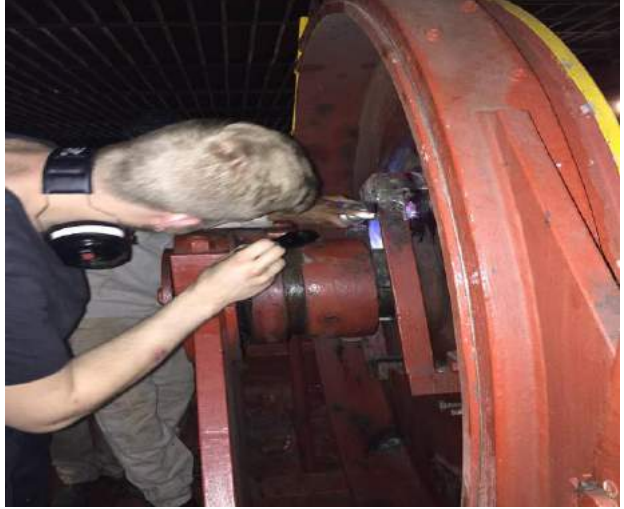
2nd Engineer carried out winch operational test, no defects found.

↖ ↗ Upon completion, ship crew carried out one coat of primer on new refit support section.
