# PHOTO REPORT

Job No. : 2935

Date : 22/6/2017

**Subject : AC Compressor No.2 (Type: SMC108S) Loading Frame and Service Works**

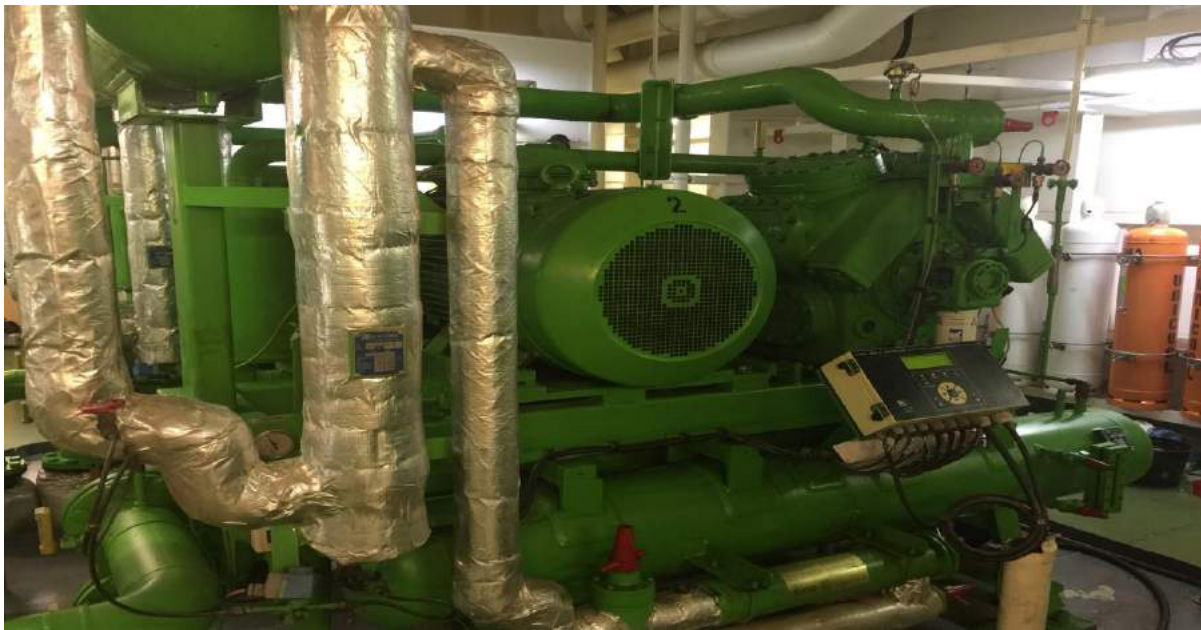
Damaged condition of existing compressor loading frame
