Work Report

LOCATION: Yantian Terminal, Shenzhen, China

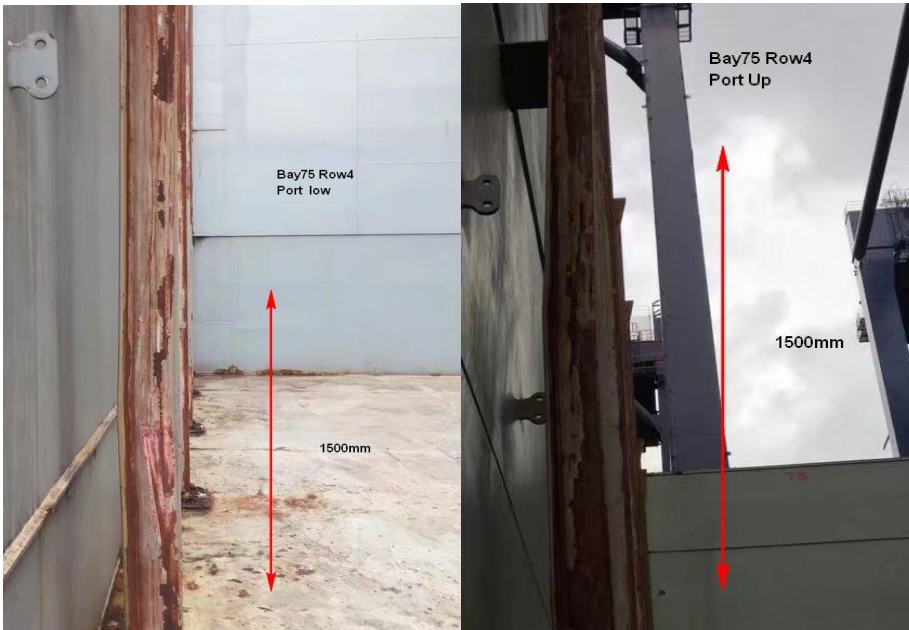
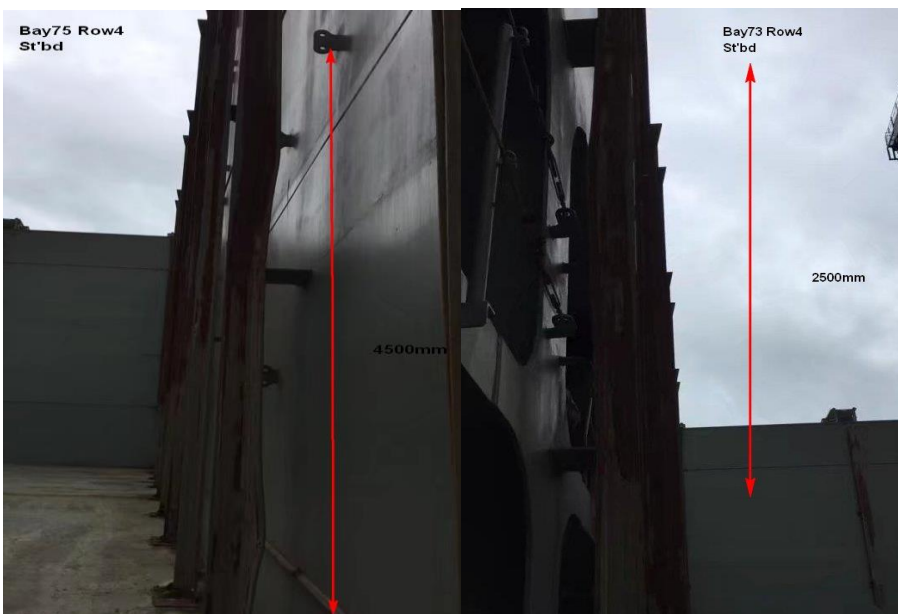
The following location cell guide dent:
