PHOTO REPORT

Date : 4th Oct 2017
Location : Singapore
Job No. : 2990

No.	Description	Pg1
	Subject : Partial Repair of 20ft Flat racks (for Lashing Gear Bin) x 2 unit	
	(1) Flat Rack - NUK1168	
	<div style="display: flex; justify-content: space-around;">     </div> <p style="text-align: center;">Install stiffening brackets onto flat rack to prevent deformation during hot works.</p> <div style="display: flex; justify-content: space-around;">     </div> <p style="text-align: center;">Proceed gas cut to remove partial joints of main frame connecting corner casting vertical legs</p>

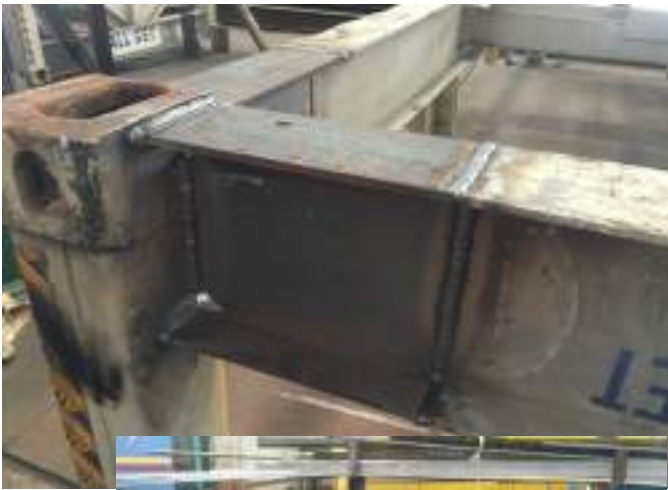
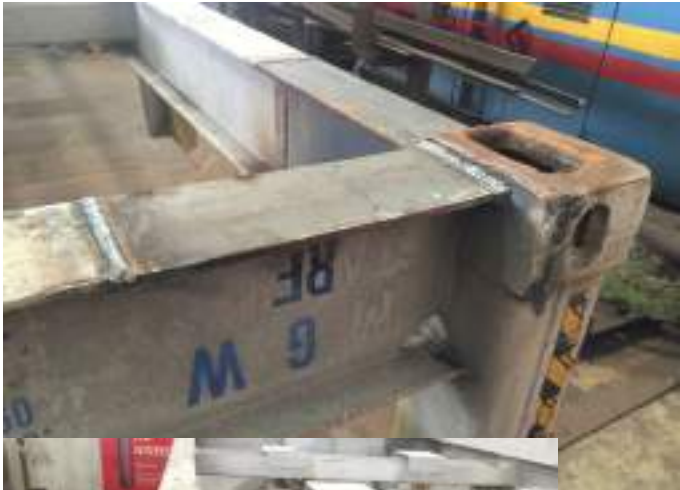
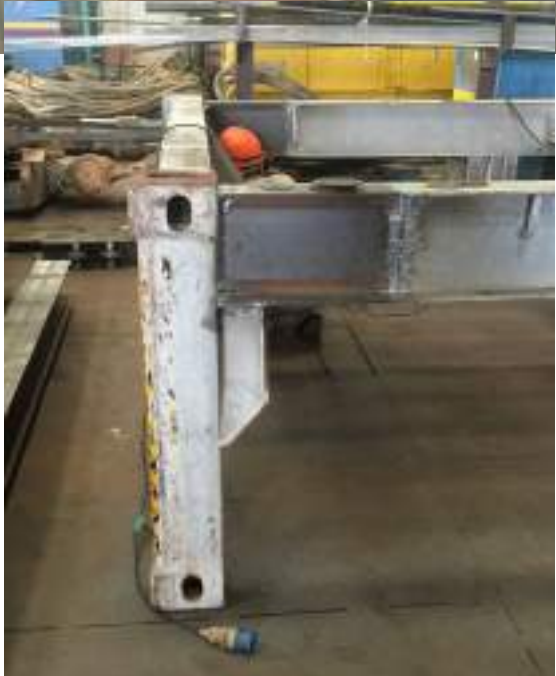
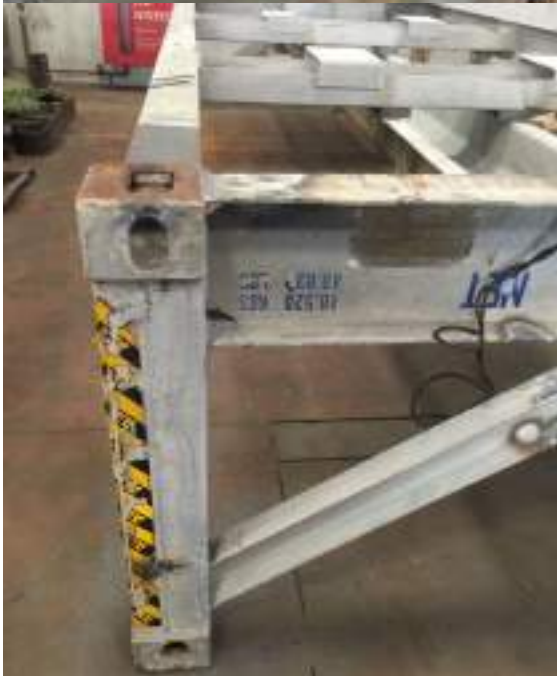
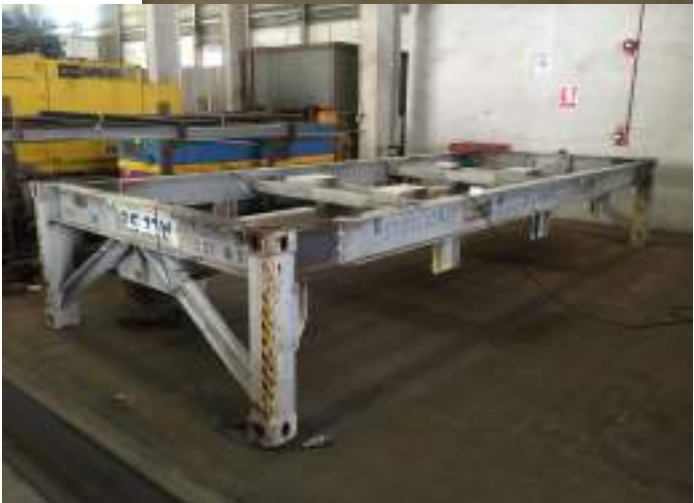
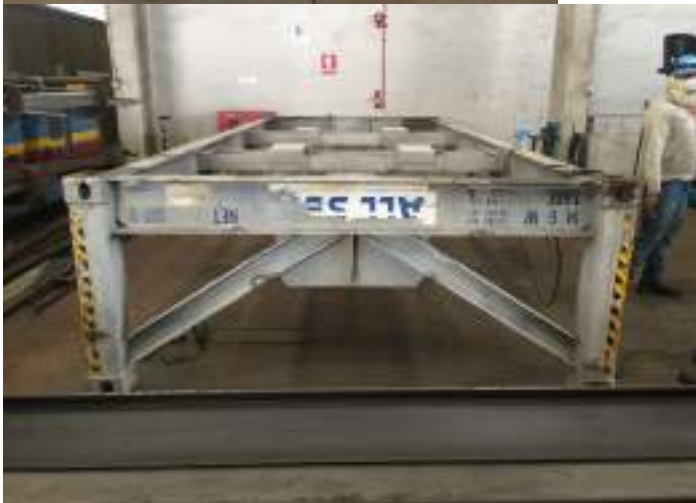
Re-adjusted & aligned corner casting vertical legs to main frame of flat rack
