PHOTO REPORT

Date : 28th Sept 2017
Location : Singapore IPL
Job No. : 3001

No.	Description	Pg1
Subject : Renewal of Portside Anchor Chain (1st length)		
<div style="display: flex; justify-content: space-around;">     </div> <p style="text-align: center;">Obtained hot work permit, vessel landed anchor onto barge & commenced hot work</p> <div style="display: flex; justify-content: space-around;">     </div>

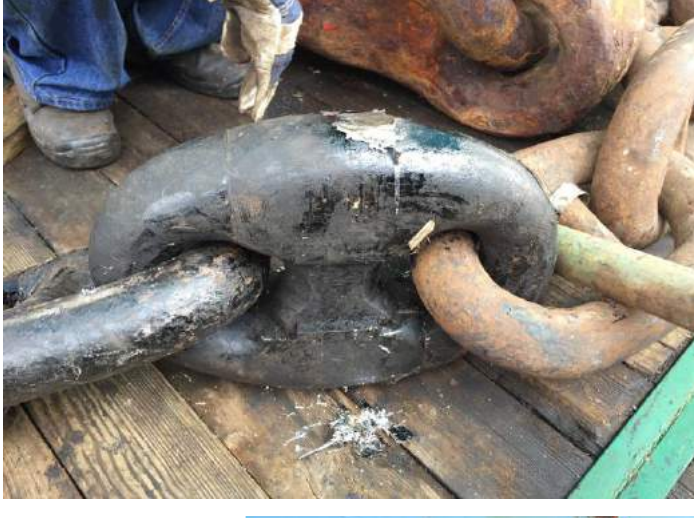
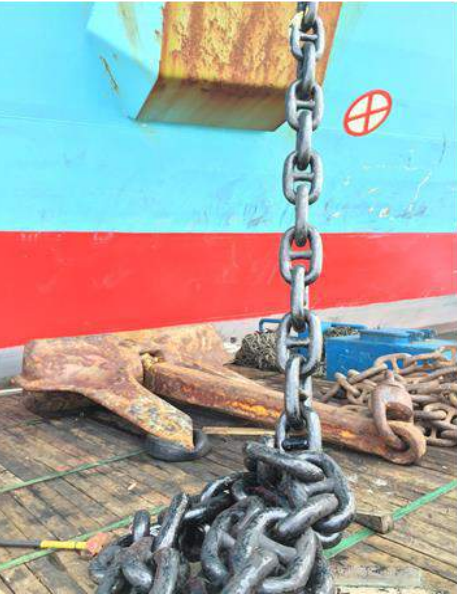
<p>Tapered pin inserted, taper pin hole pre-heated, filled with lead, hammered & sealed 1st kenter shackle</p>
