<p>Day 4 Mobilisation / 15th Jan 2018</p>

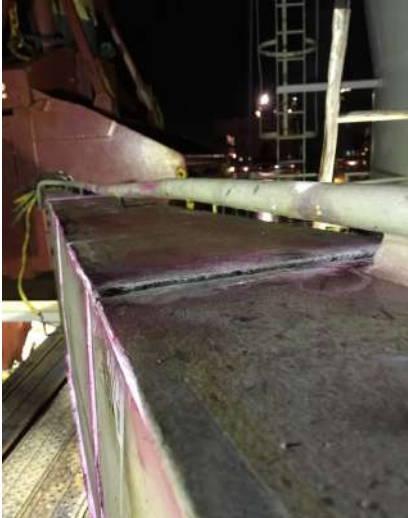
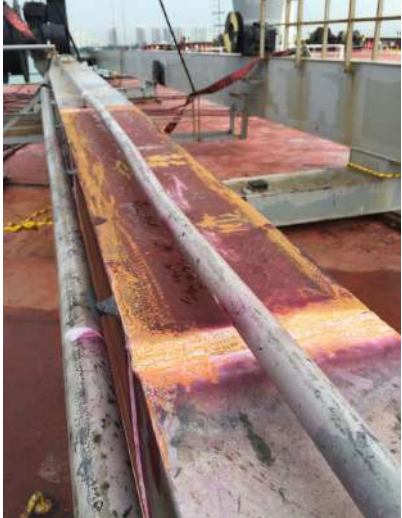
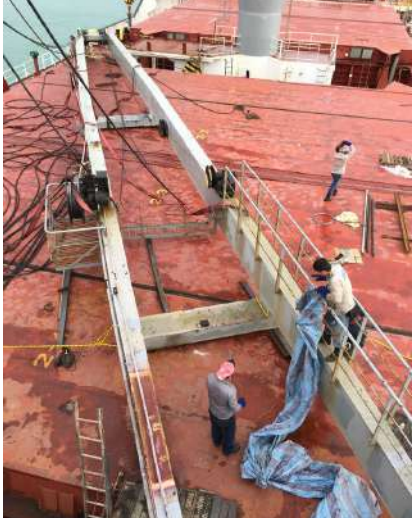
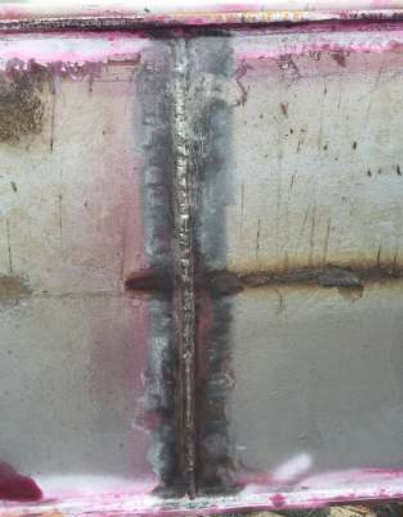
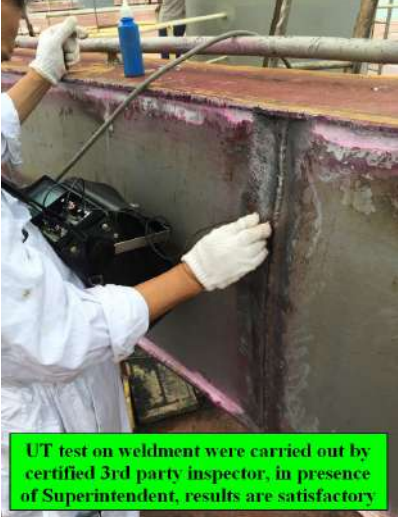
<p data-bbox="598 1926 981 2004">UT test on weldment were carried out by certified 3rd party inspector, in presence of Superintendent, results are satisfactory</p>

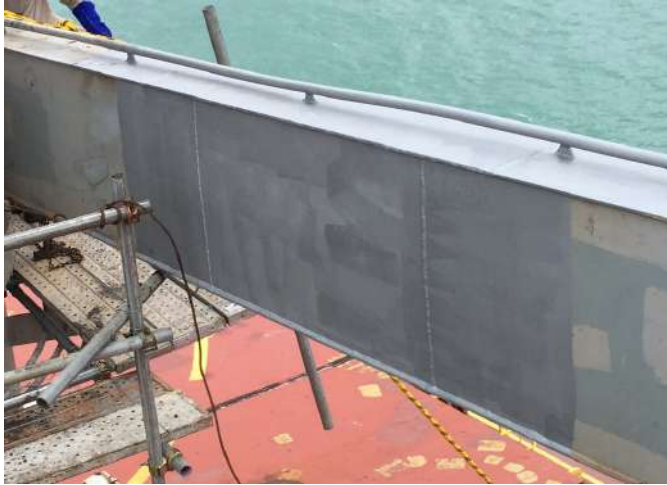
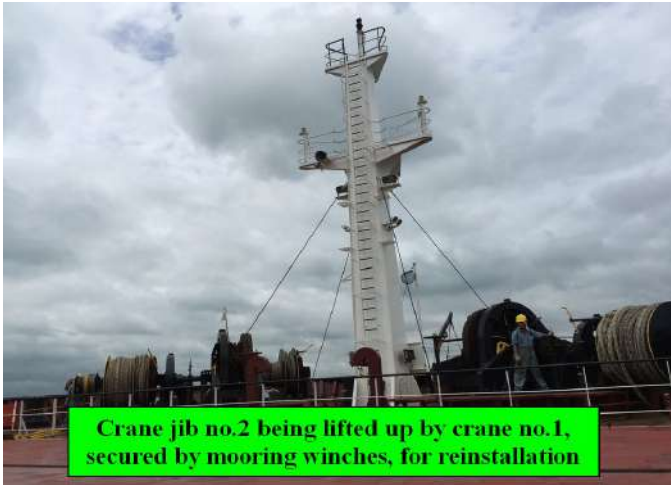
<p data-bbox="874 750 1401 813">Crane jib no.2 being lifted up by crane no.1, secured by mooring winches, for reinstallation</p>

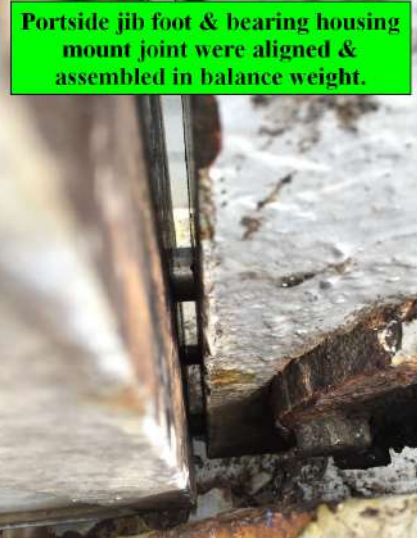
<p data-bbox="135 887 534 974">Portside jib foot & bearing housing mount joint were aligned & assembled in balance weight.</p>

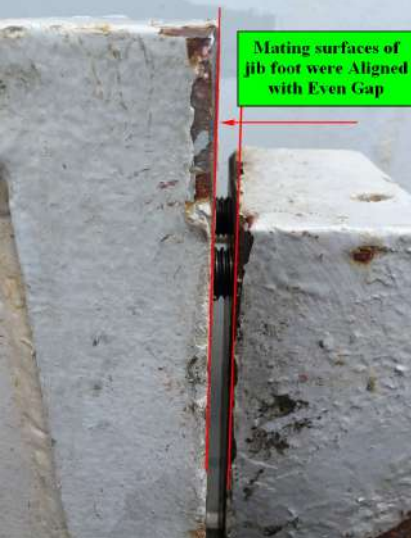
<p data-bbox="821 913 997 981">Mating surfaces of jib foot were Aligned with Even Gap</p>

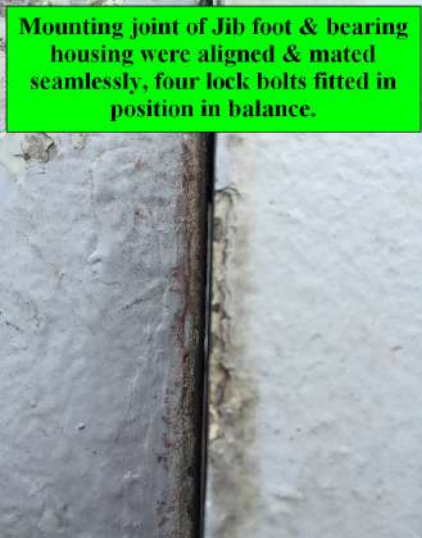
<p data-bbox="1050 887 1453 1003">Mounting joint of Jib foot & bearing housing were aligned & mated seamlessly, four lock bolts fitted in position in balance.</p>	
<p data-bbox="108 1444 247 1473">STBDSIDE</p>

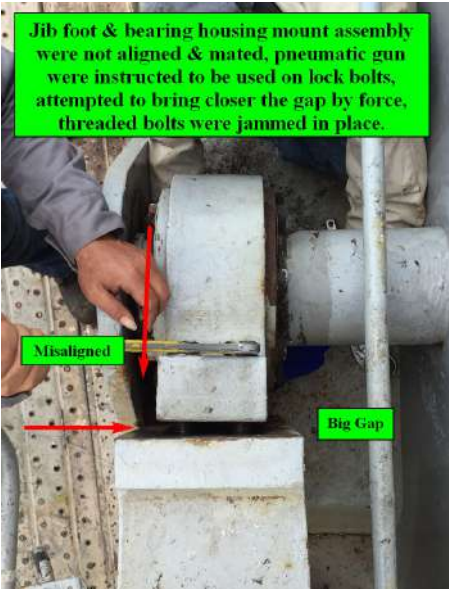
<p data-bbox="598 1444 997 1568">Jib foot & bearing housing mount assembly were not aligned & mated, pneumatic gun were instructed to be used on lock bolts, attempted to bring closer the gap by force, threaded bolts were jammed in place.</p> <p data-bbox="598 1758 694 1792">Misaligned</p> <p data-bbox="885 1836 965 1870">Big Gap</p>

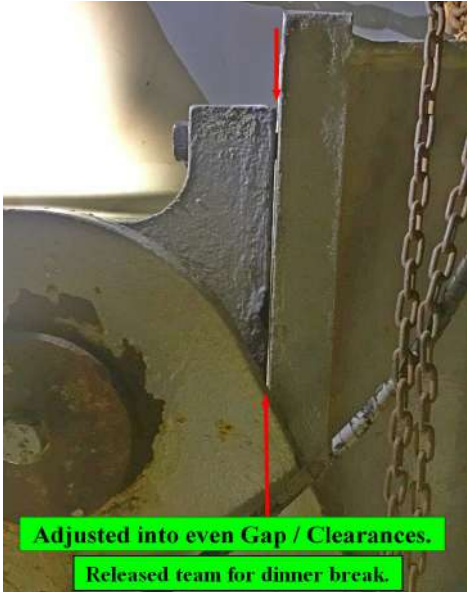
<p data-bbox="92 862 510 929">Adjusted into even Gap / Clearances. Released team for dinner break.</p>

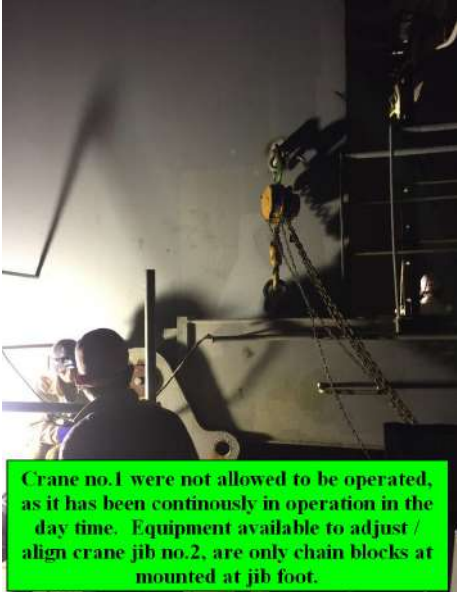
<p data-bbox="566 806 1005 929">Crane no.1 were not allowed to be operated, as it has been continuously in operation in the day time. Equipment available to adjust / align crane jib no.2, are only chain blocks at mounted at jib foot.</p>

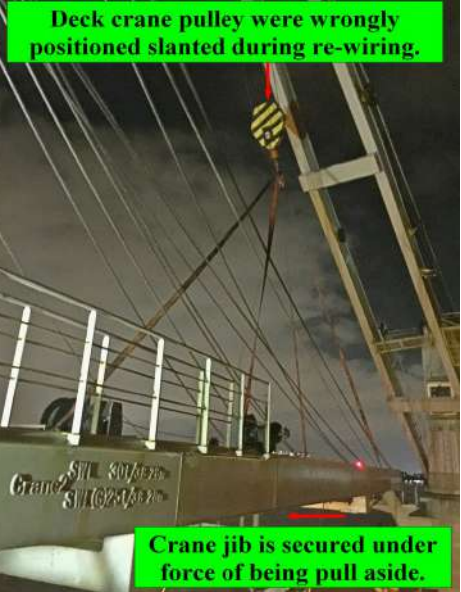
<p data-bbox="1061 347 1492 414">Deck crane pulley were wrongly positioned slanted during re-wiring.</p> <p data-bbox="1189 873 1492 929">Crane jib is secured under force of being pull aside.</p>
<ul style="list-style-type: none"> • Before dinner break, clearances / gap between jib foot & bearing housing mount assembly were adjusted evenly. When return to site, pulley block of deck crane no.1 were mis-positioned when crew carry out re-wiring works, hanging in slanted condition which pulling crane jib no.2 • Crane jib no.2 which in lifting condition by crane no.1, were therefore misaligned again. • Deck crane no.1 were not allowed to be operated, as it was in continuous operation during day time. • Hot work permit has expired therefore no hot work allowed for welding on additional pad eyes for lifting. • Work location are on hanging staging at height, there are not strong point for pulling by lifting gear / belt. • The only method allowed, to re-adjust & re-aligned entire crane jib no.2, are with chain blocks & muscle. • Have seriously considered & discussed through the possibilities of carrying out above task with method suggested by Owner, but found not possible and dangerous as wind are strong at height. • Released team to rest as all member were exhausted working continuously through-out the day.

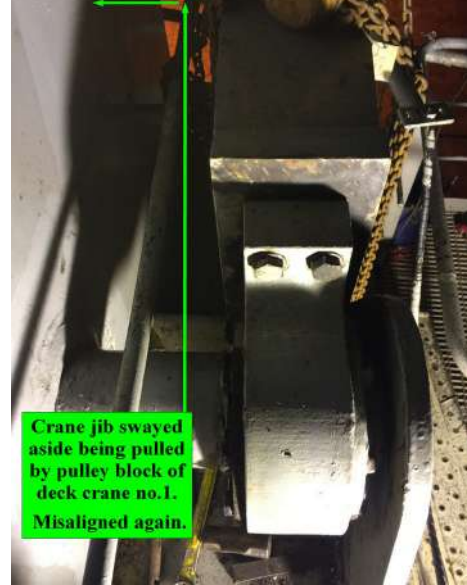
<p data-bbox="92 1814 263 1937">Crane jib swayed aside being pulled by pulley block of deck crane no.1. Misaligned again.</p>

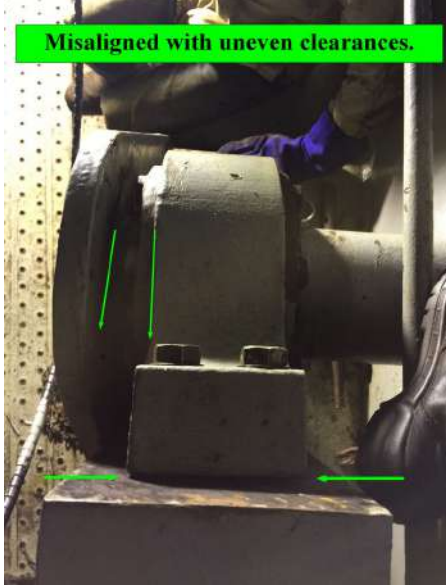
<p data-bbox="582 1422 997 1467">Misaligned with uneven clearances.</p>
