## PHOTO REPORT

Job No. : 3190-3

Location : PSA Singapore

No.	Description		
	<p><b><u>Subject : Oil Water Separator (OWS) Wall Insert Plate Renewal</u></b></p> <div style="display: flex; justify-content: space-around;">     </div> <p style="text-align: center;">Inspected &amp; Marked upon Wall Plate @Oil Water Separator</p> <div style="display: flex; justify-content: space-around;">     </div> <div style="display: flex; justify-content: space-around;"> <p>Pre - fabricated with bending new plate</p> <p>Hempel HB4520/1999 Coating Paint with Thinner 0845</p> </div>

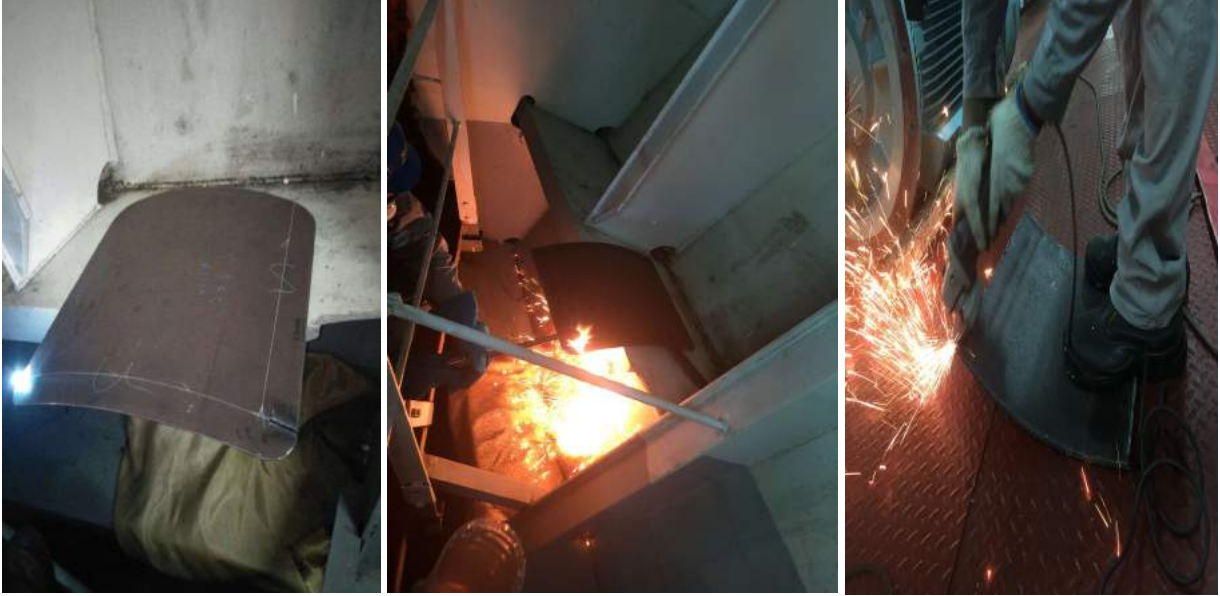
<p>Further alter pre-fabricated insert new plate</p>

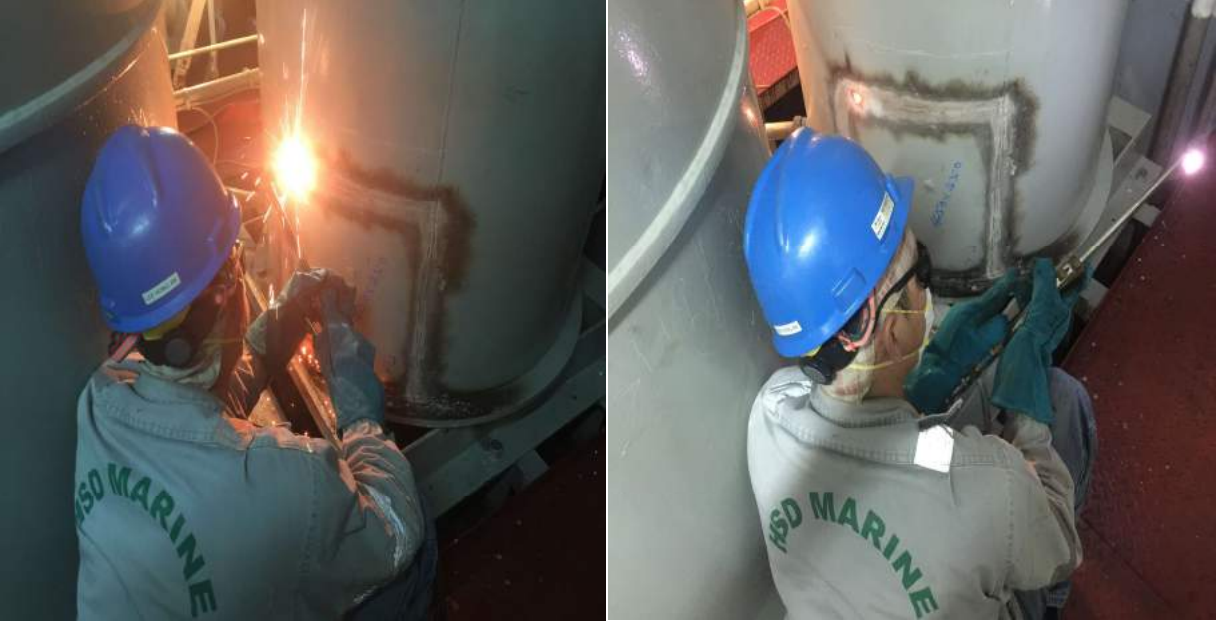
<p>Fairing off and removal of paint on existing wall plate @OWS</p>

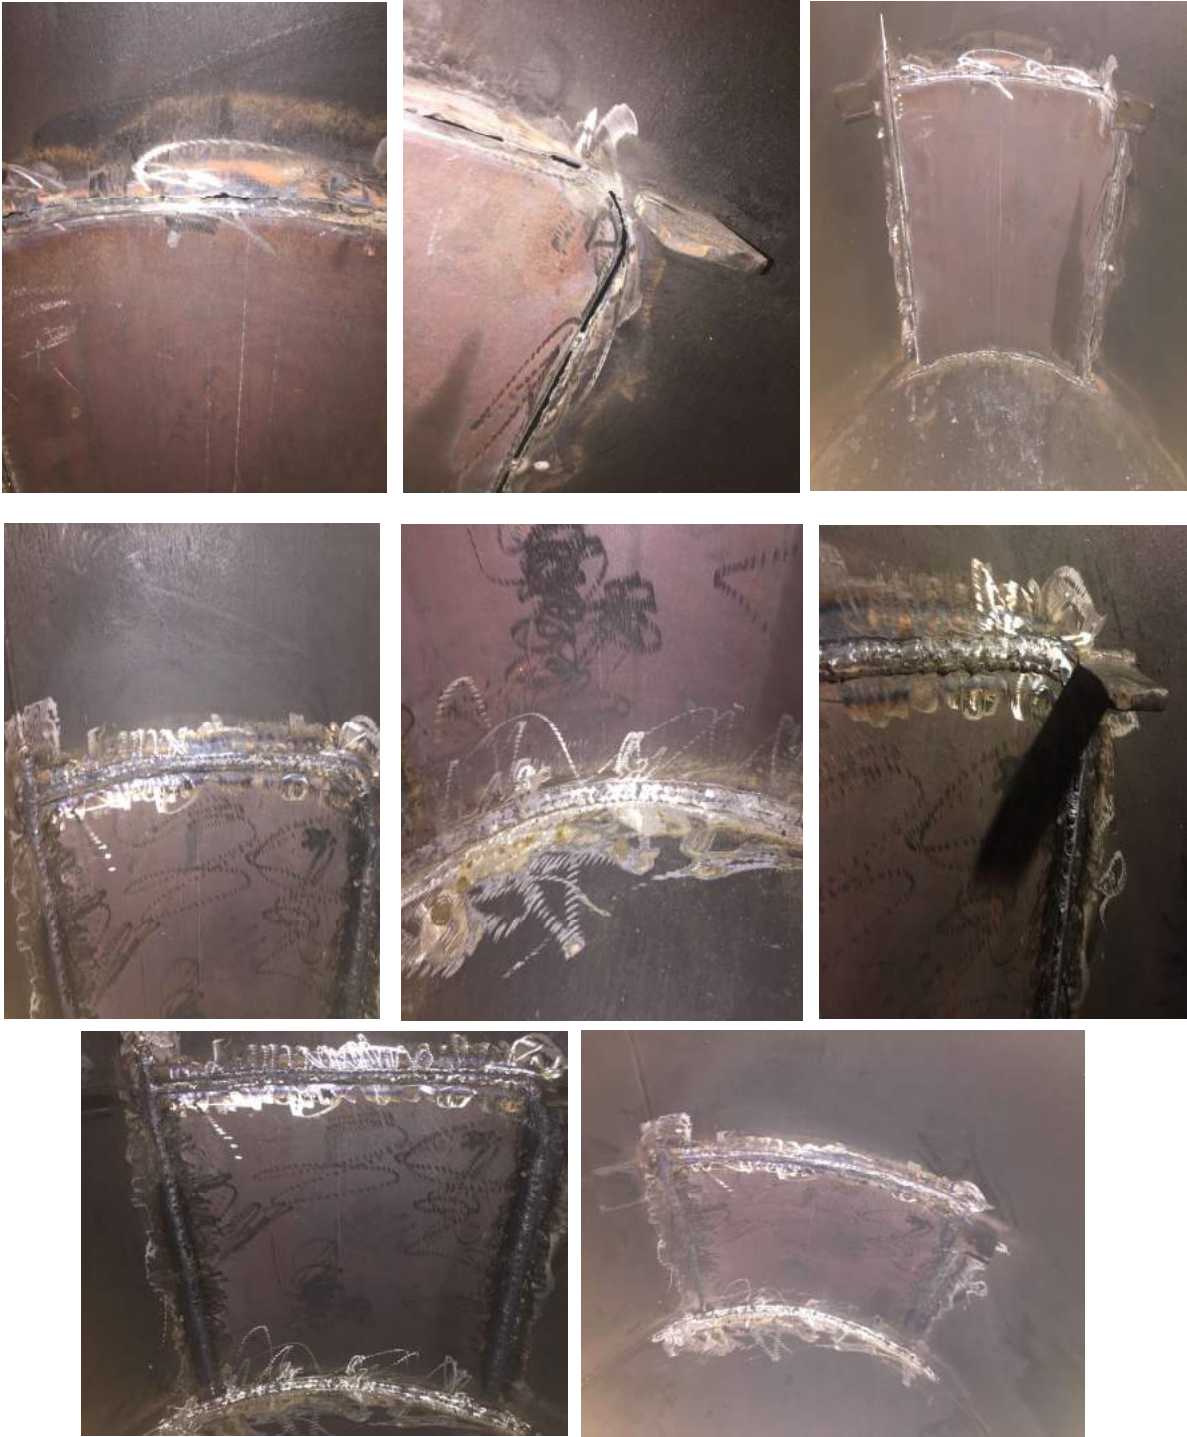
<p>Carried out grinding and continuously welding on wall plate inside in OWS</p>
