PHOTO REPORT

Job No. : 3383

Location : Singapore IPL

No.	Description	Pg1
Subject : Crane no.3 Foot Jib Bearing Renewal works

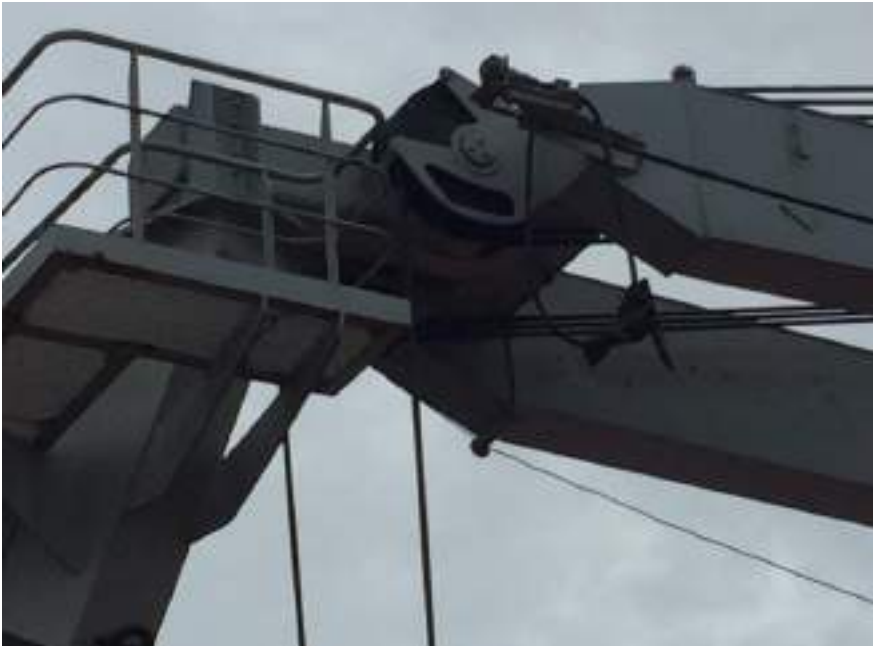
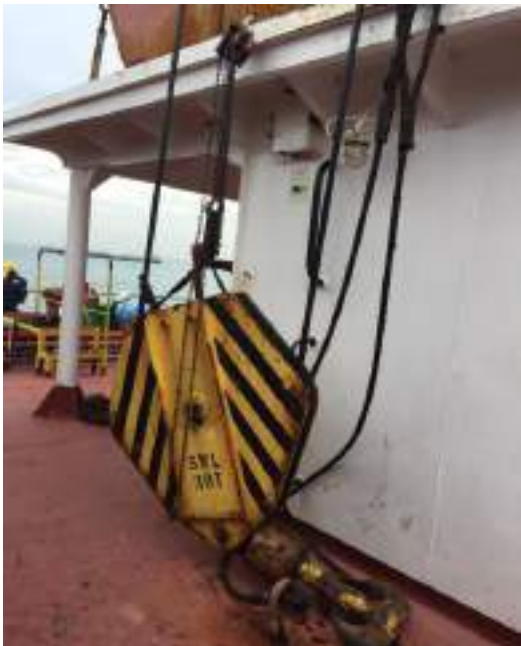
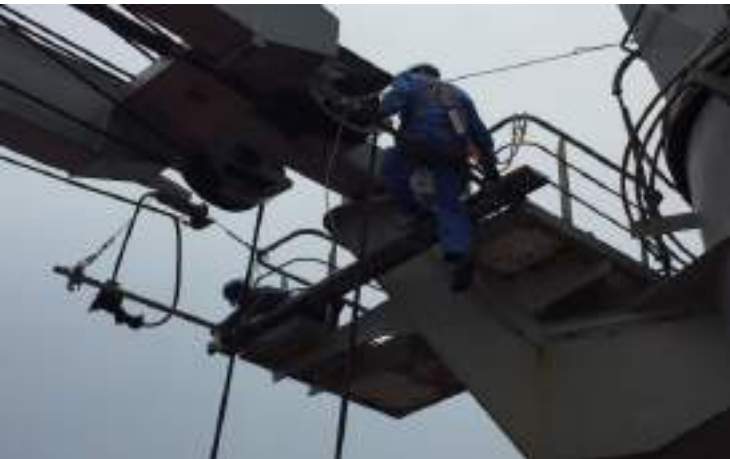
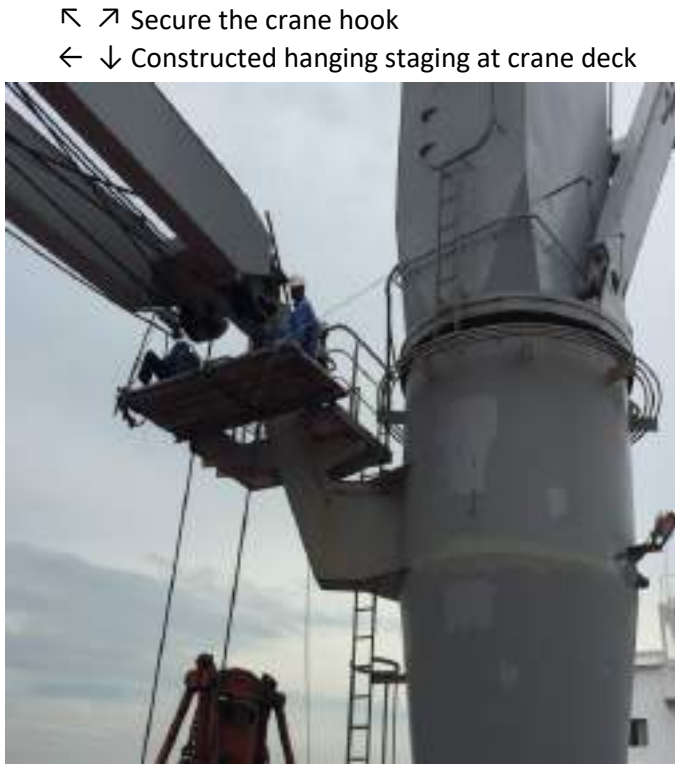
<p>↖ ↗ Secure the crane hook ← ↓ Constructed hanging staging at crane deck</p>

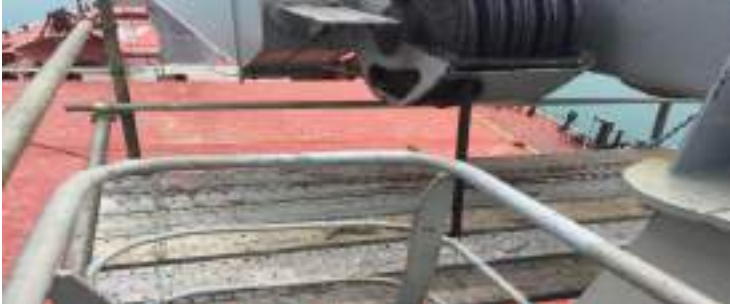
<p>↖ Fabricated frame and uplifted wire ropes to loosen roller sheaves. ↓ Removed lock bolts and welded nuts at shaft pin in position.</p>

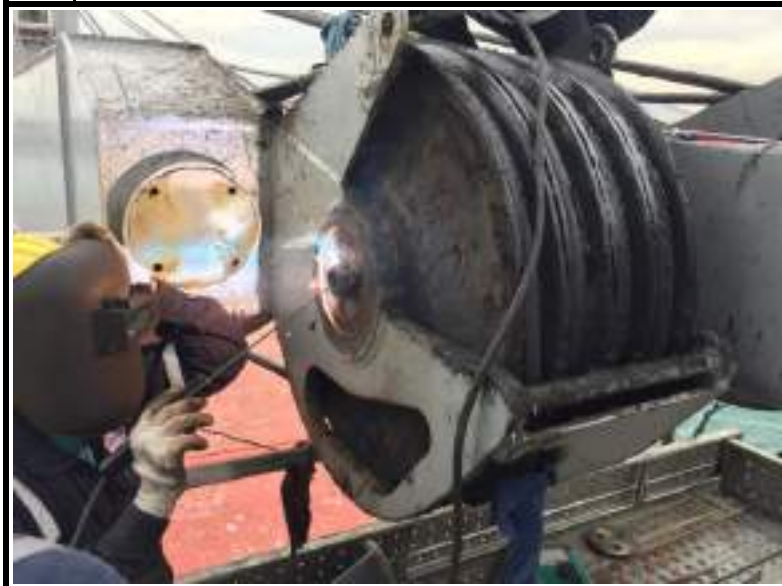
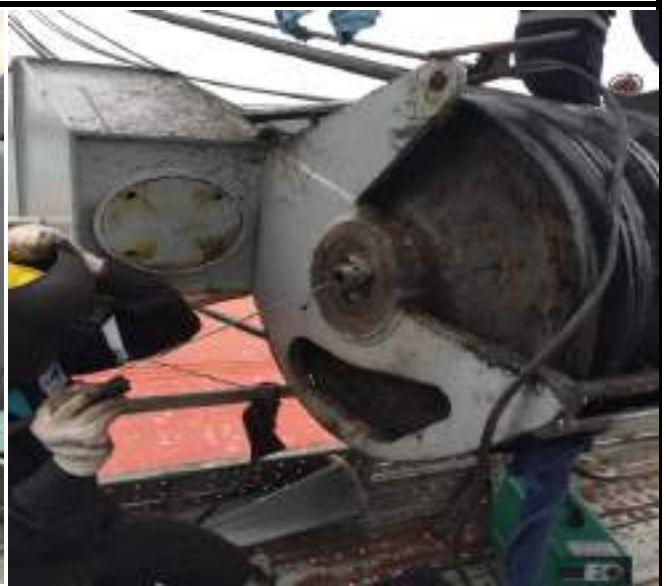
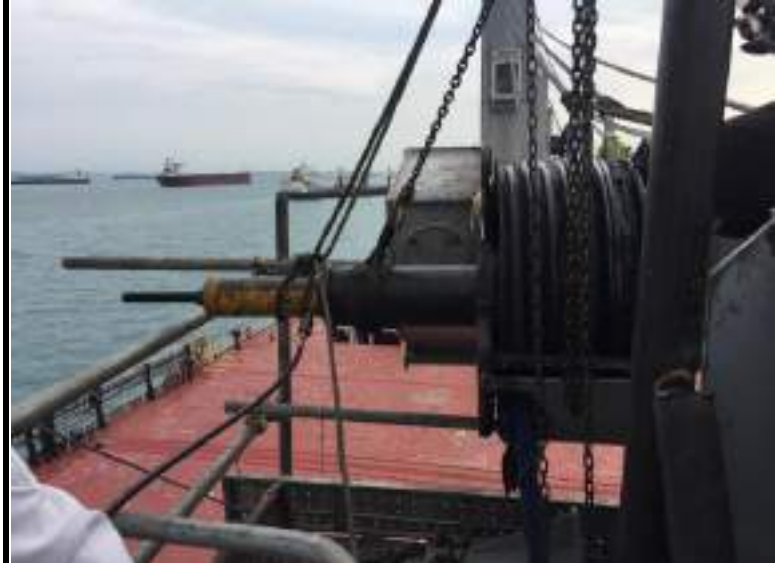
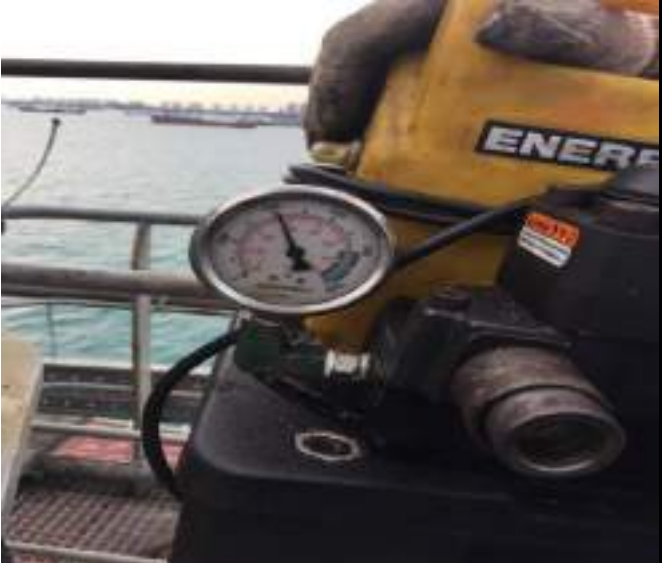
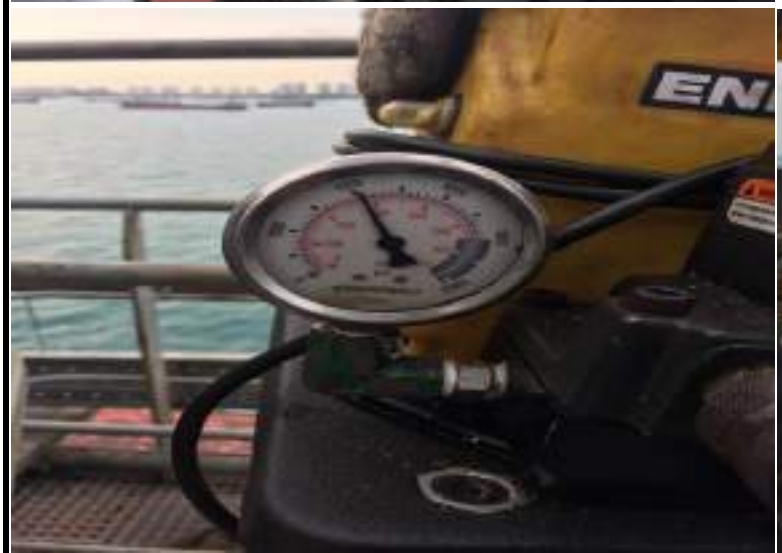
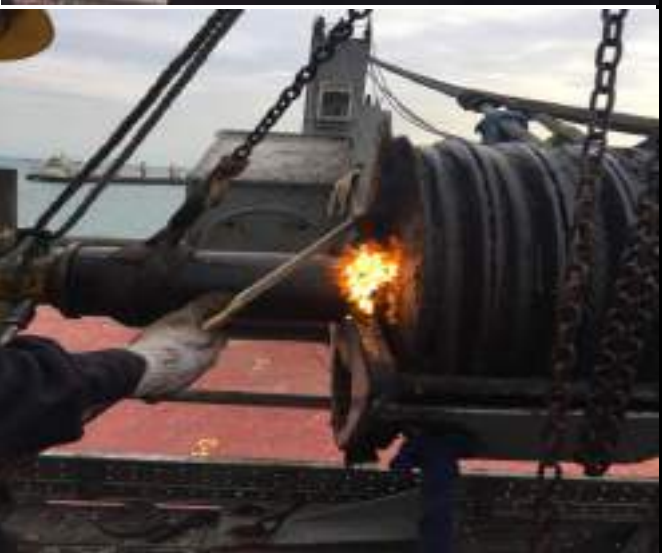
<p>↓ Fit up hydraulic tools in position, applies heatan mount housing and commenced jacking of shaft pin</p>

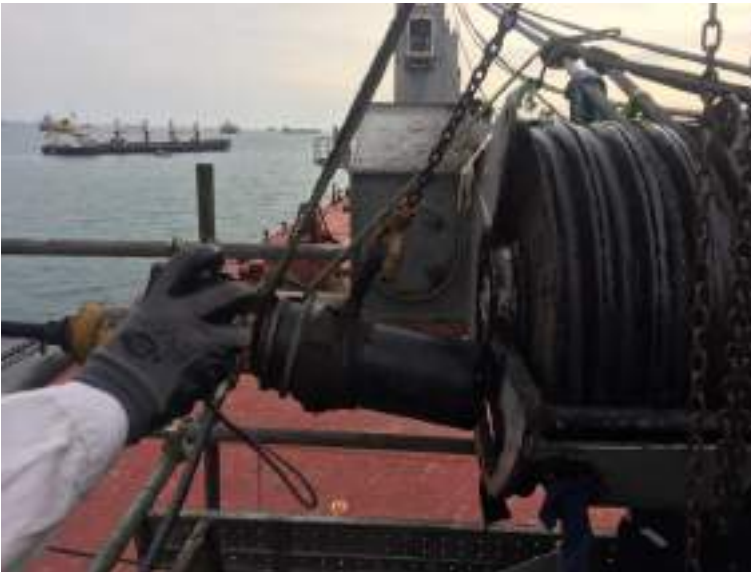
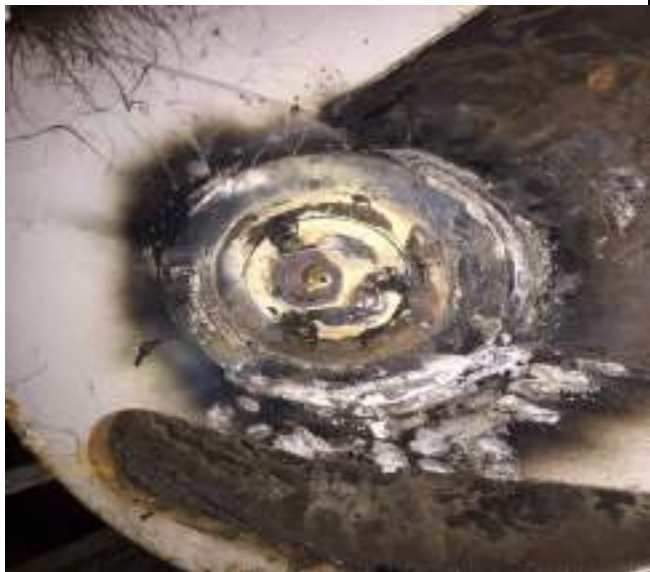
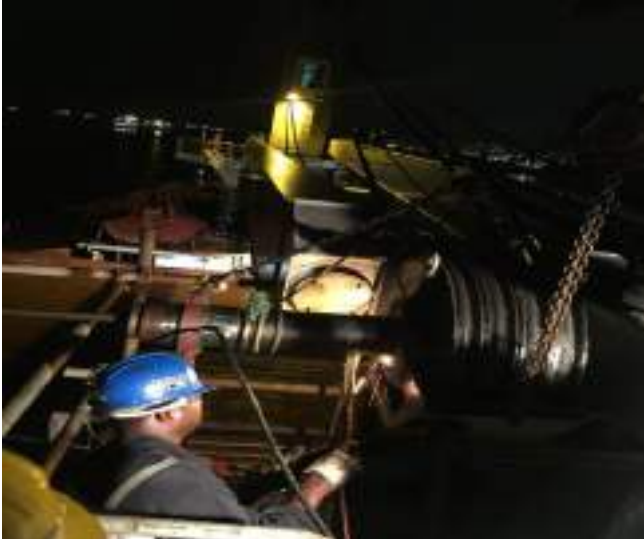
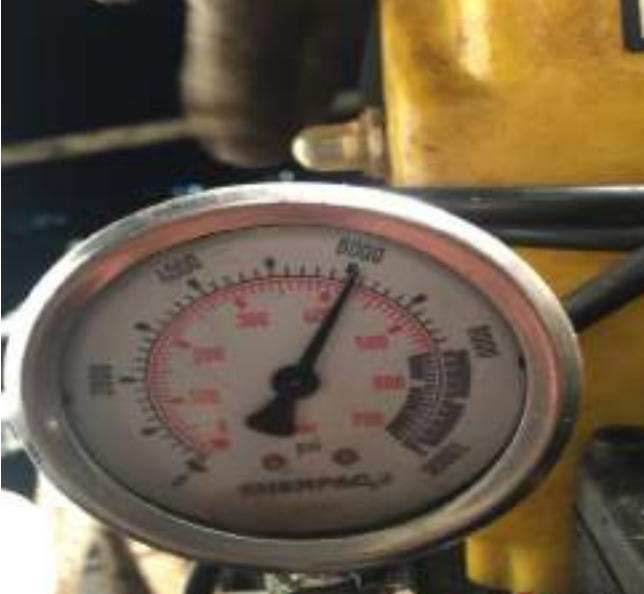
<p>↖ ↗ During attempts of shaft pin extraction, weldment nuts cracked, threaded of nuts worn off, shaft pin still not removed.</p> <p>↙ ↘ During 2nd attempts of shaft pin extraction with 60ton Shaft pin still moved by 5 mm and studs got bent.</p>

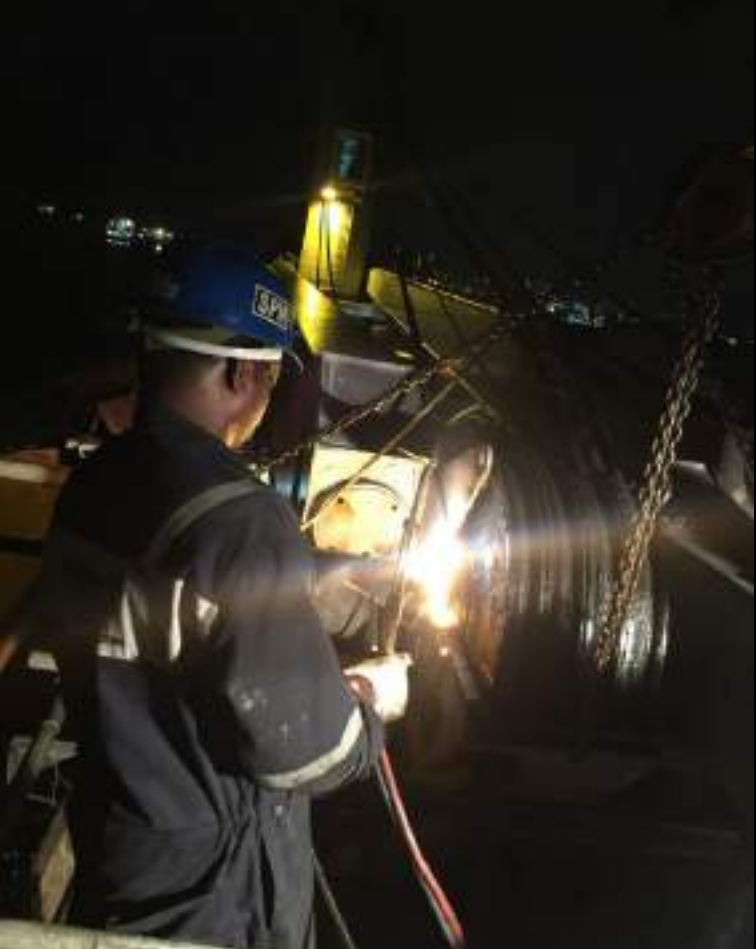
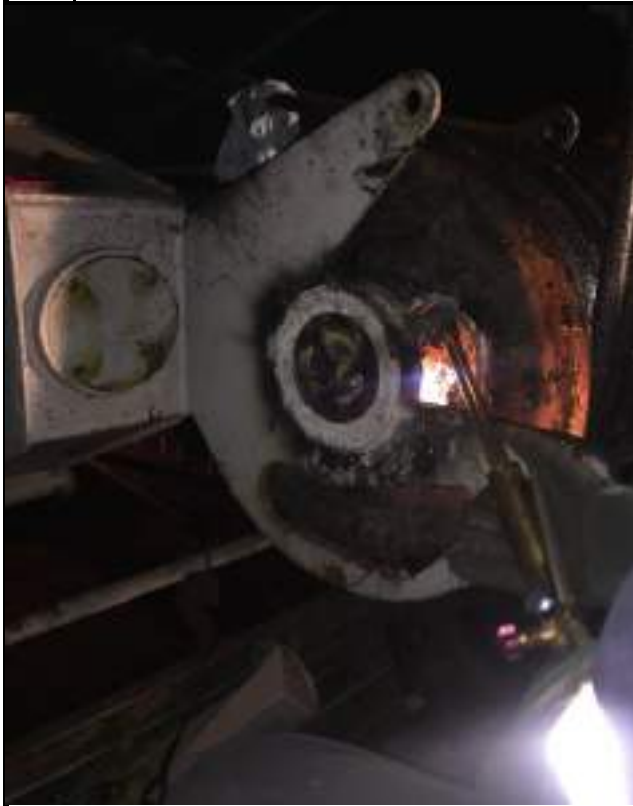
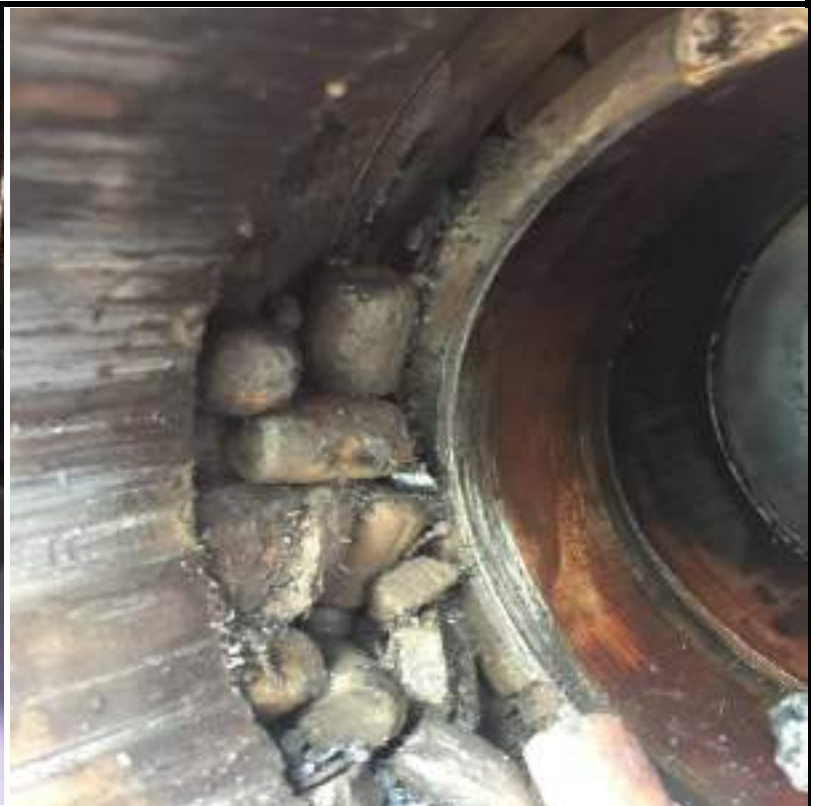
↑ Highlighted vessel CE about first bearing cut and struck in slot and vessel allow to proceed to cut the sheave of damaged first bearing ↓

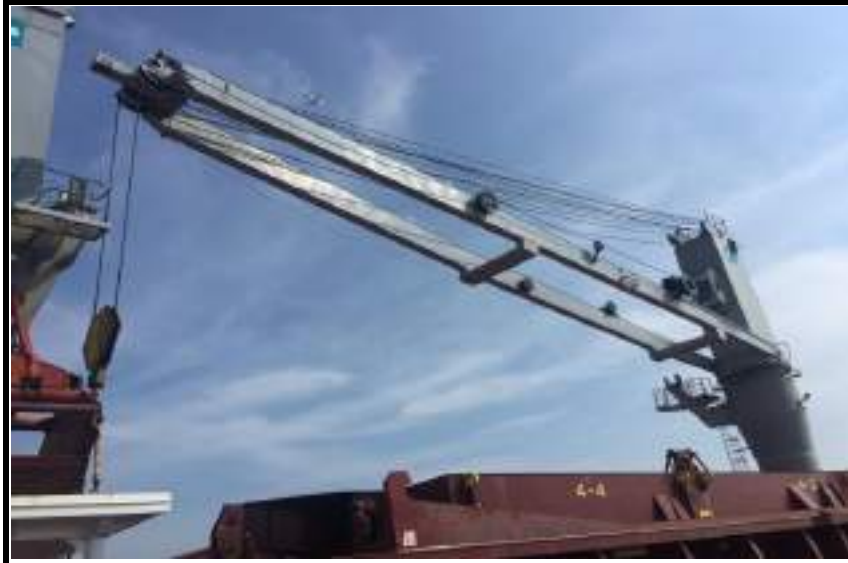
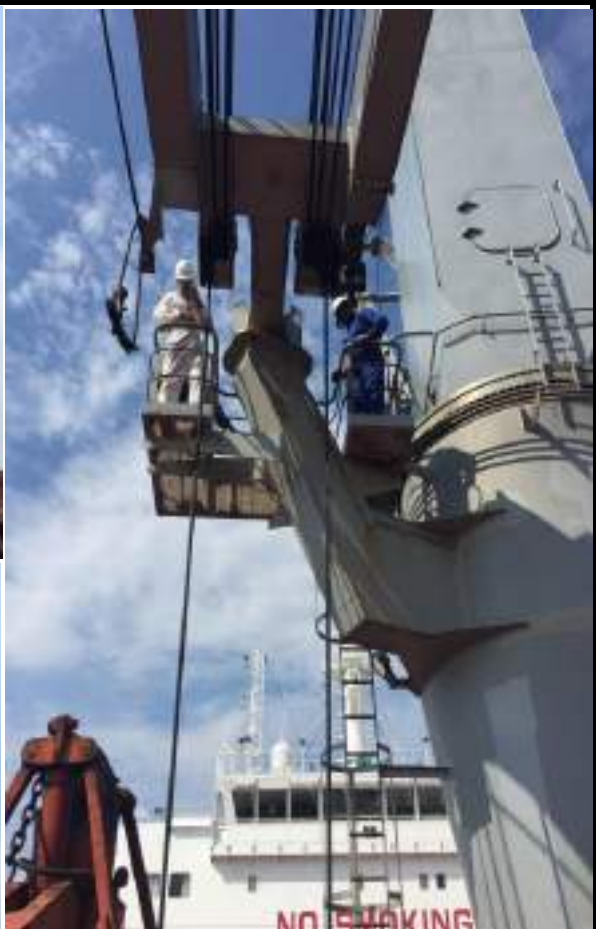
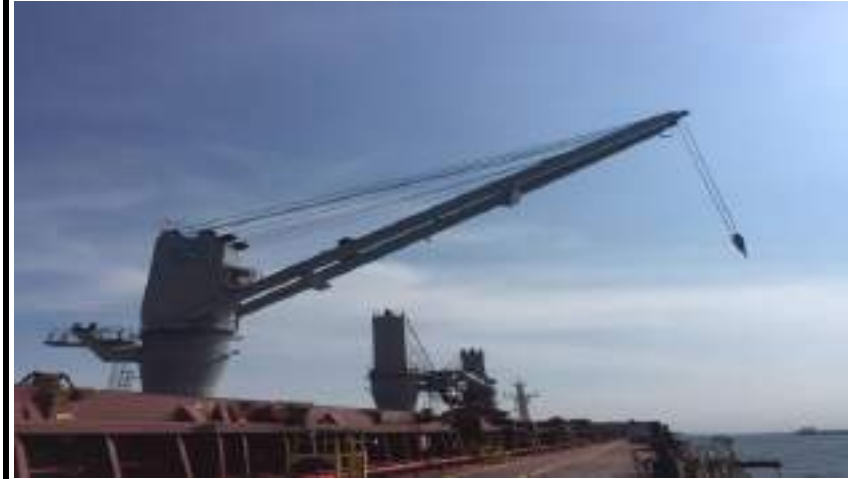
<p>↑ Upon completion of works Chief Engineer Inspected during function test. ↓</p>
