PHOTO REPORT

Job No: 3482
Date: 22th December 2018.
Location: Hai Phong Port Alongside.

No.	DESCRIPTION	Page 1
1	STBD ACCOMMOUDATION LADDER:	
1.1	MOVE OUT HANDRAIL, STANCHIONS KEPT ACC. LADDER AT SAILING POSITION:

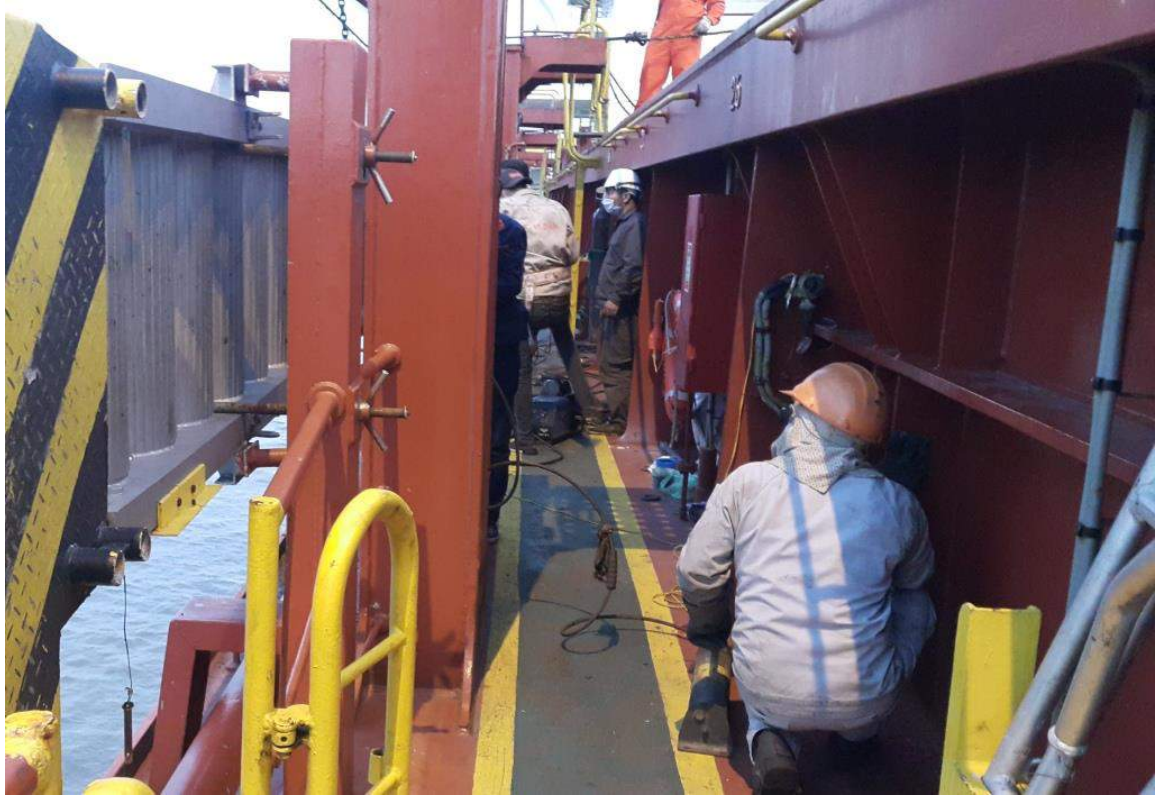
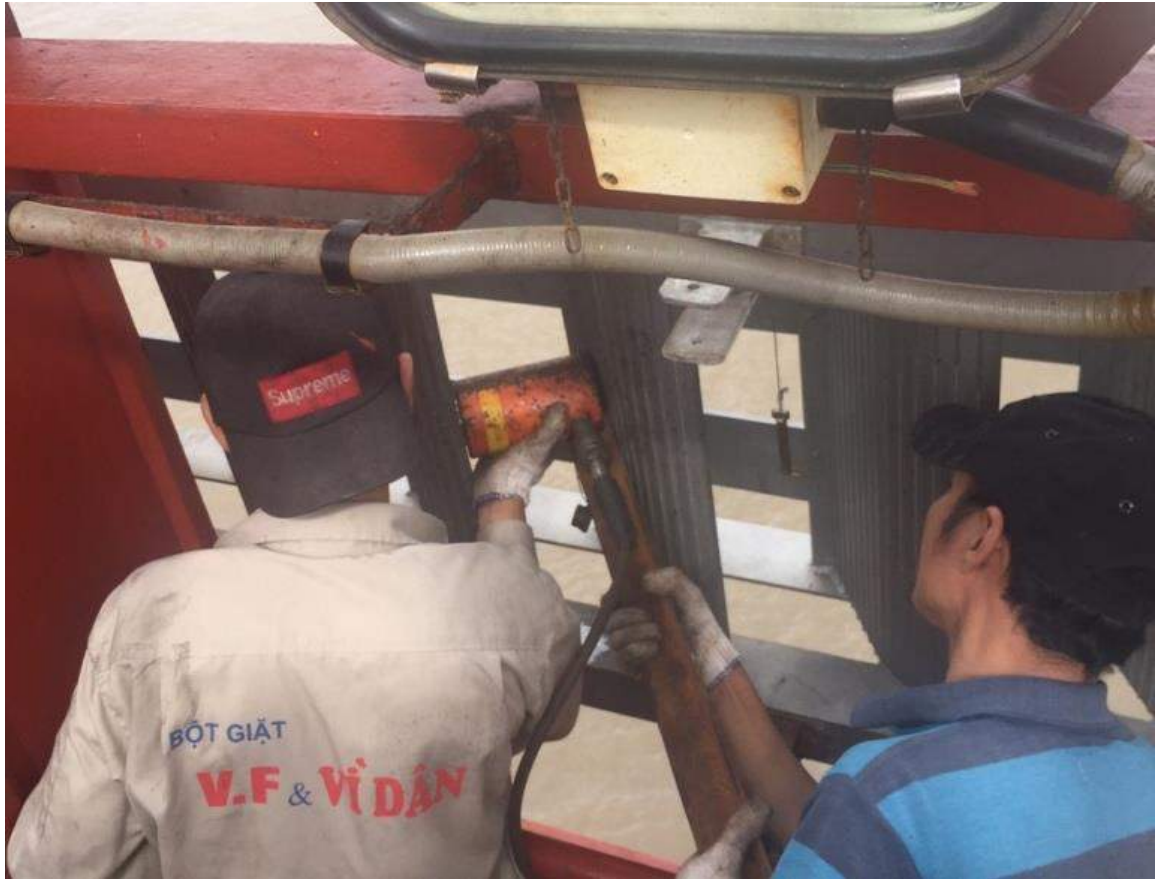
No.	DESCRIPTION	Page 3
1.3	GOUGING OUT ALL CRACK WELDING SEAMS BY GRINDER:	 
1.4	STRAIGHTENED BY HYDRAULIC JACK, CHAIN BLOCK AND HAMMER:

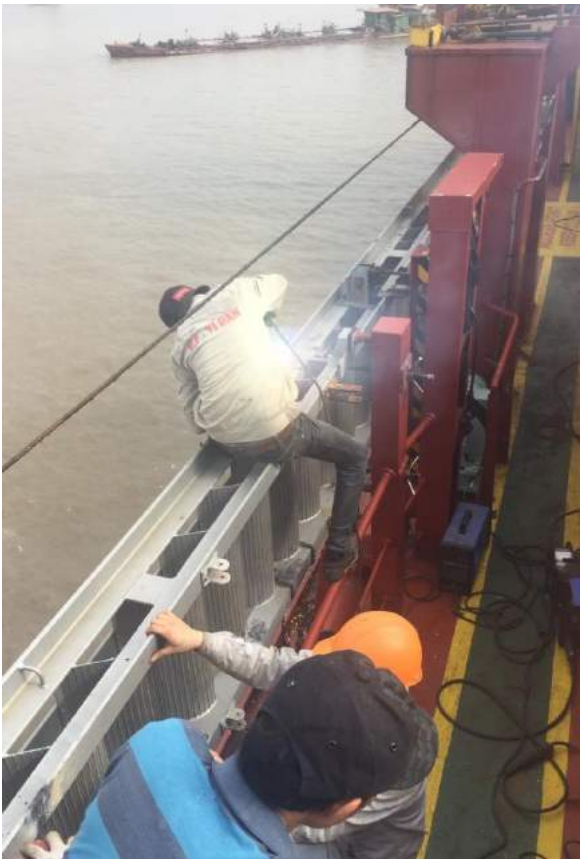
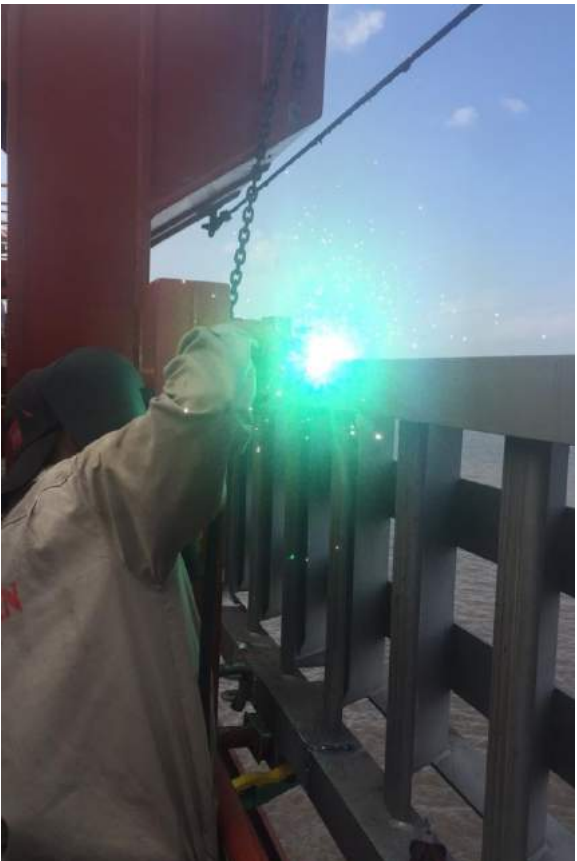
1.5	RE-WELDING
