# PHOTO REPORT

Job No. : 2242

No.	Description
<p><b>Subject : <u>Repair of Hatch Cover's damages</u></b></p>

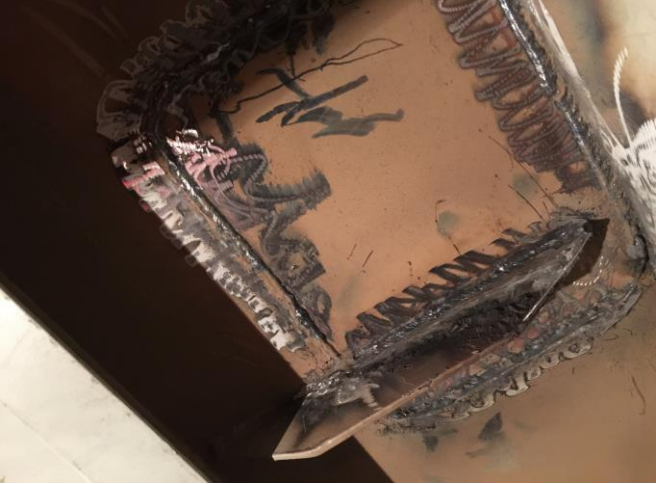
<p>Inspected &amp; Identified damaged area</p>	<p>Off cut high tensile steel plate</p>

No.	Description	
 	 	<p>Constructed staging inside cargo hold No.2 for access to bottom of hatch cover for welding works.</p>
 	 	<p>Cropped out existing damaged top plate</p>

<p>Altered and grinded plate edges to welding standard</p>

<p>New Top Plate Fitted</p>

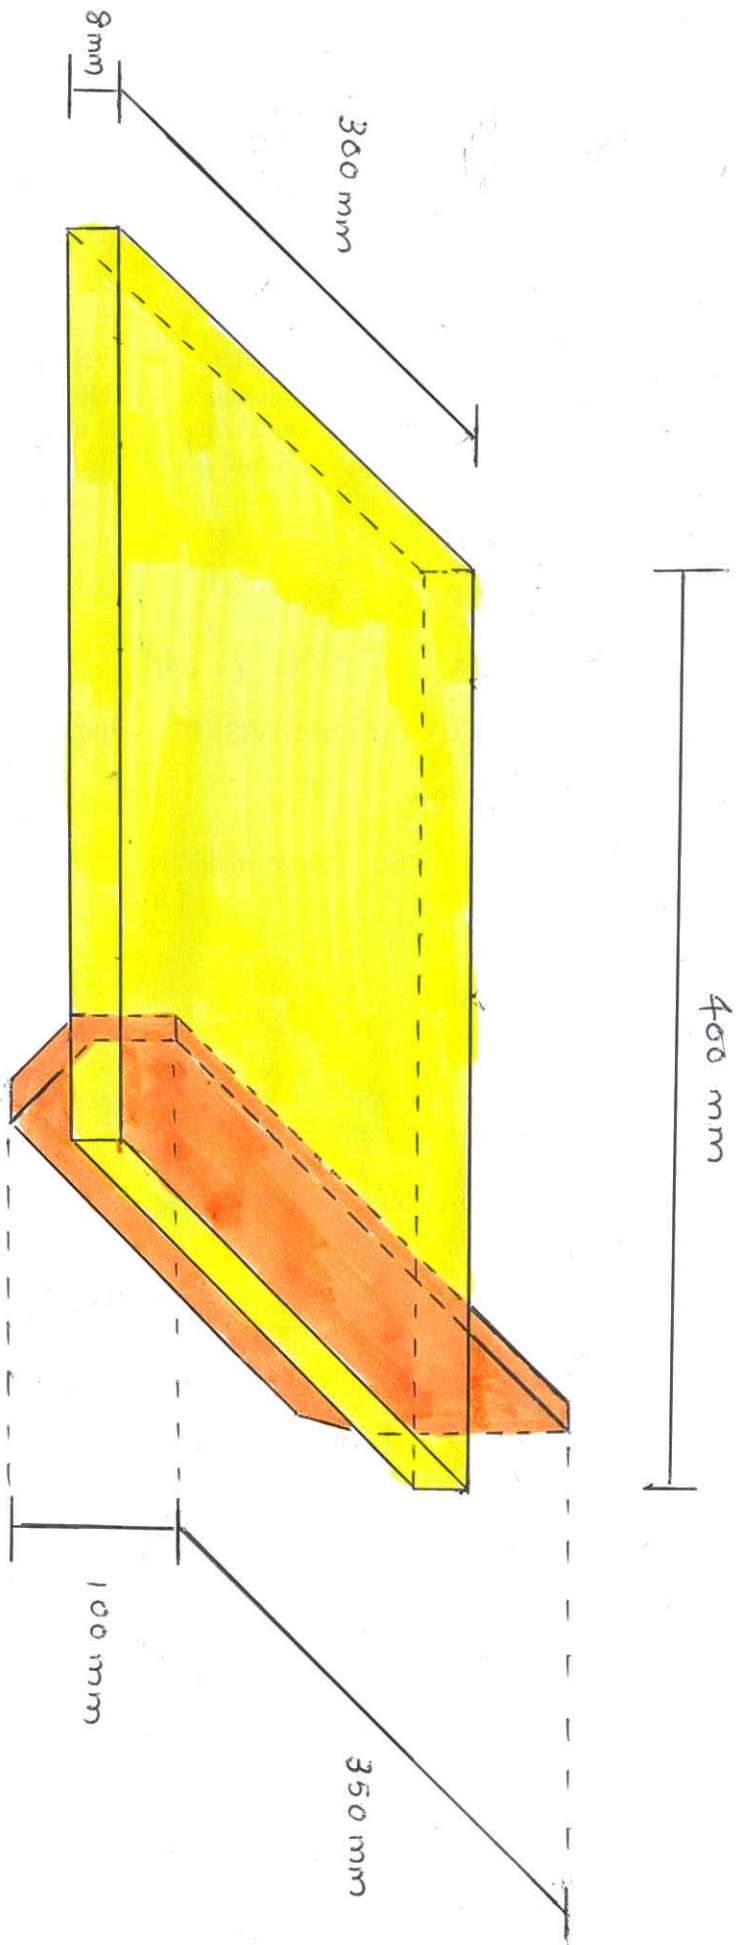
No.	Description
 	Welding Completed
 	Weldment grinded clean
 	Carried out NDT color test on weldment
 	C/O inspected work result and certified good work Ship crew proceed to apply paint upon completion of NDT test.

- TO CRIP DAMAGED AREA AND REWELD WITH INSERT PLATE 300 X 400 X 8 mm THK .
- TO WELD ON UNDER SECTION BRACKET .
