PHOTO REPORT

Job No. : 2410
Date : 23 Jul '15
Location : TPP, Malaysia

Subject : Ventilation door renewal works IWO Bay 23 (3 pcs)

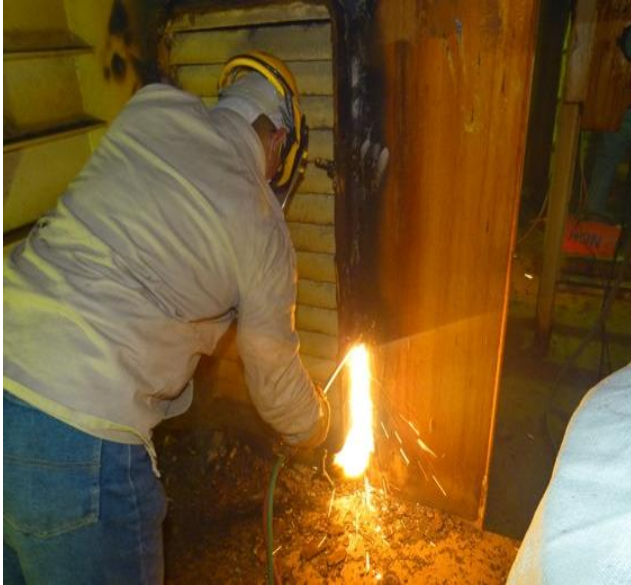
Cropped off all renewal door using flame cutter

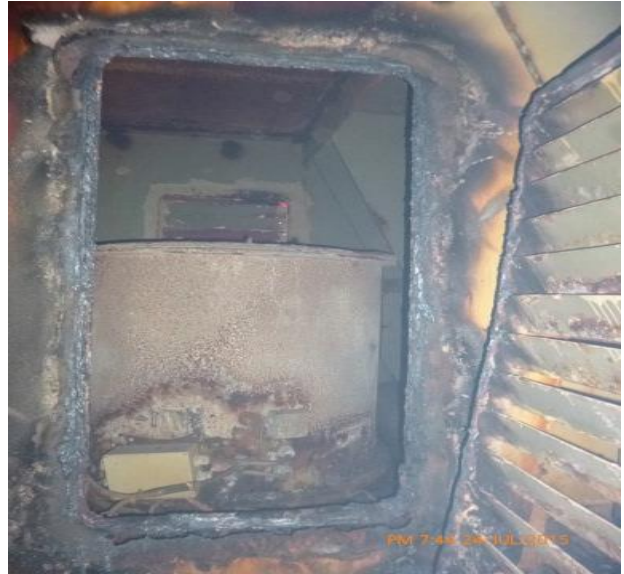
Ventilation door after completely crop off

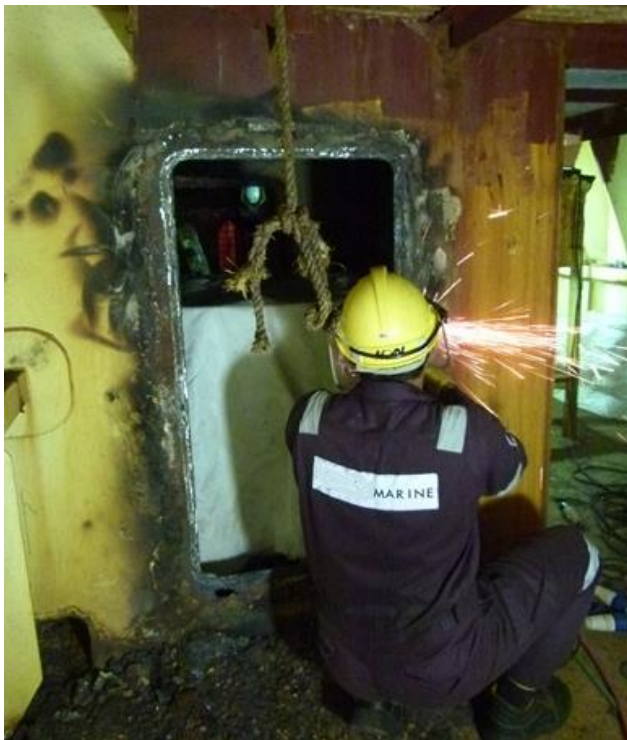
Grinding after cropping off

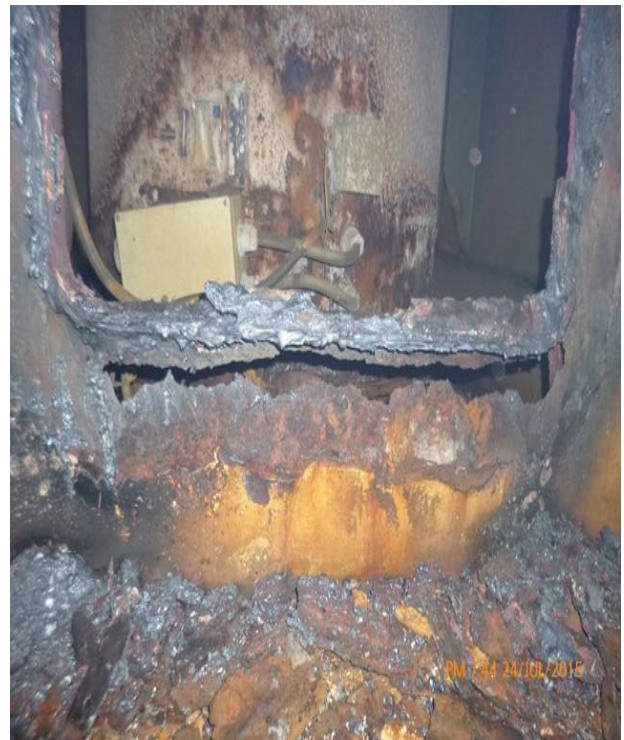
Condition of bottom part which required replacement

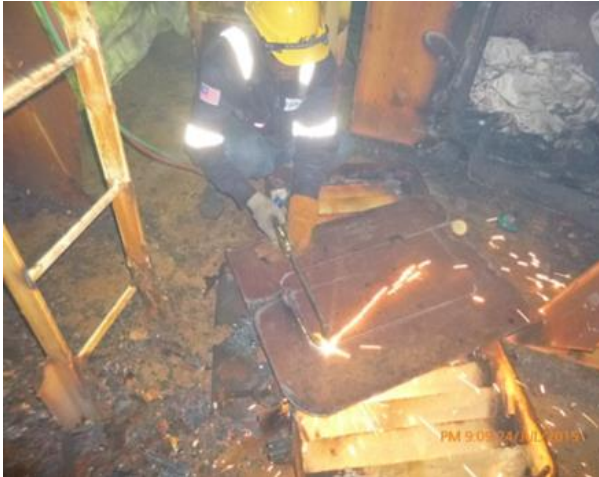
New plates were fabricated for bottom part

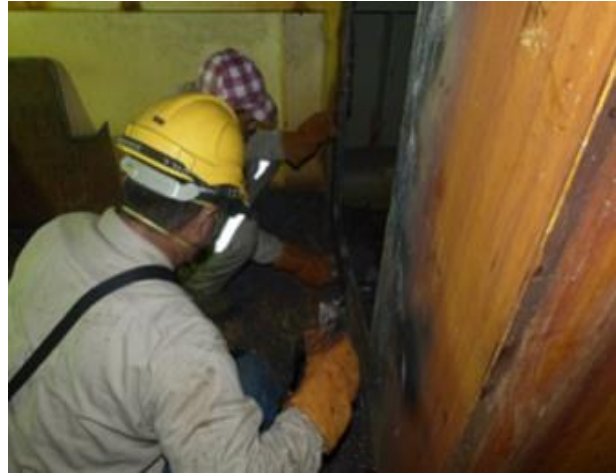
Replacement of 1st door bottom part

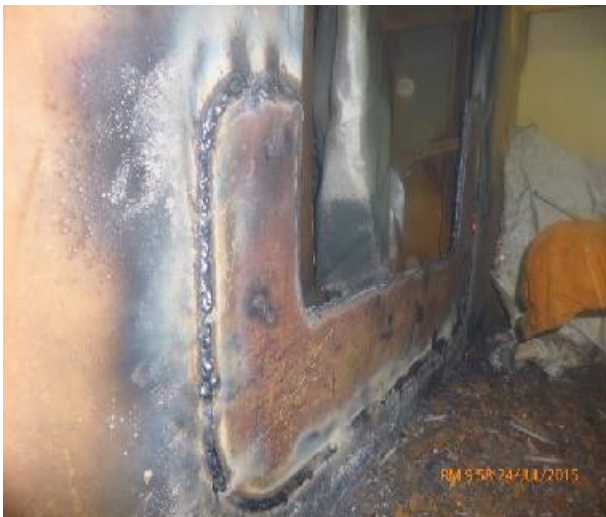
Replacement of 2nd door bottom part

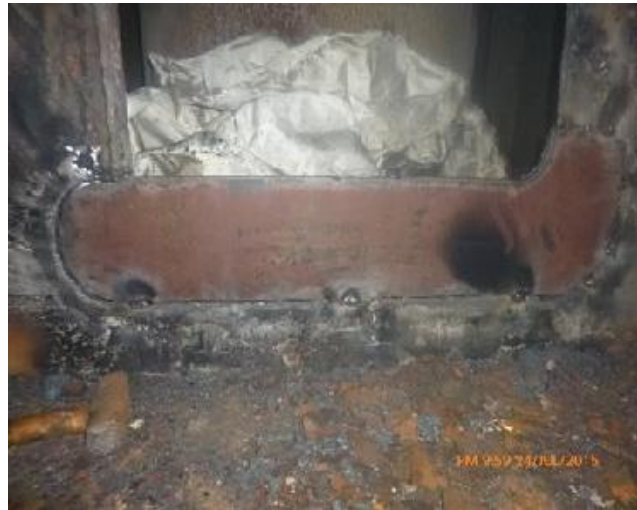
Replacement of 3rd door bottom part

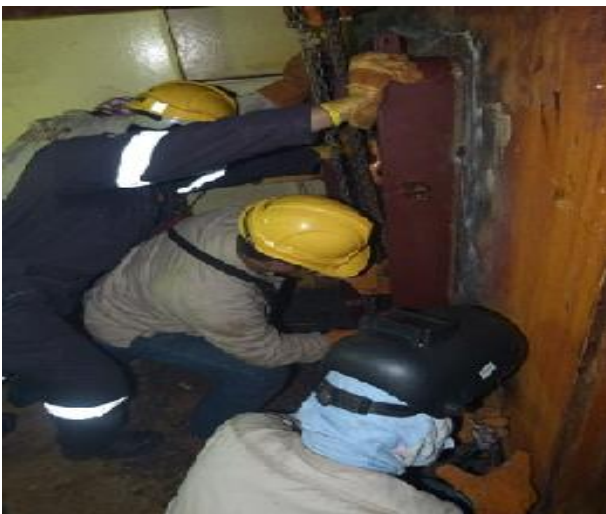
Hoist up new door using chain block for fitting

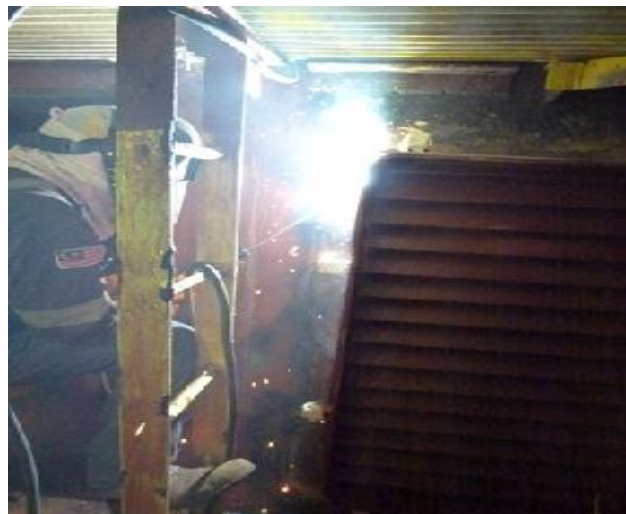
Fit up and commenced with full welding

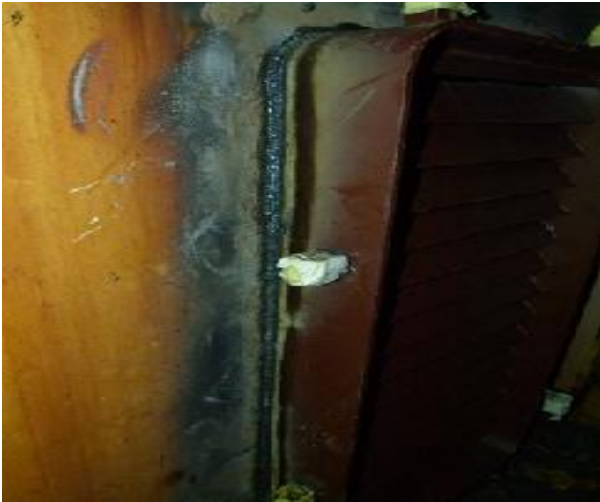
Full welding completed

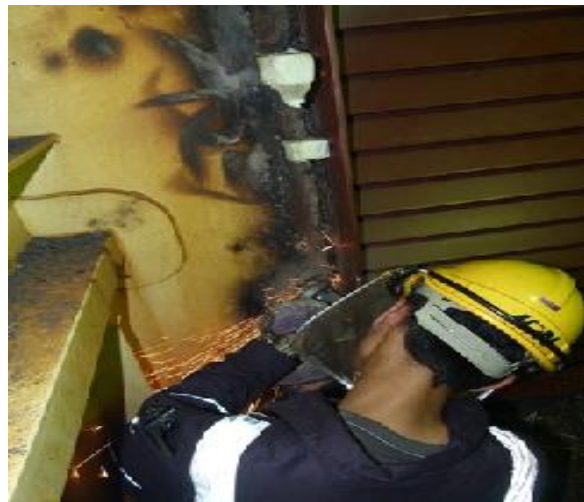
Grinding at the weldment

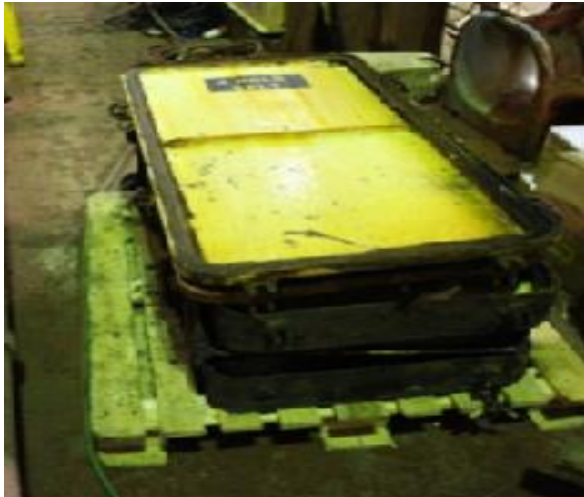
All 3 doors that has been cropped to be scrapped

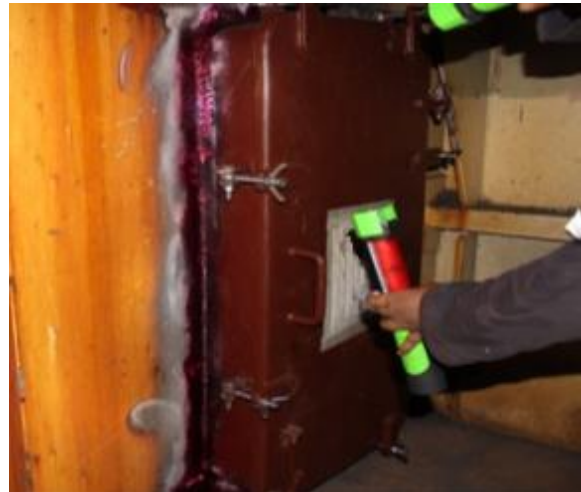
DPI Test carried out on all 3 locations
and witnessed satisfactory by C/O
