PHOTO REPORT

Job No. : 2623

Location : Singapore Anchorage

No.	Description
<p>Subject : Replacement of Computer Desk for Simulators Location: C-Deck Training Room Table Dimension: L4000 + 1590mm + 1360mm x W700 + 580mm x H760mm</p>

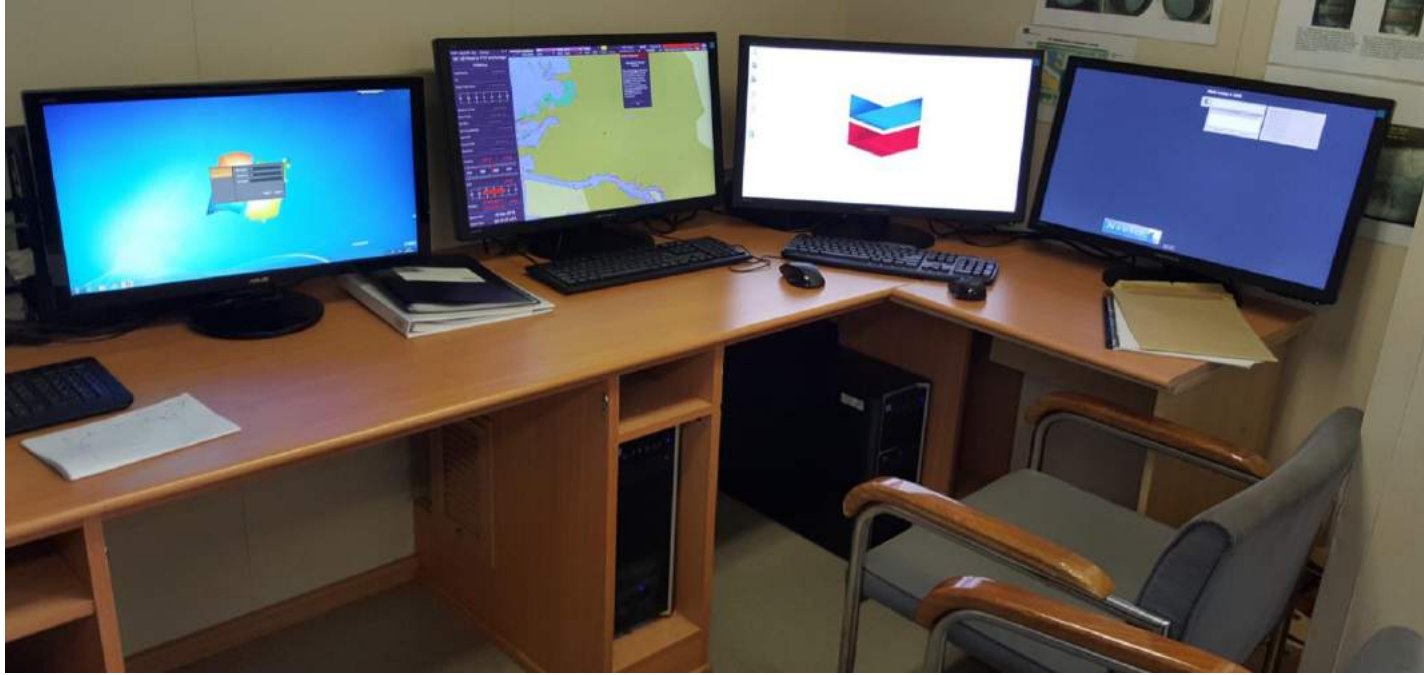
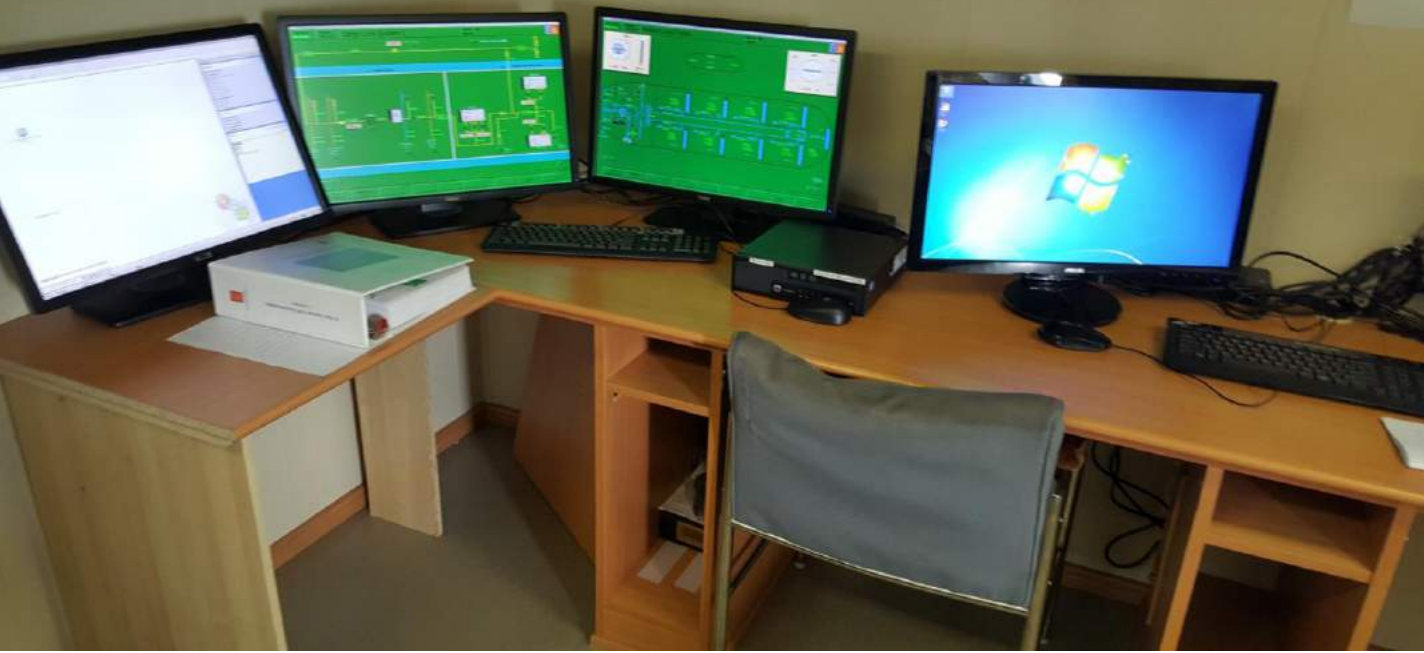
<p align="center">Existing Computer Desk for Simulators in C-Deck Training room</p>

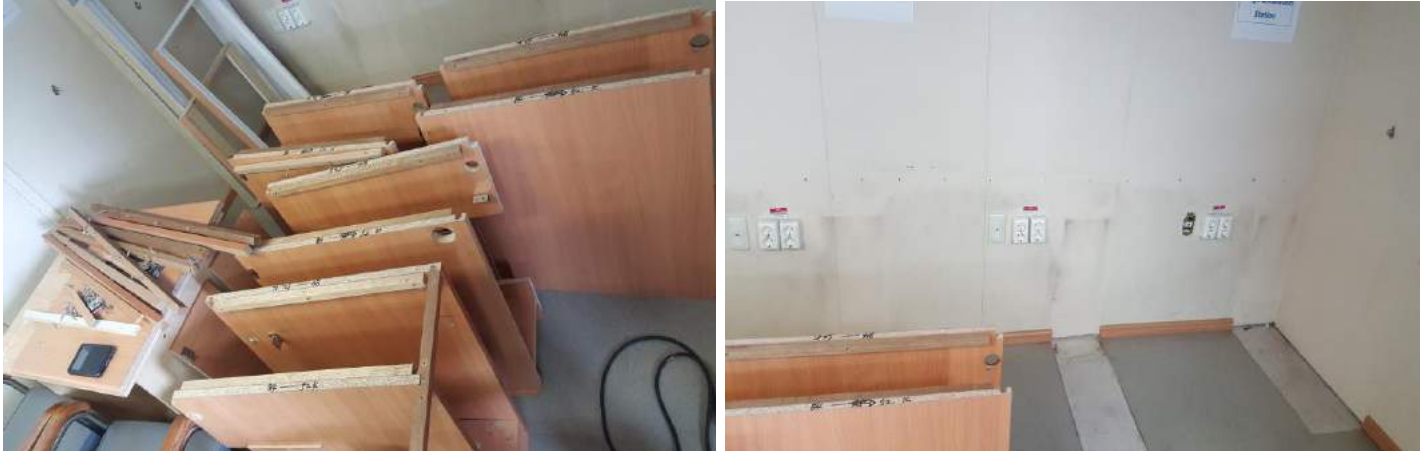
<p style="text-align: center;">Existing table was dismantled into parts</p>

<p>> All parts of the dismantled table were placed outside the training room and handed over to ship crew for disposal</p> <p>> Housekeeping was done in the area before commencing works for installation of new table</p>

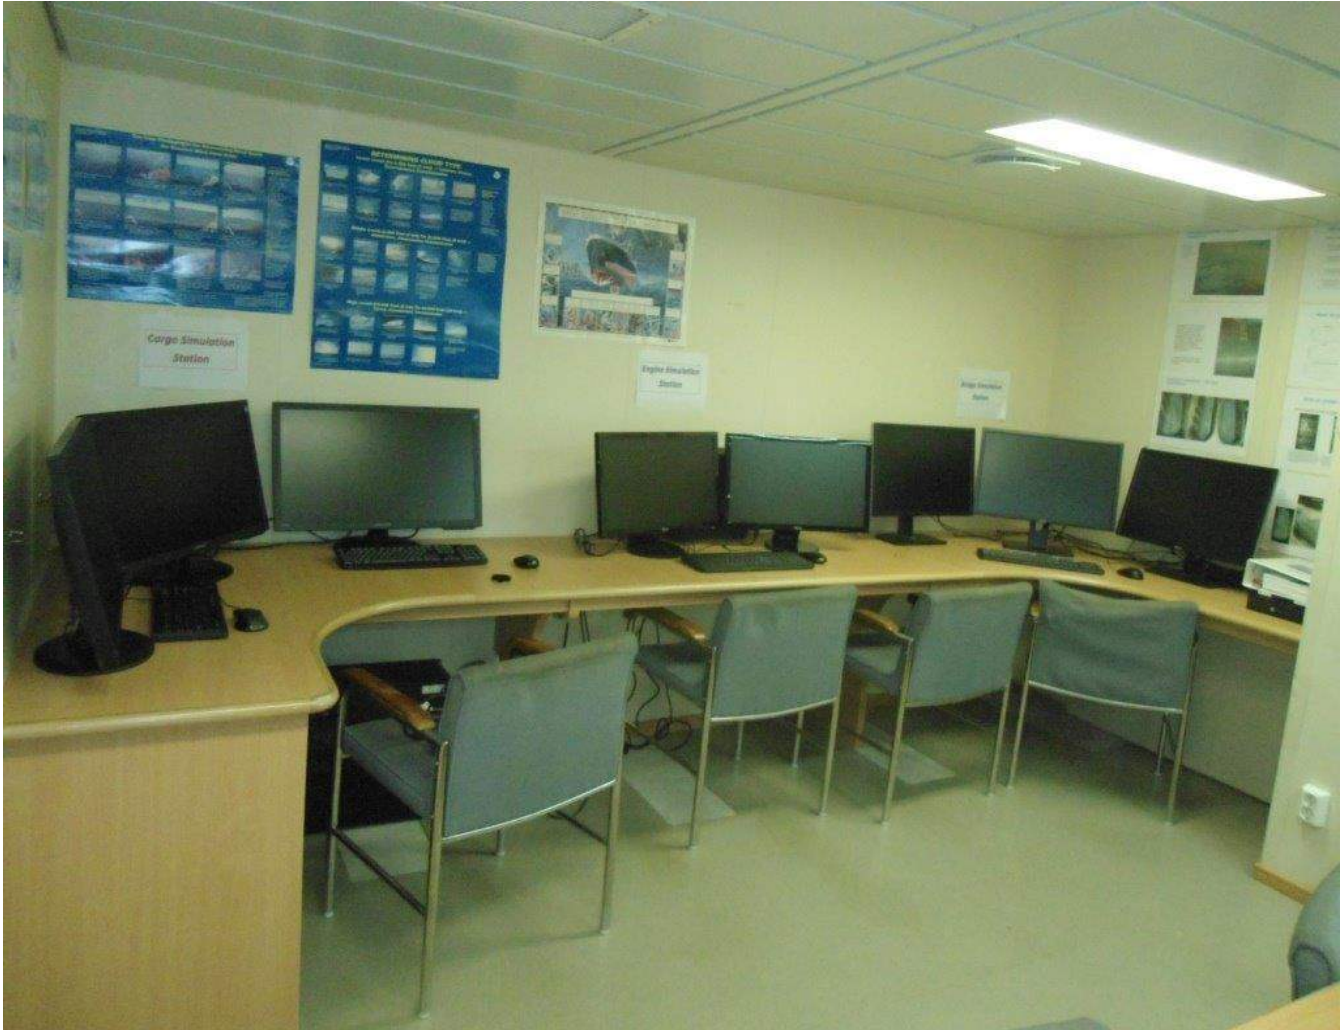
> Final condition of table was inspected by Chief Engineer and found Satisfactory
