Photo Report

Job No. : 3206/C0005

Location : Yantian Terminal, China

Subject: Damaged Hatch Cover Structure Renewal

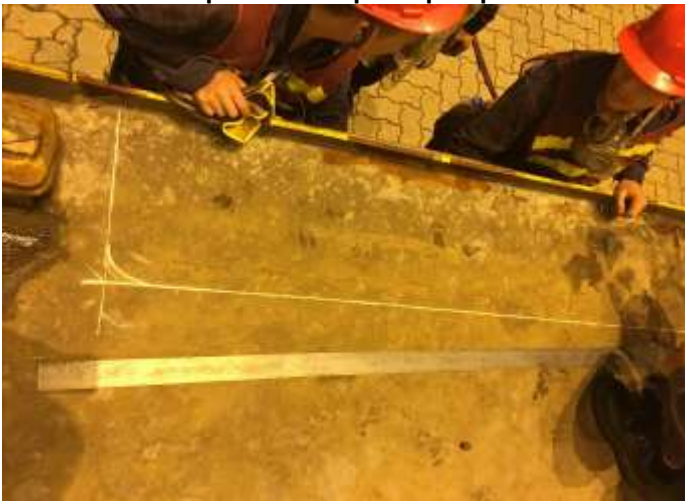
1. Marked the repair area as pre repair plan.

- a. deck plate 400mm*1850mm*10mm thk DH36
- b. vertical web 100mm*2000mm*10mm thk DH36
- c. gutter plate F. bar 65mm*2000mm*12mm thk
- d. bracket 150mm*200mm*10mm thk DH36

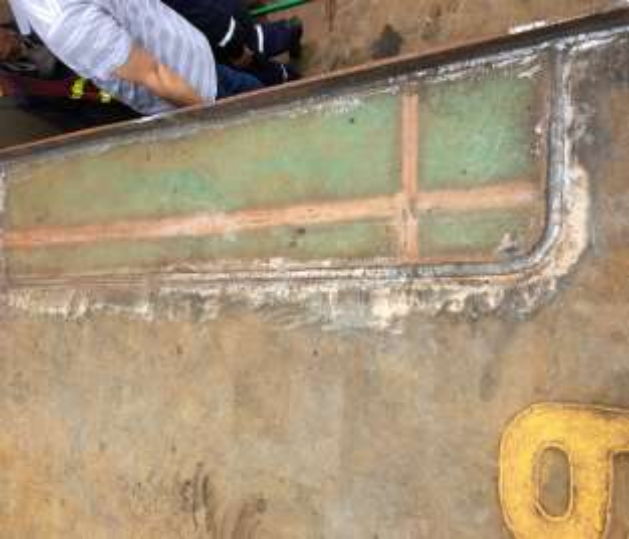
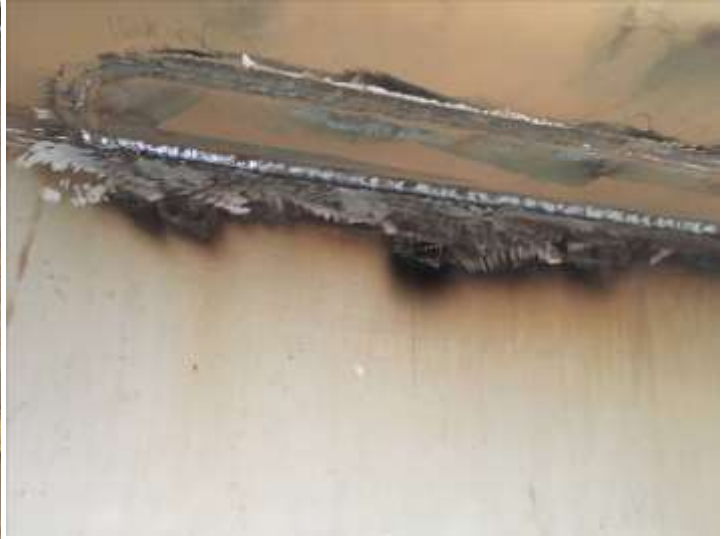
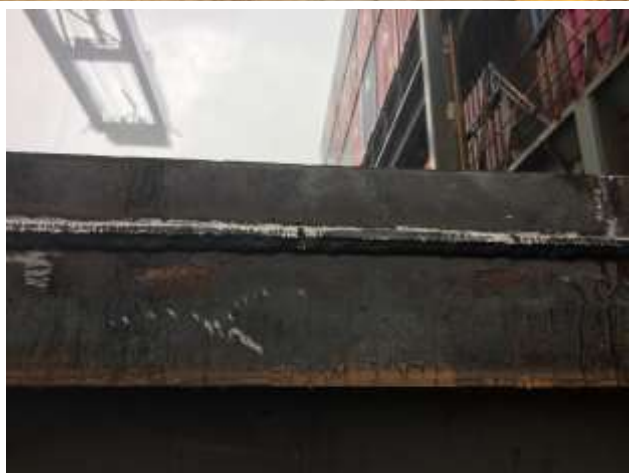
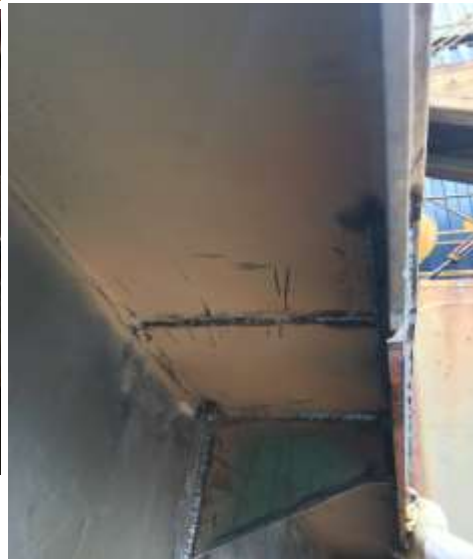
5. During heavy raining after completing the job, NDT was not carried out. After a little long time, no leaking was found under deck.

4. Completed welding and grinding.
