PHOTO REPORT

Job No. : 2325

Location : PSA Singapore

No.	Description
Subject A : Main Engine Piston Liner Overhauling Unit no11

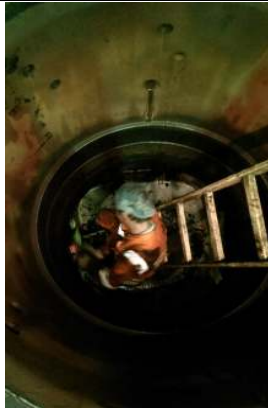
Piston rod extracted	Liner extracted

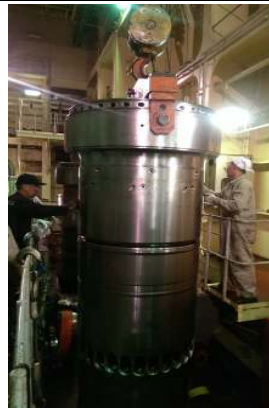
Cylinder bore cleaned

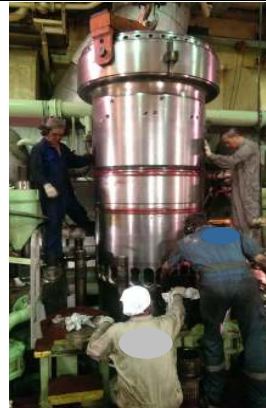
Spare liner were cleaned

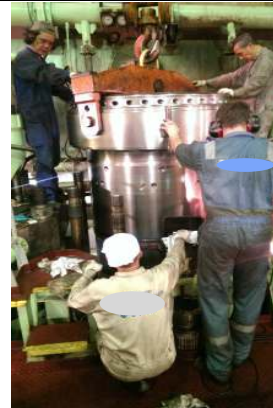
Liner was installed and new O rings were changed

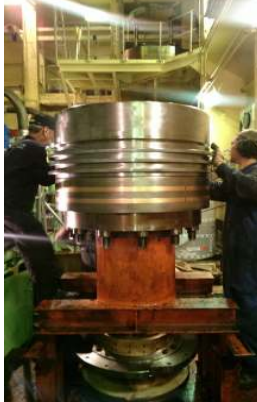
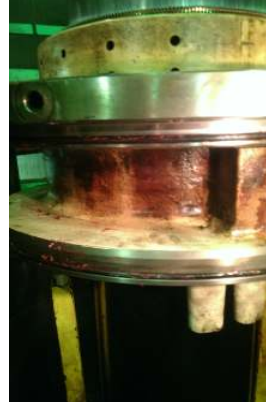
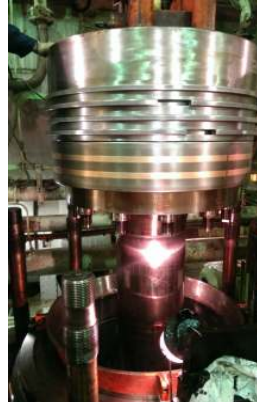
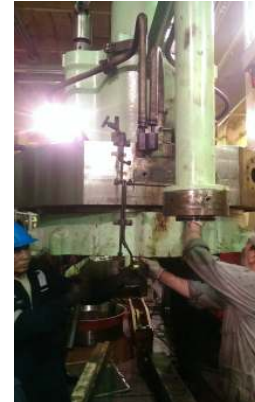
Spare piston were installed with spare piston rings and stuffing box O rings.
Water jacket cleaned and O rings replaced. All connections were reassembled back in good order.

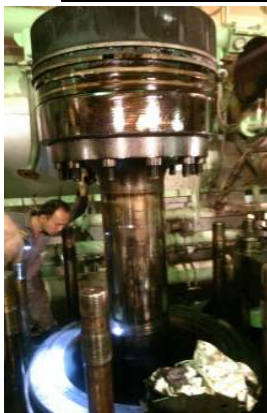
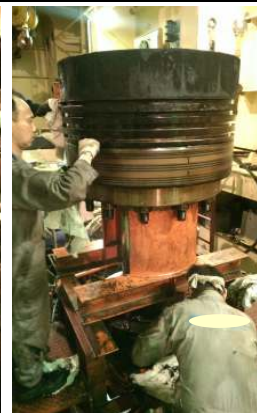
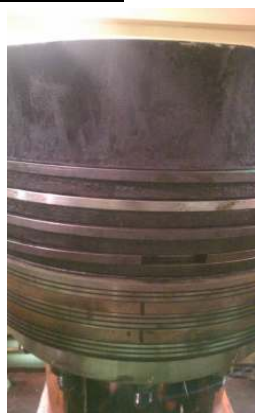
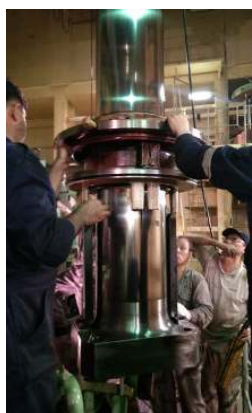
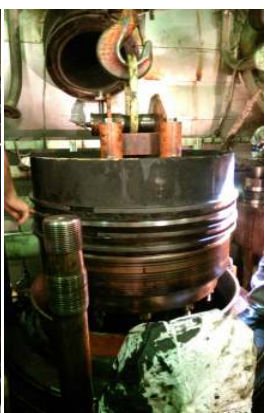
Subject - B : Main Engine Piston Overhauling Unit no4

Piston rod was extracted and cleaned the groove. Spare piston rings, stuffing box O rings were changed and reinstalled back in good order.
