# PHOTO REPORT

Job No. : 2348

Date : 18th April 2015

No.	Description
<p><b>Subject / Workscope</b> : Troubleshooting With Hydraulic Locking Alarm System On Steering Gear Pump No2.</p>

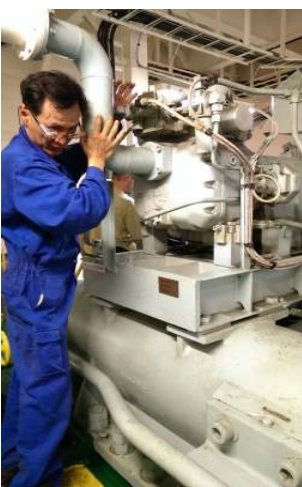
<p>: Hydraulic pump operation were checked and tested.</p>

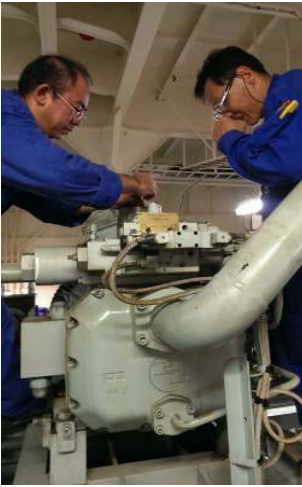
<p>: Manual operation of the control valve checked and tested.</p>

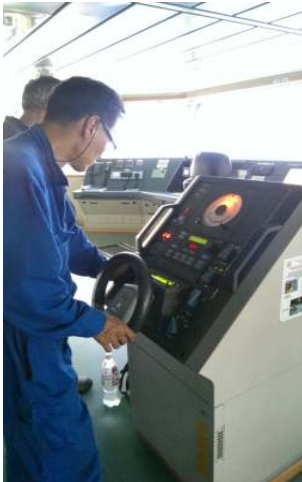
: Auto Pilot function were checked and tested.

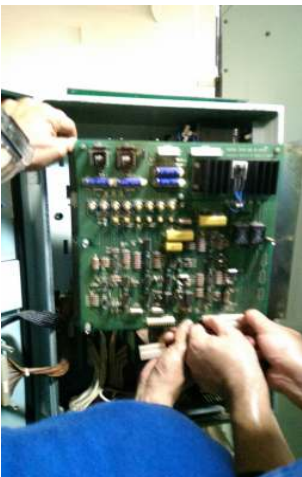
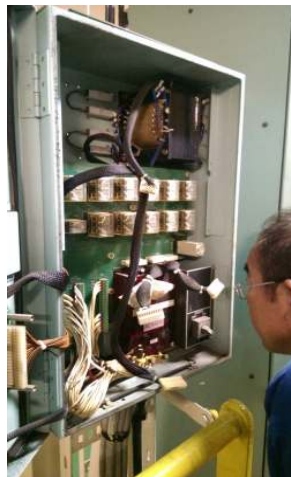
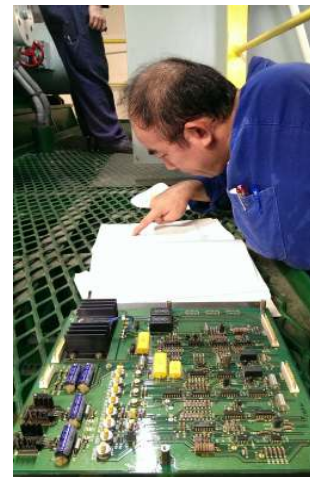
Hydraulic locking alarm unit PCB card in no2 control panel box were Checked and tested .

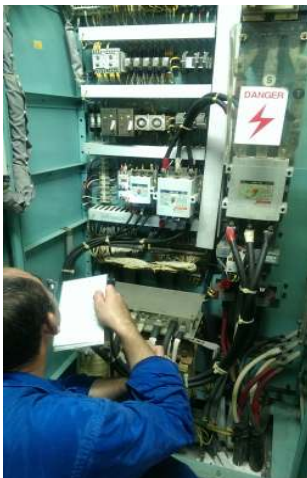
: Checked and tested the function of alarm system.

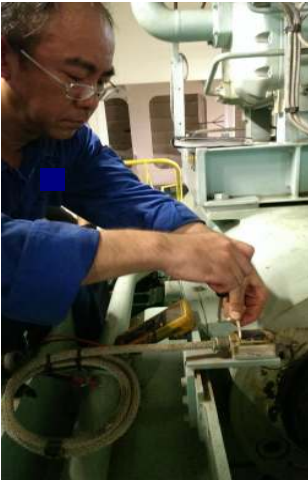
: Limit switch were checked and tested. And made some adjustment.

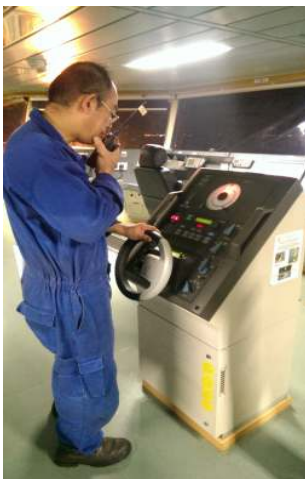
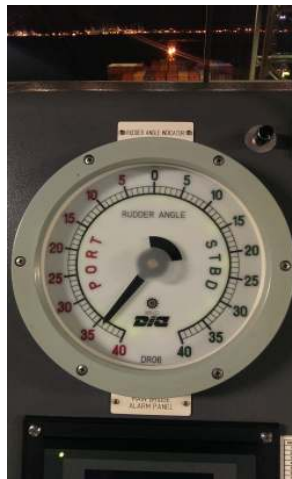
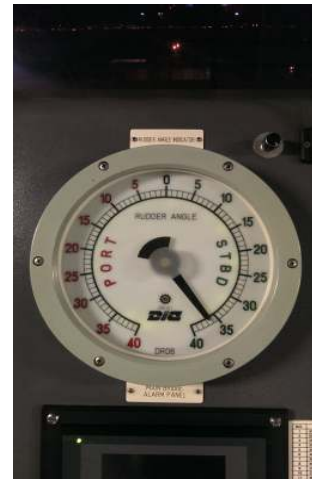
Upon completion of troubleshooting on the Hydraulic locking alarm system pump no2 function test was done. Rudder was turned PORT and STARBOARD to the maximum and NO alarm were found.
