PHOTO REPORT

Job No. : 2763

Subject : Removal of Damaged Cell Guide @ Bay14 Row01 Tier12 by Cold Cut Method

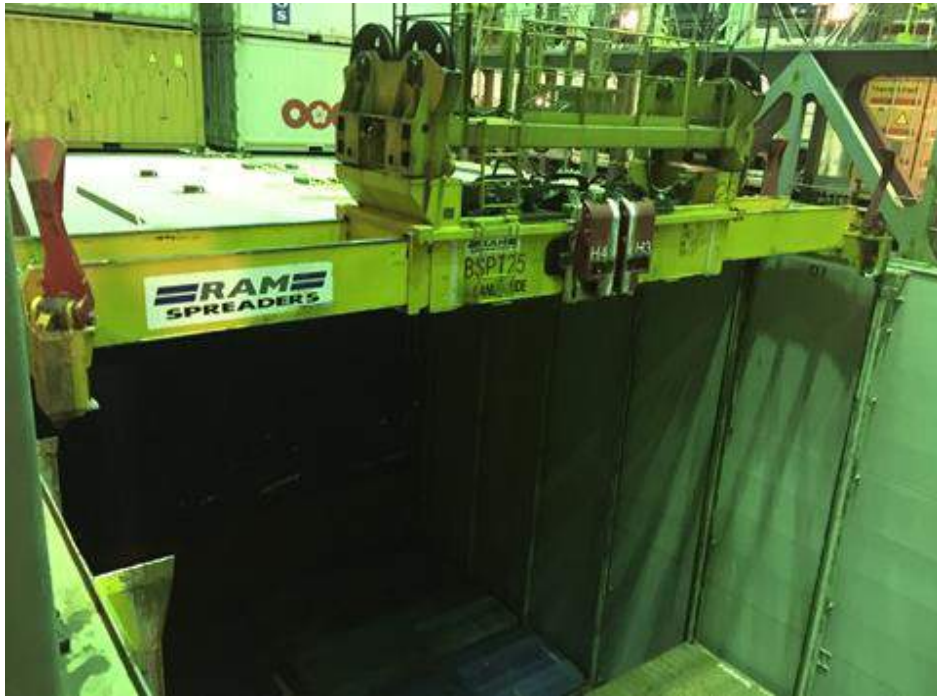
- * After discharged some of containers in Bay 14 Centre, for safe operation, PSA terminal proceed to try to discharge containers in Row 1 with spreader.
- * Attempt not successful and confirmed removal of damaged cell guide by cold cut.

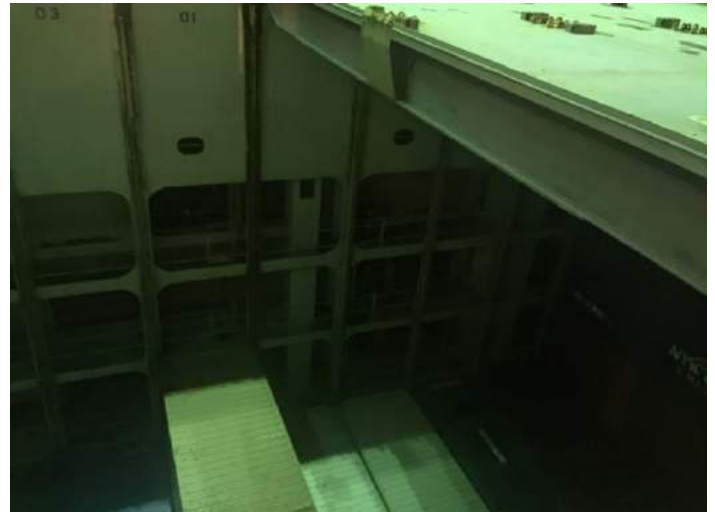
- * Prior to work commencement, for safe work/operation, PSA terminal to isolate Row 1 by discharging surrounding containers @ Row 2/4/6 and Row 3/5/7.

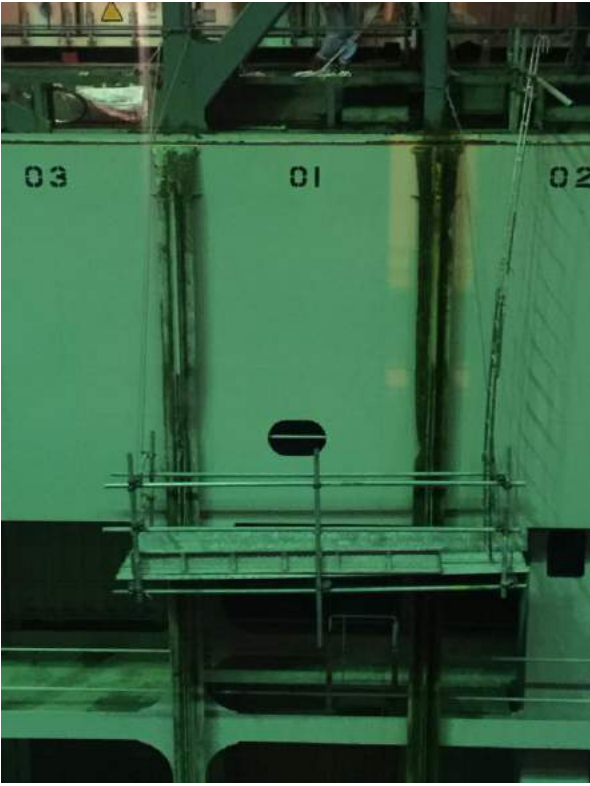
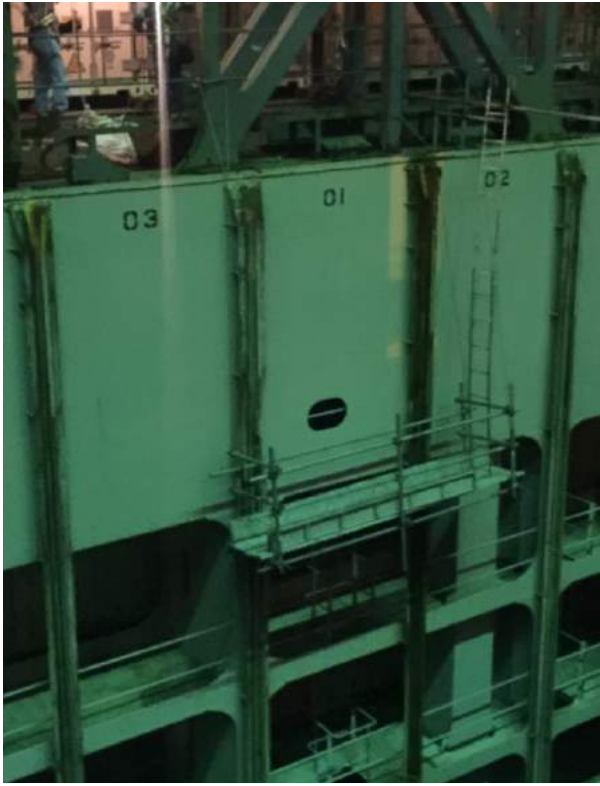
<p>* Constructed hanging staging in bay 14 covering Port & Stbdside cell guide of Row 1.</p>

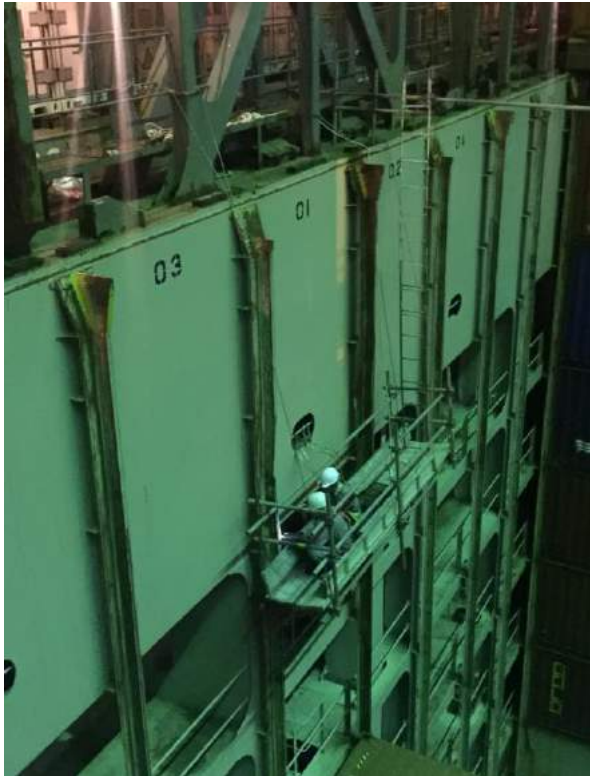
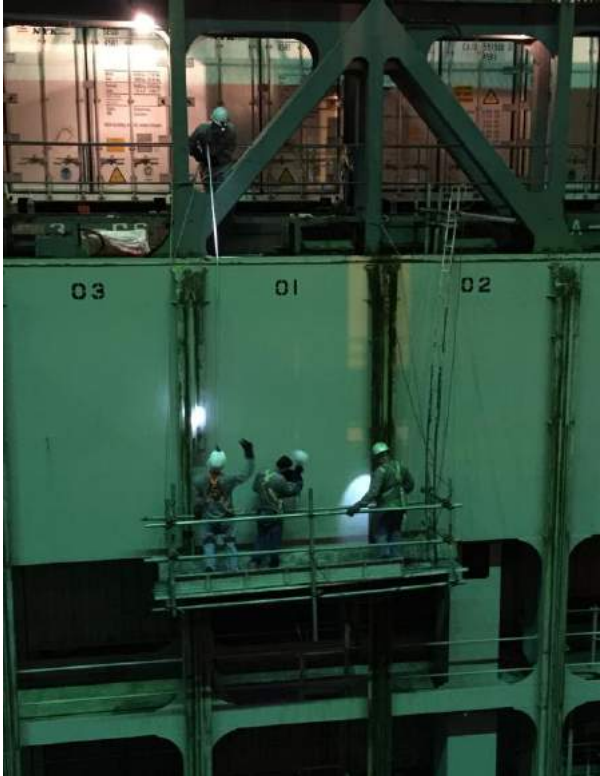
<p>* Carried out cold cutting on deformed cell guide with electrical saw, water applied throughout.</p>

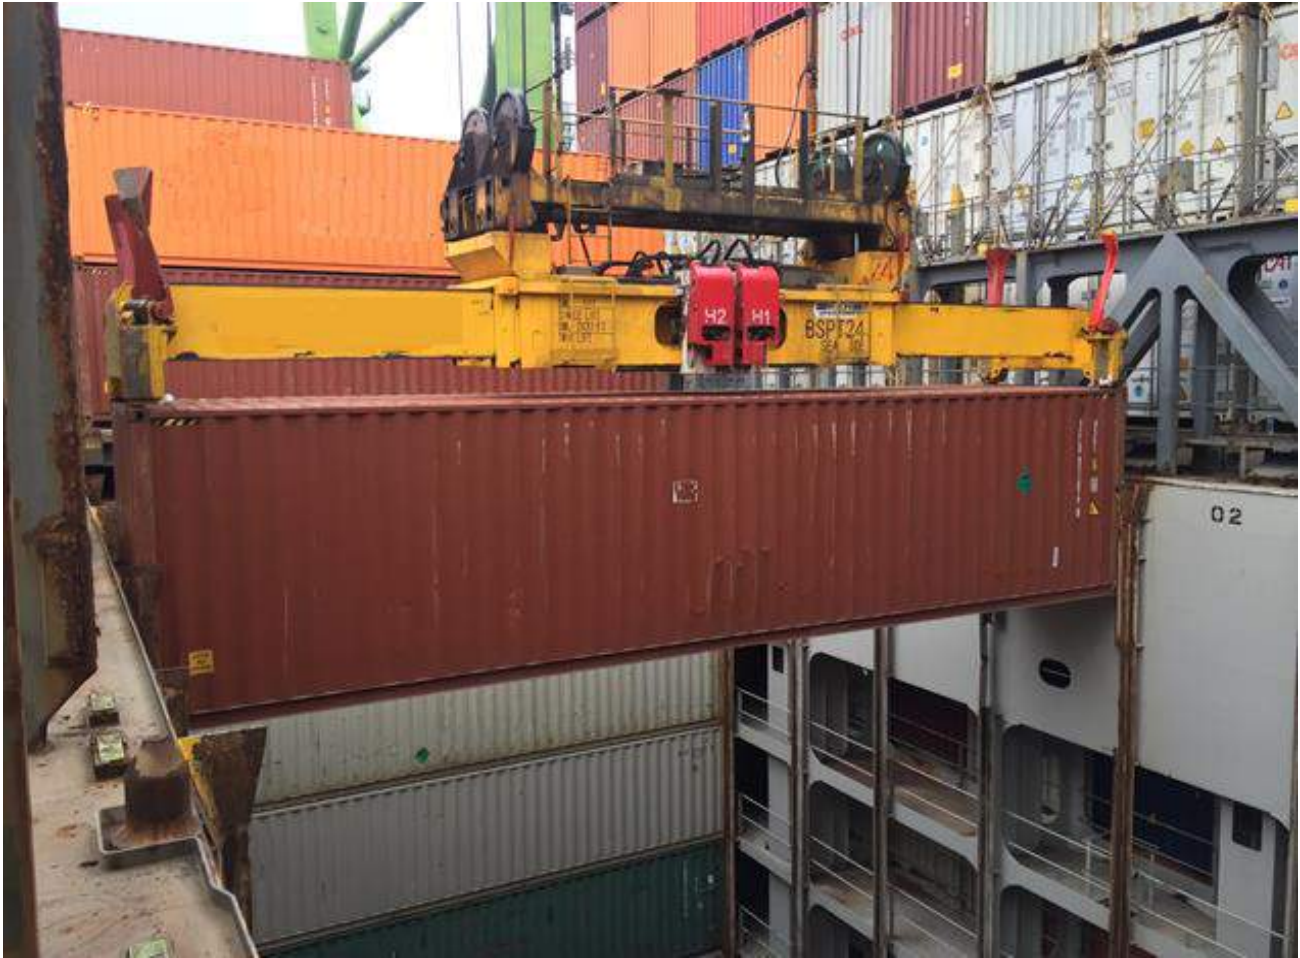
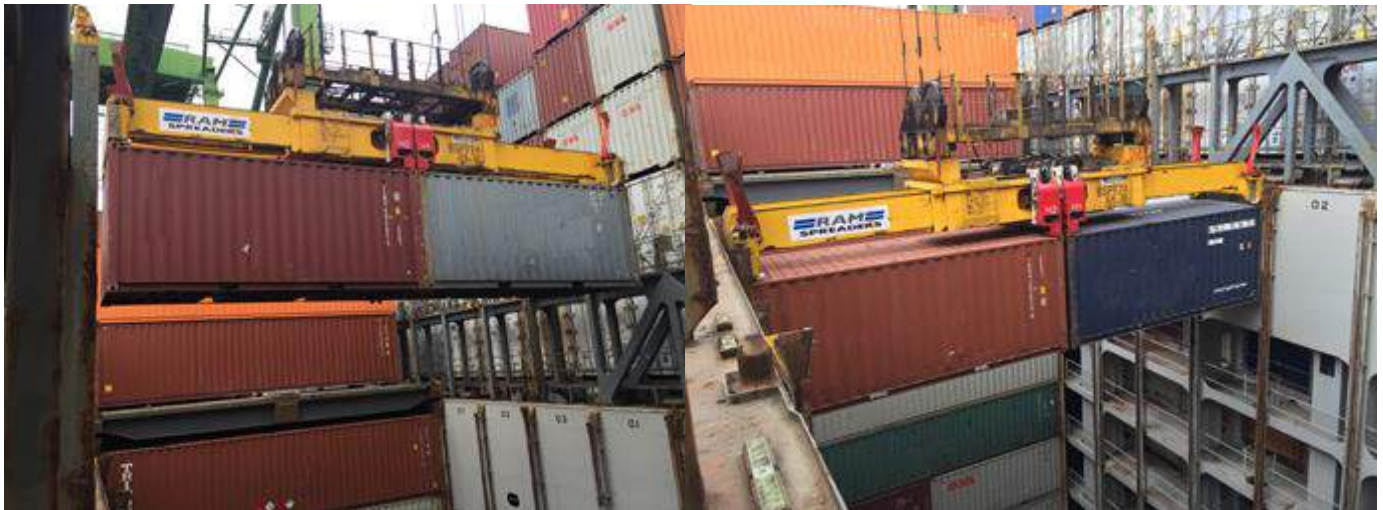
* Containers in Row 1 were successfully discharged, work certified completed.
