# PHOTO REPORT

Job No. : 2365

Location : PSA Singapore

**Subject Workscope : Transformer Room Ducting Modification**

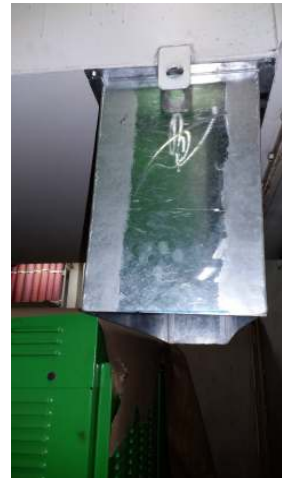
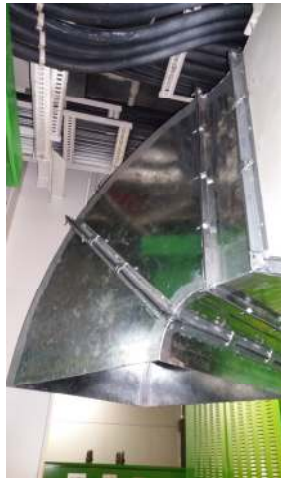
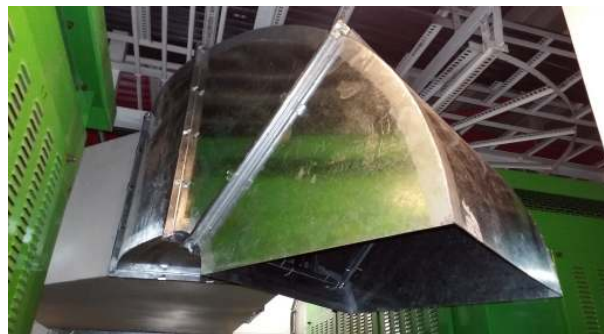
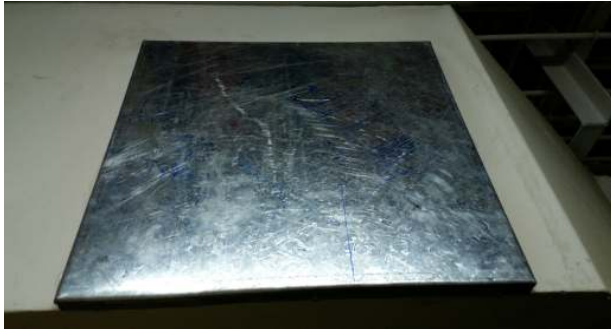
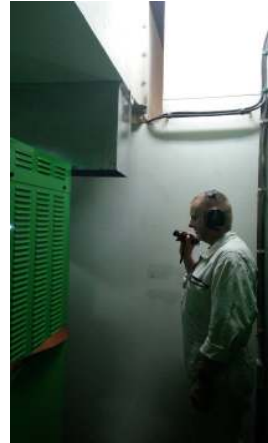
**Above All Job Was Done. All Work Progress Was Inspected, Witnessed, And Accepted By Chief Engineer With satisfactorily.**

All Elbows Joints and End Caps were fitted accordingly and Silicone paste were applied in all the joint corners.
