PHOTO REPORT

Job No. : 2372

Location : PSA Singapore

No.	Description	Pg1
Subject/Workscope : High Sea Chest Rubber Coating (port side)

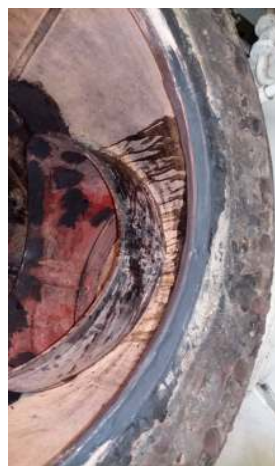
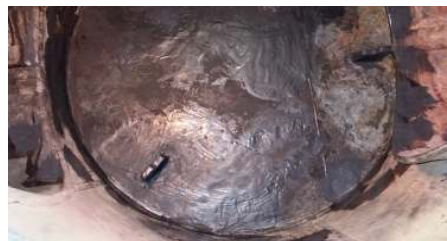
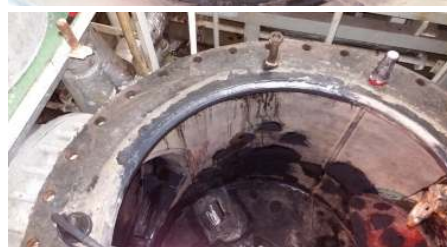
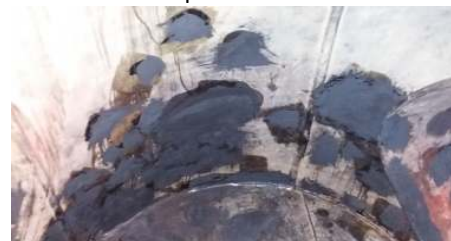
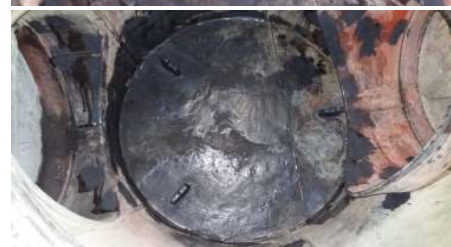
Applied New Rubber coating on all the spots

Above All Job Was Done. All Work Progress Was Inspected, Witnessed, Accepted By Chief Engineer With Satisfactorily
