<p>Day 4 Mobilisation / 15th Jan 2018</p>

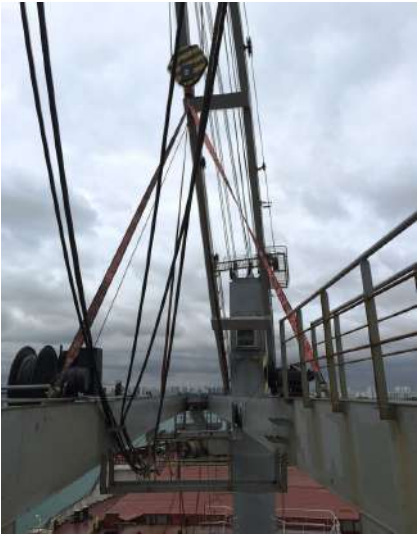
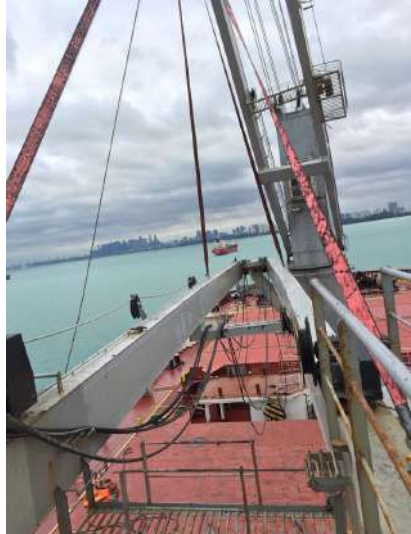
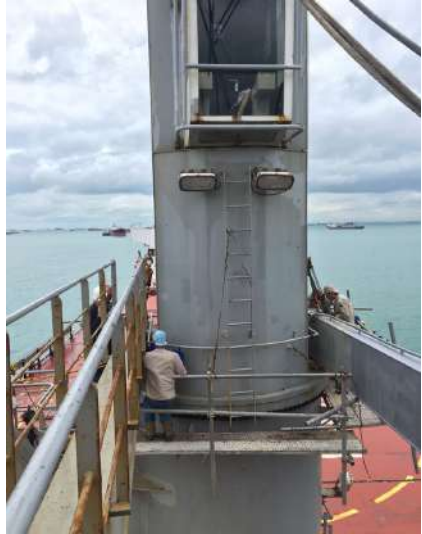
<p data-bbox="135 887 534 974">Portside jib foot & bearing housing mount joint were aligned & assembled in balance weight.</p>

<p data-bbox="821 913 997 981">Mating surfaces of jib foot were Aligned with Even Gap</p>

<p data-bbox="1050 887 1453 1003">Mounting joint of Jib foot & bearing housing were aligned & mated seamlessly, four lock bolts fitted in position in balance.</p>	
<p data-bbox="108 1444 247 1473">STBDSIDE</p>

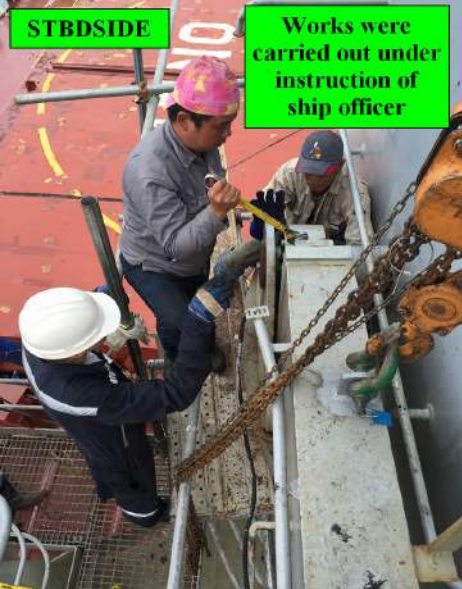
<p data-bbox="335 1444 534 1556">Works were carried out under instruction of ship officer</p>

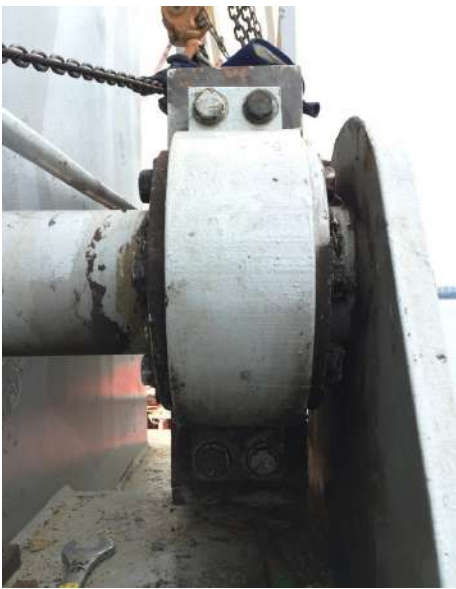
<p data-bbox="598 1444 997 1568">Jib foot & bearing housing mount assembly were not aligned & mated, pneumatic gun were instructed to be used on lock bolts, attempted to bring closer the gap by force, threaded bolts were jammed in place.</p> <p data-bbox="598 1758 694 1792">Misaligned</p> <p data-bbox="885 1836 965 1870">Big Gap</p>
