# PHOTO REPORT

Job No. : 2345

Date : 13th April 2015

Location : PSA singapore

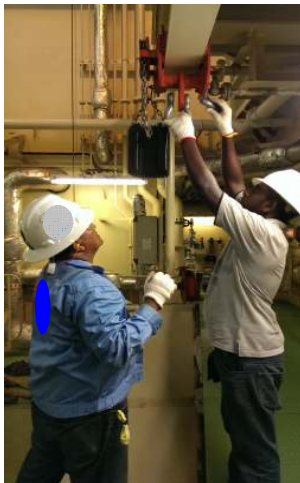
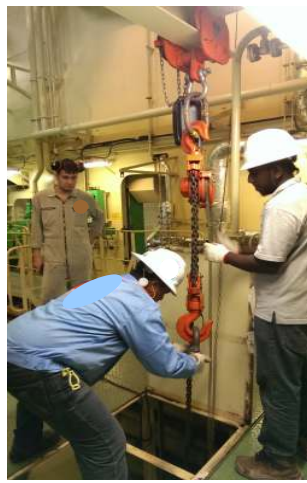
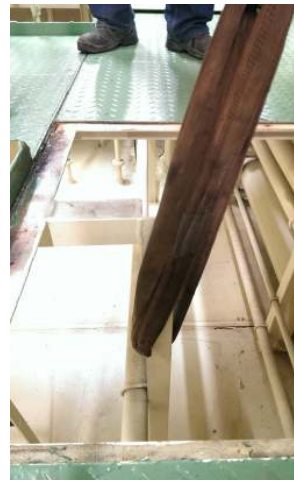
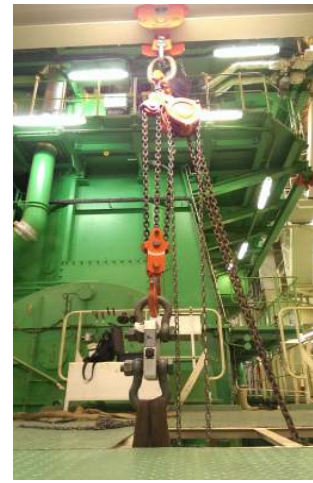
Prepared tools and equipments to do the load test. Every test was performed by using strong points Which were provided by Chief Engineer.

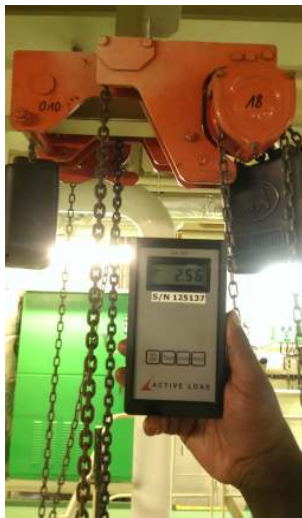
Distinguishing Number or Mark	Number Tested	Descriptions	Safe Working Load	Proof Load Applied
2098/01	1	Gear Trolley Model : Blackbear DLH Manufacturer : Dae Kyung Co.	2 Tons	2.5 Tons

All above items were successfully proof loaded and were held for approximately ten minutes.  
All job progress was inspected, witnessed and accepted by Chief Engineer satisfactorily.

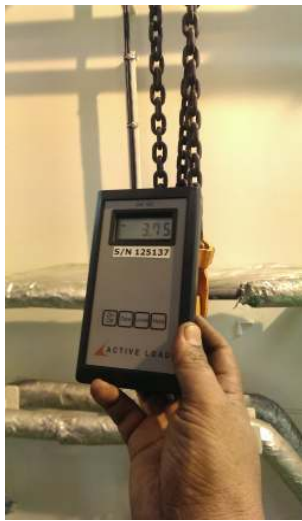
Distinguishing Number or Mark	Number Tested	Descriptions	Safe Working Load	Proof Load Applied
2098/19 to 2098/25	7	Gear Trolley Model : Blackbear DLH Manufacturer : Dae Kyung Co.	3 Tons	3.75 Tons

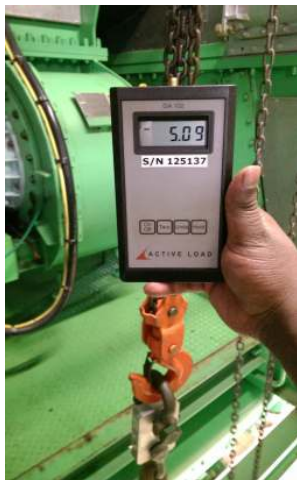
Distinguishing Number or Mark	Number Tested	Descriptions	Safe Working Load	Proof Load Applied
2098/01 to 2098/06	6	Gear Trolley Model : Blackbear DLH 50 Manufacturer : Dae Kyung Co.	4 Tons	5 Tons

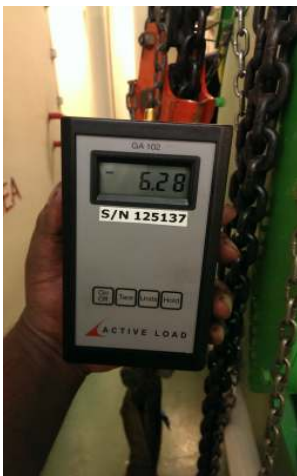
Distinguishing Number or Mark	Number Tested	Descriptions	Safe Working Load	Proof Load Applied
2098/17 And 2098/18	2	Gear Trolley Model : Blackbear Manufacturer : Dae Kyung Co.	5 Tons	6.25 Tons

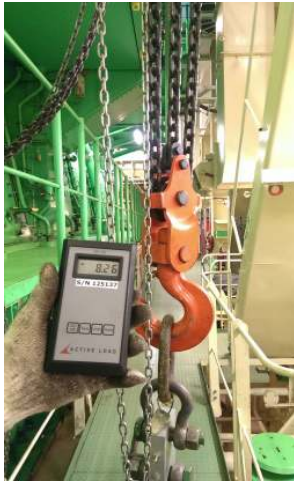
Distinguishing Number or Mark	Number Tested	Descriptions	Safe Working Load	Proof Load Applied
2098/01	1	Gear Trolley Model : Blackbear DLH Manufacturer : Dae Kyung Co.	6.5 Tons	8.2 Tons
