# PHOTO REPORT

Job No. : 2381

Date : 24 And 25th May  
Location : PSA Singapore

No.	Description	Pg1
<p><b>Subject / Work Scope : M/E Wartsila RTA 96 C fuel injection pump unit no 1 and 2 Exchange.</b></p>		
 	 	<p>Third engineer isolated and shut the fuel oil and air pipes in order to open the connections.</p>

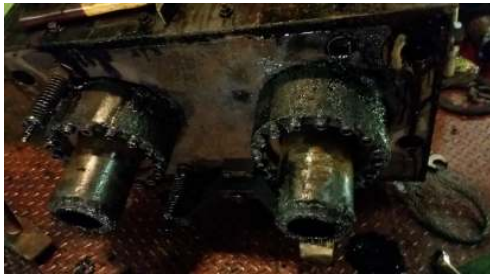
<p>Upon confirmation removed air, fuel oil, return fuel pipe, actuator pipe connections and extract the existing fuel injection pump.</p>

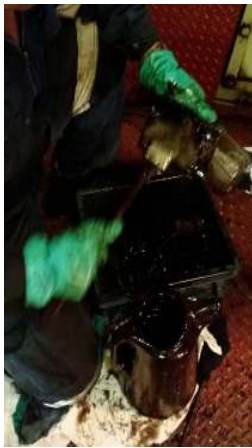
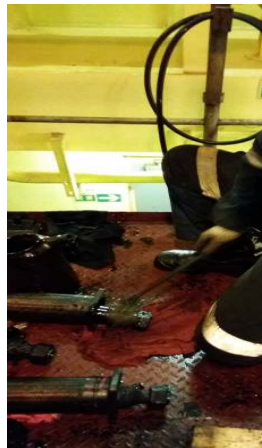
Thick hard carbon layer were found around on the fuel injection pump.

Fuel pipes, fuel injection pump block, plunger, pipe caps were cleaned with diesel oil.

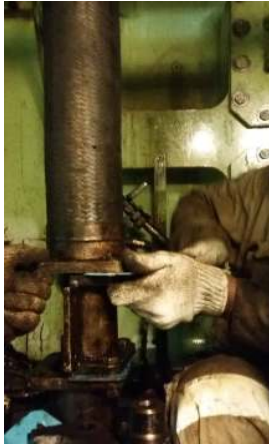
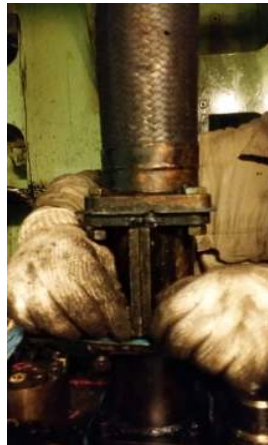
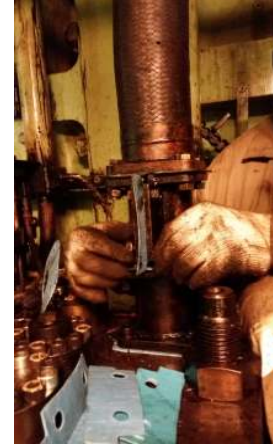
Cleaned and replaced ship's spare fuel injection pump in place. Applied silicone around the pump seating and tighten the foundation nuts.

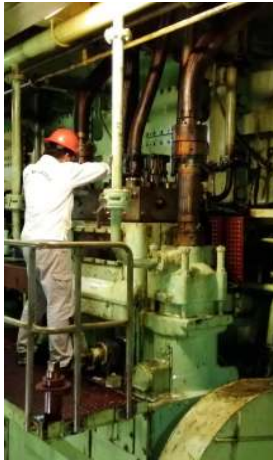
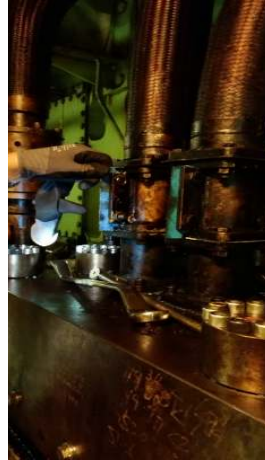
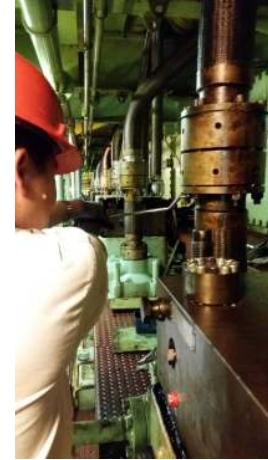
Cleaned the fuel oil pipes with diesel oil and installed and new gasket were changed

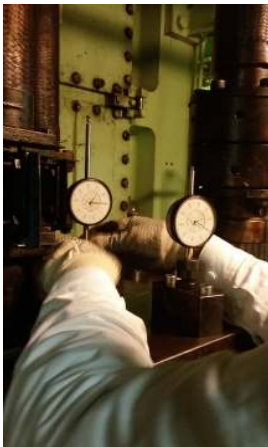
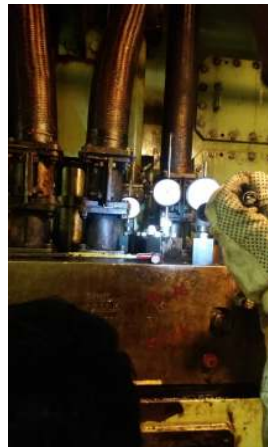
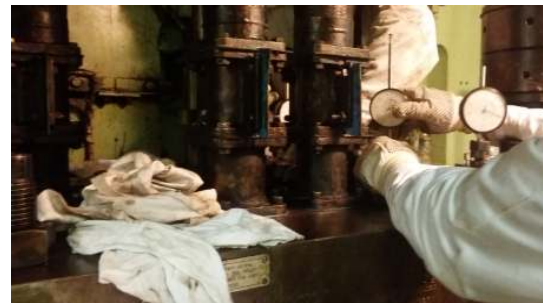
All connections were installed back in order

Upon Completion Fuel Injection Pump Timing Were Carried Out And Found Satisfactory. All Work Progress Was Inspected Witnessed Accepted By Chief Engineer With Satisfactorily.
