PHOTO REPORT

Job No. : 2388

Location : PSA Singapore / HSD Workshop

No.	Description	Pg1
Subject / Workscope : Fabrication Of Sea Water Manifold And Reducer Pipe.

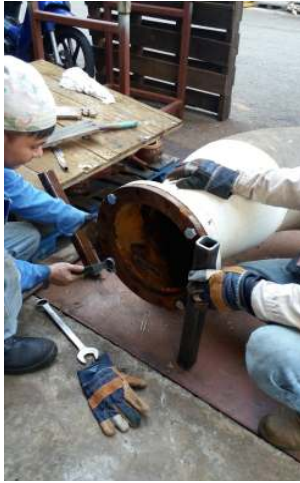
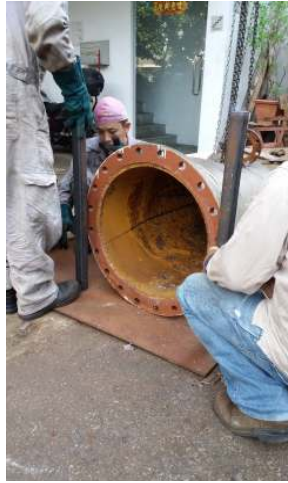
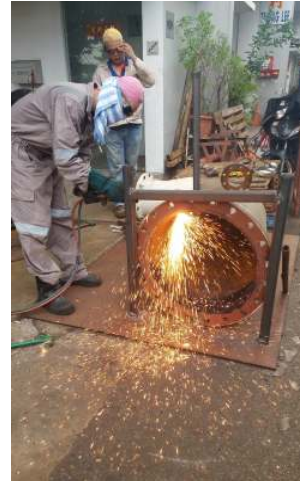
Reducer pipe were templated

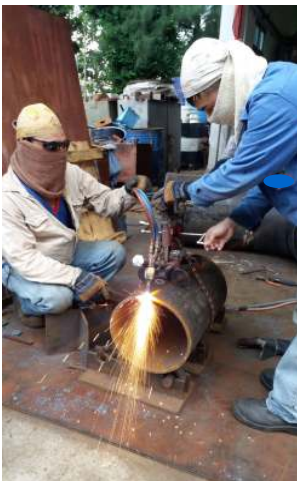
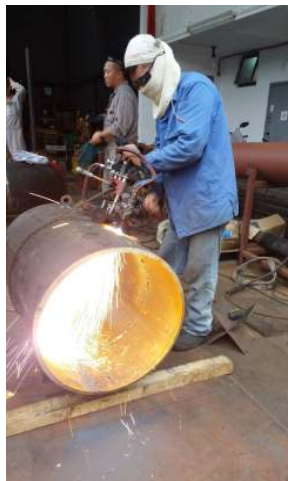
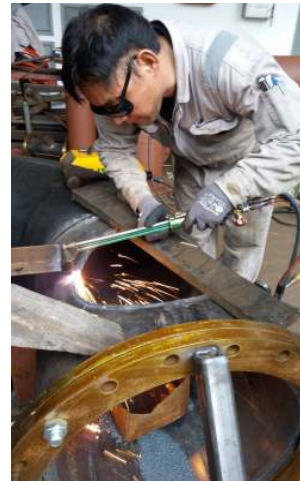
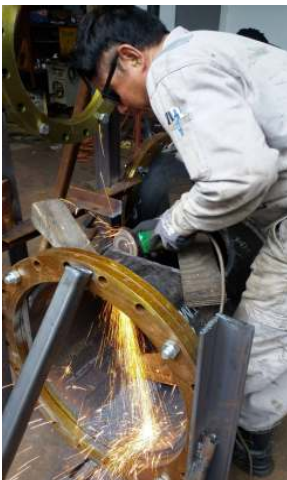
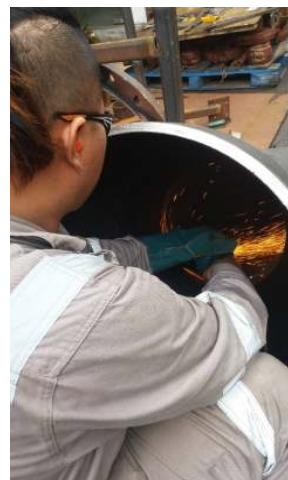
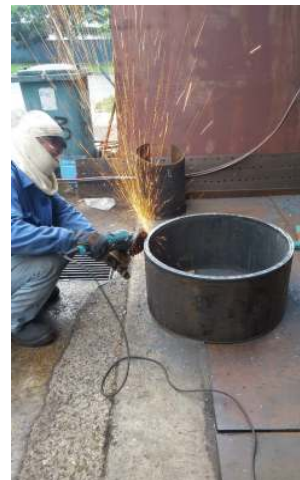
All pipes, fittings were cutted and grinded before fitting

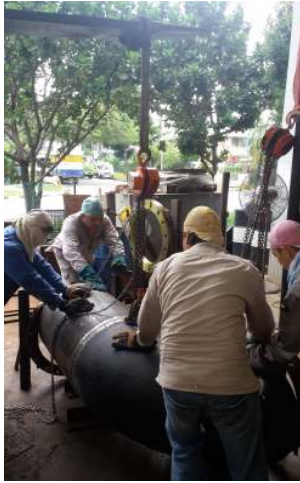
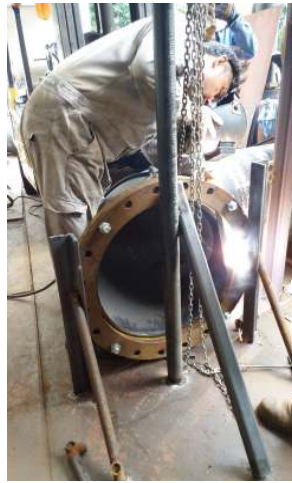
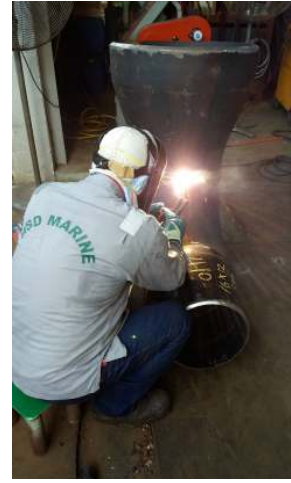
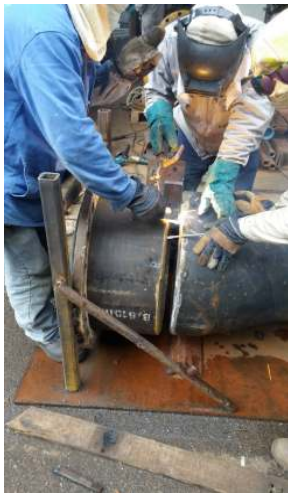
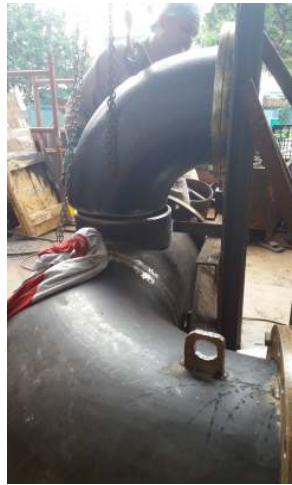
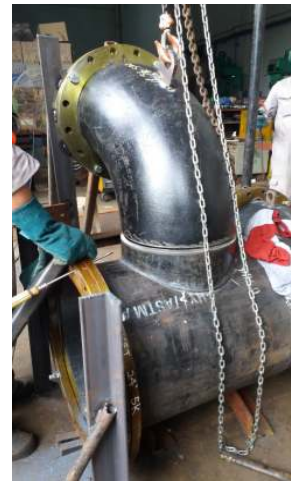
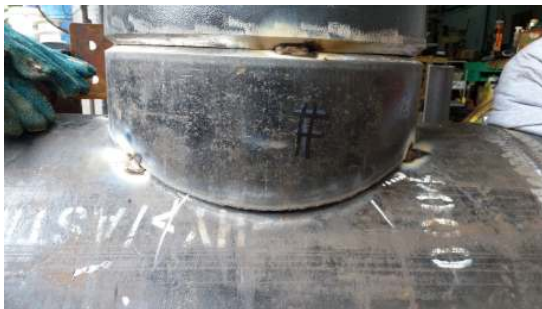
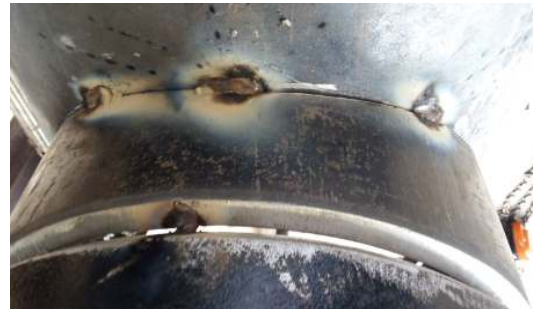
All pipes, elbows, flanges, branches were fitted according to the template measurements.

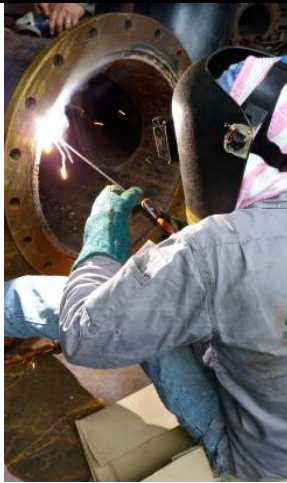
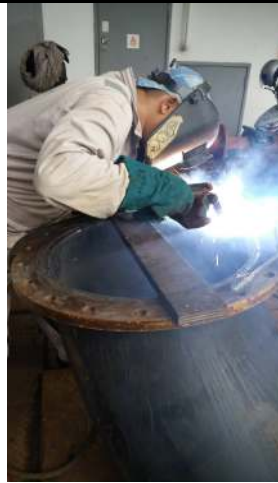
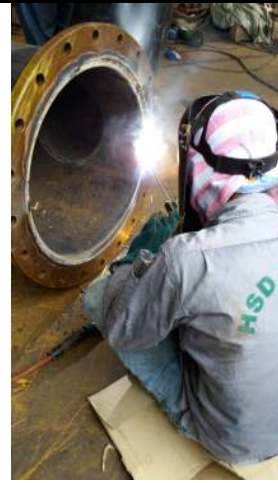
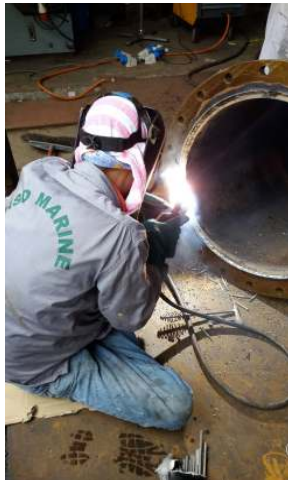
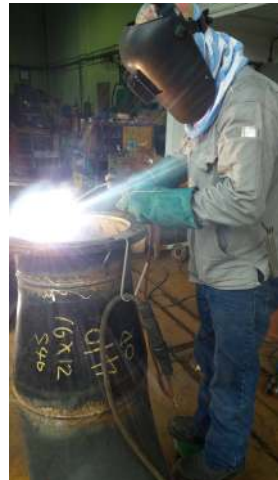
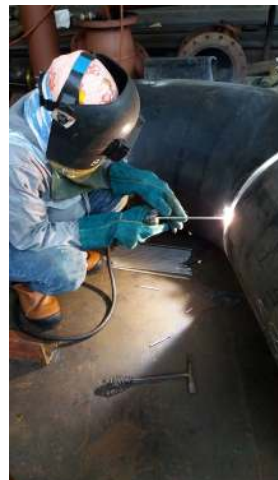
Carried out full welding on all the fittings, flanges and branches.

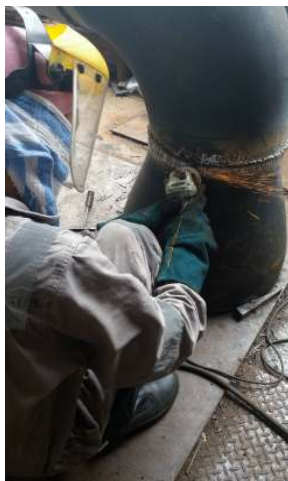
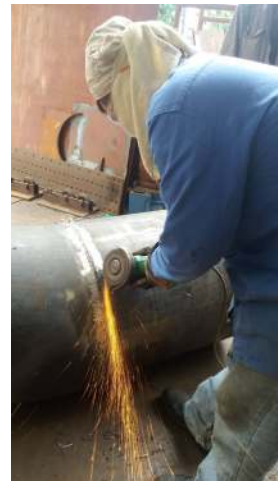
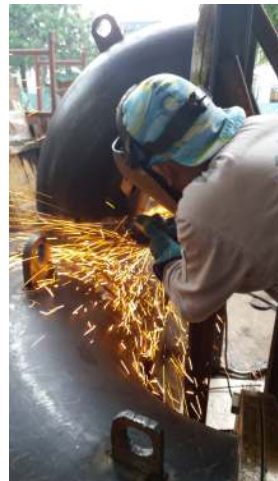
Well grinded on all the weldments and made smooth surface.

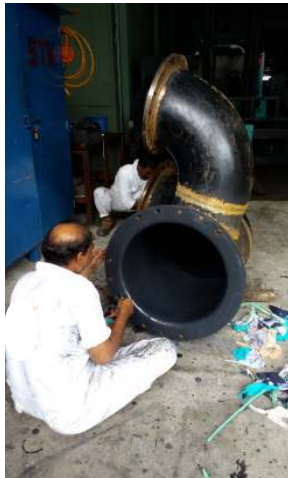
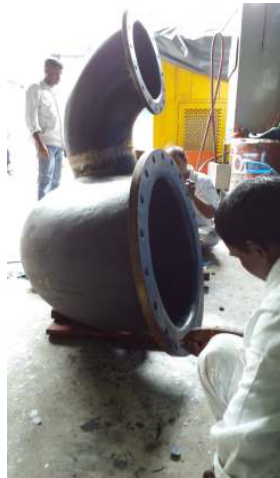
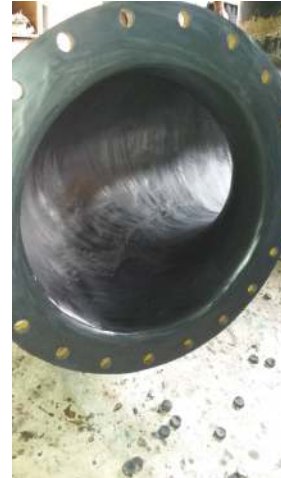
Upon completion carried out rubber coating in both pipes.

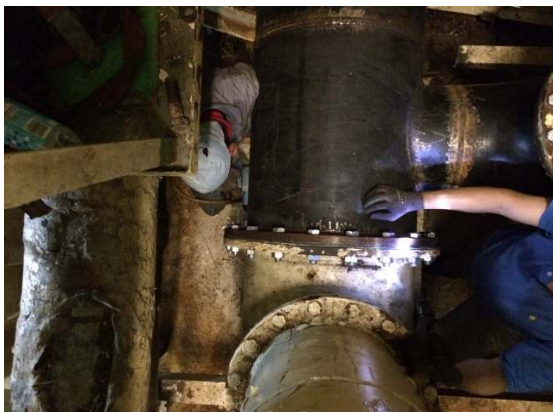
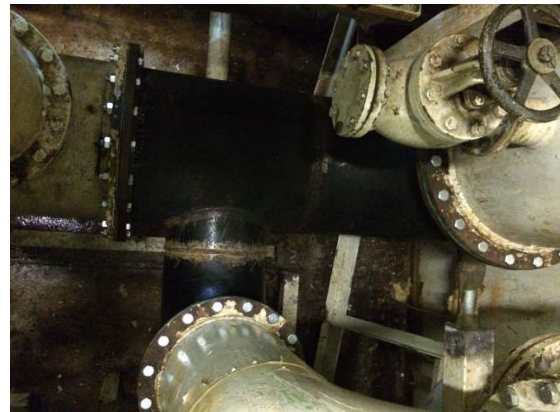
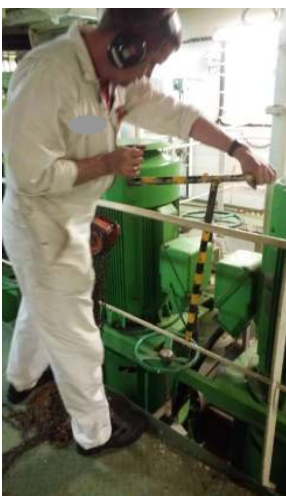
Fabricated pipes were deliver to vessel and installed. Upon completion Chief Engineer carried out test and found satisfactory. All work progress was inspected, witnessed, accepted by Chief Engineer With Satisfactorily.
