Work Report

LOCATION: Waigaoqiao Terminal, Shanghai, China

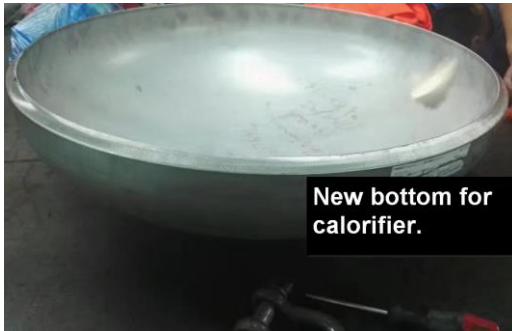
1. Supplied new bottom bowl. The size is dia630mm x 150mm x 15mm thickness.

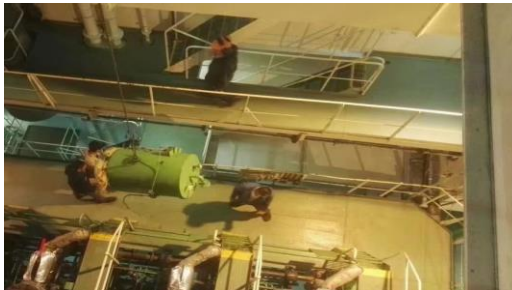
2. Dismantled the calorifier and brought it to ship's workshop.

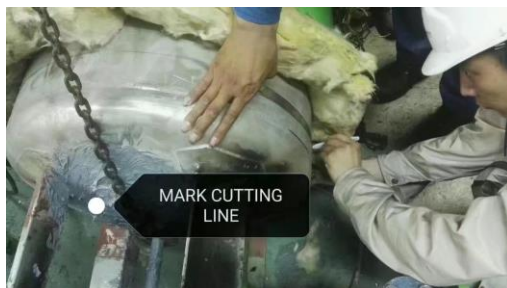
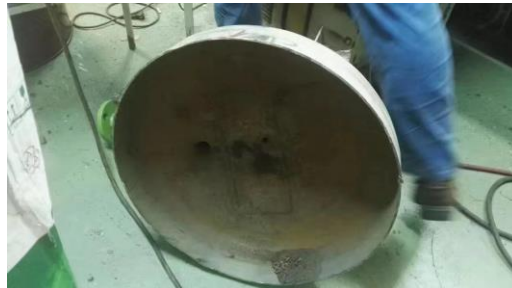
3. Cropped off damaged bottom

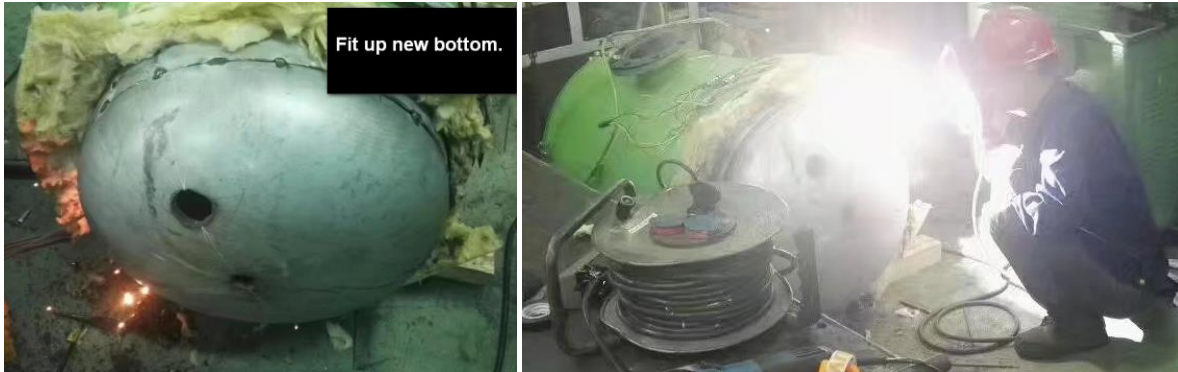
4. Fit back new bottom and carried out welding and grinding.

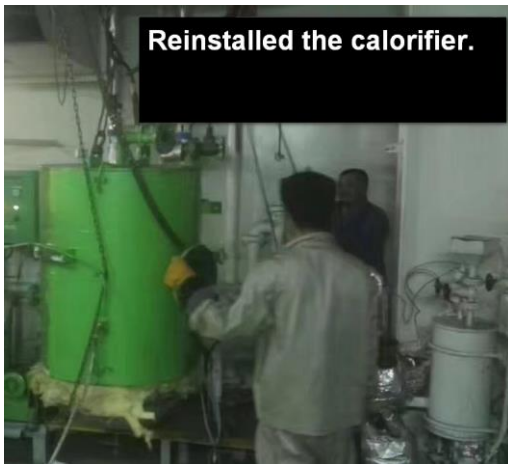
5. Install the calorifier in situ.

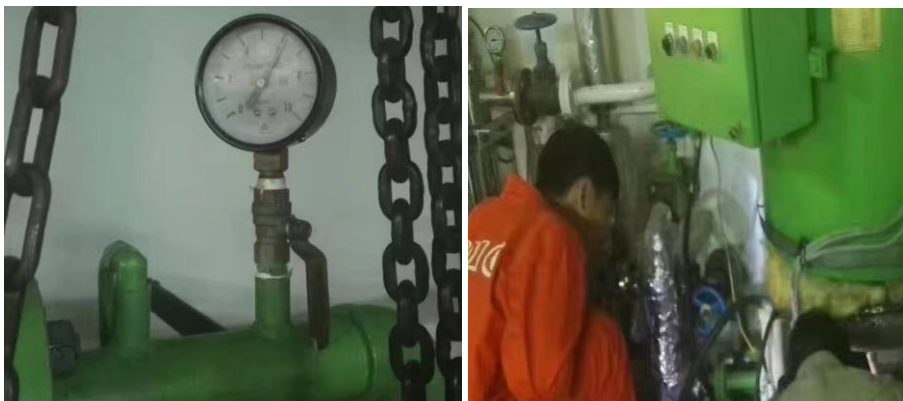
6. Carried out pressure test and no leaking was found.

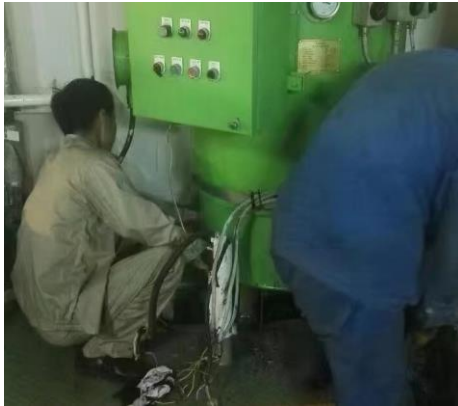
7. Covered back insulation and cover sheet.

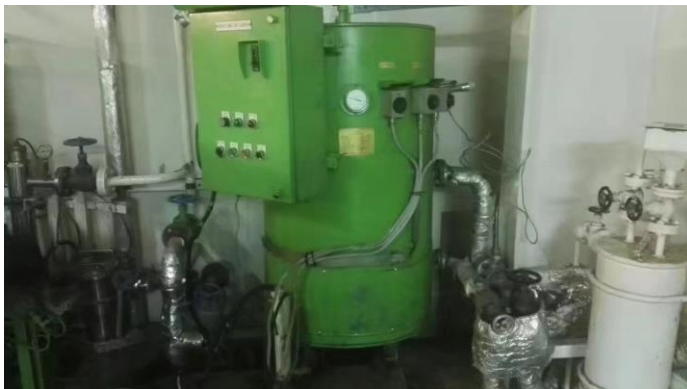
8. Completed job and executed housekeeping.
