PHOTO REPORT

Job No. : 2633
Date : 06th May 2016
Location : Singapore IPL Anchorage

Description	Pg1
<p><u>Subject : Transportation, Relocation & Positioning of Shaft Generator</u></p>

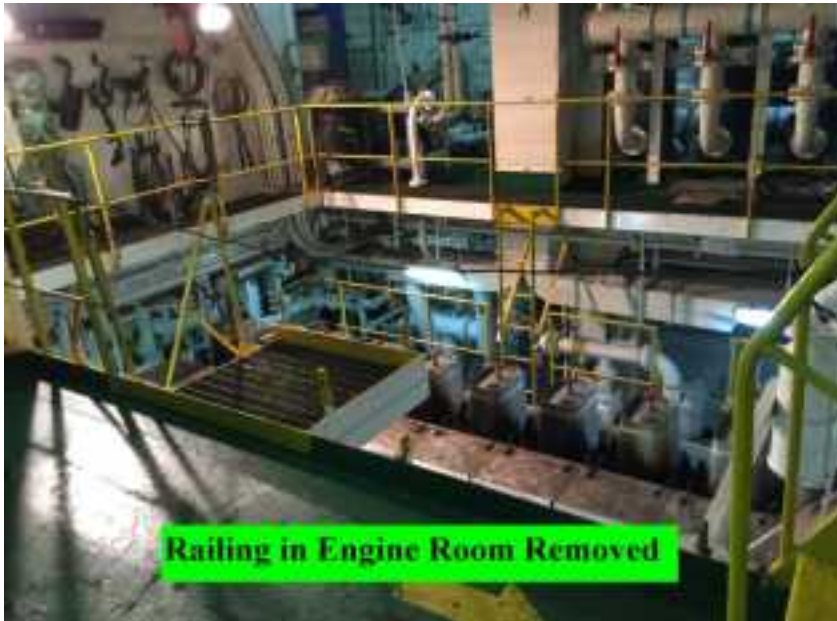
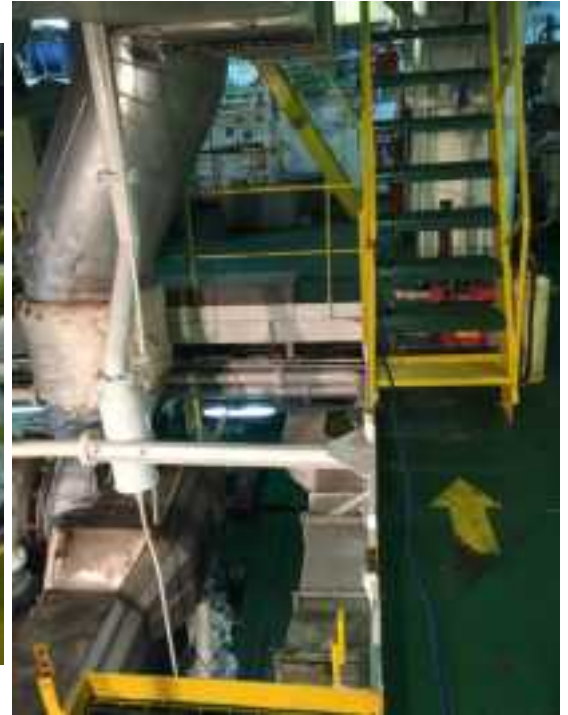
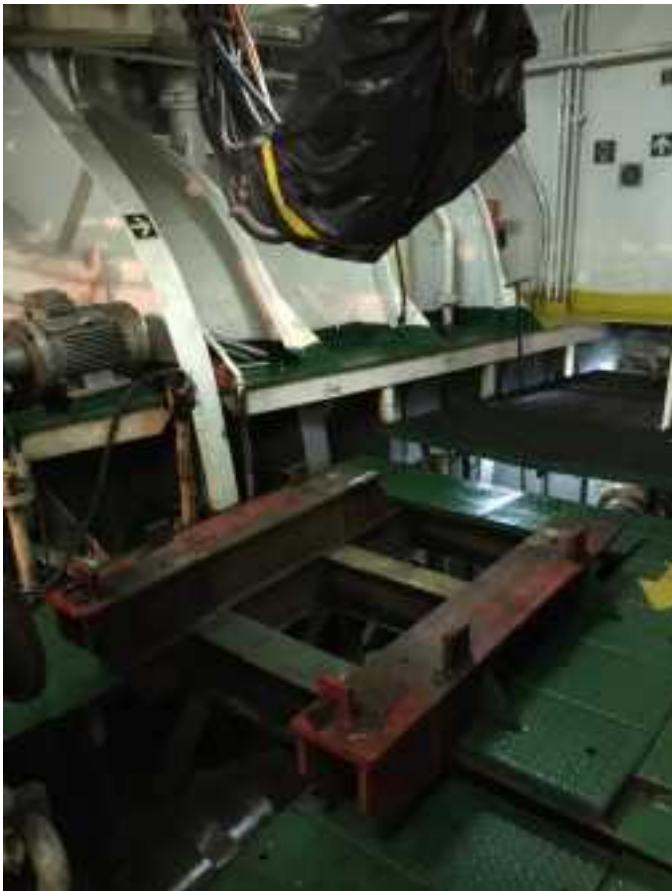
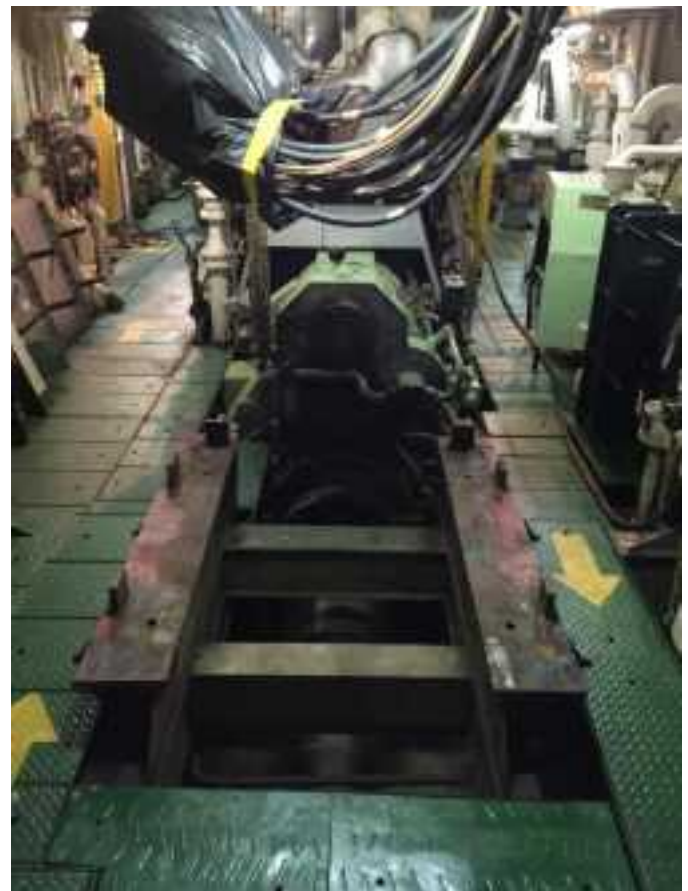
Foundation of Shaft Generator

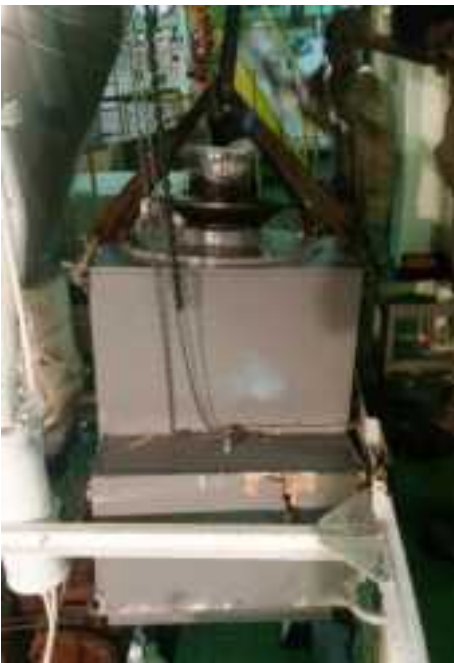
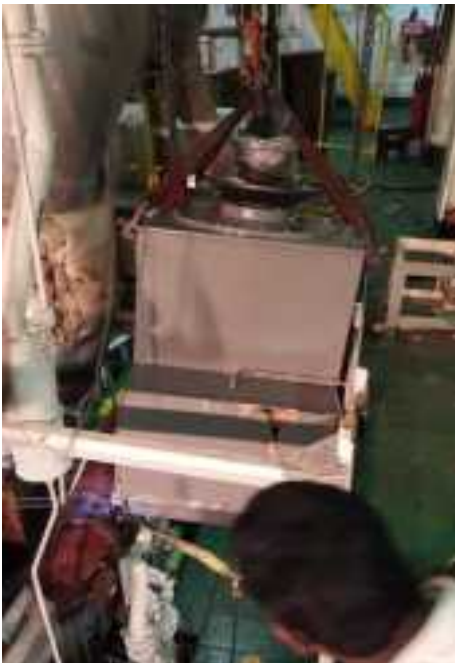
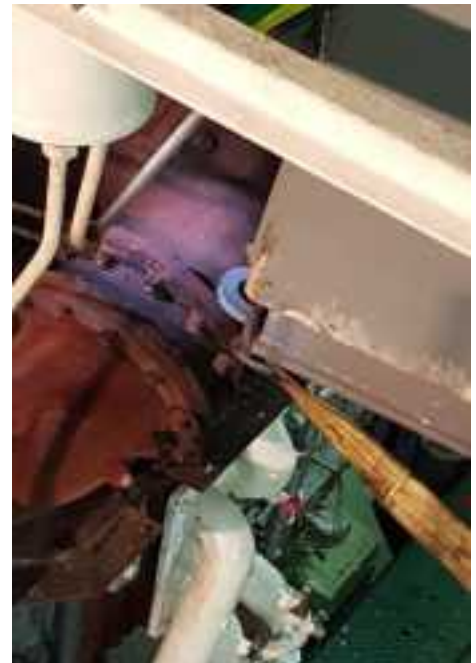
From 2300hrs to 0300hrs, further removal of pipes, brackets, phone booth & air duct then resume shifting

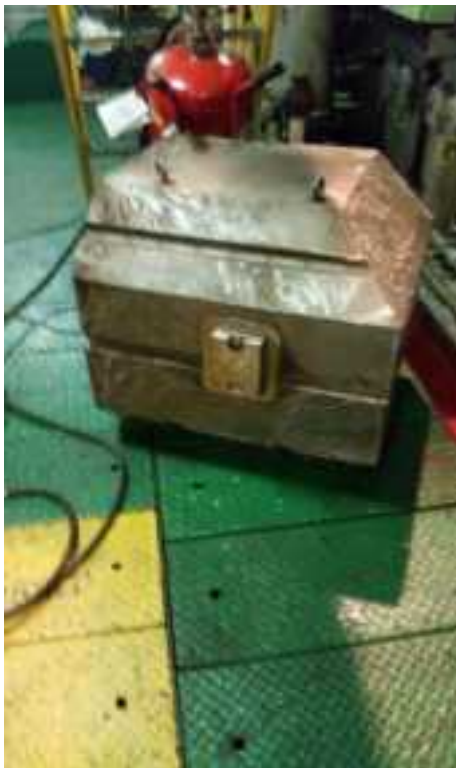
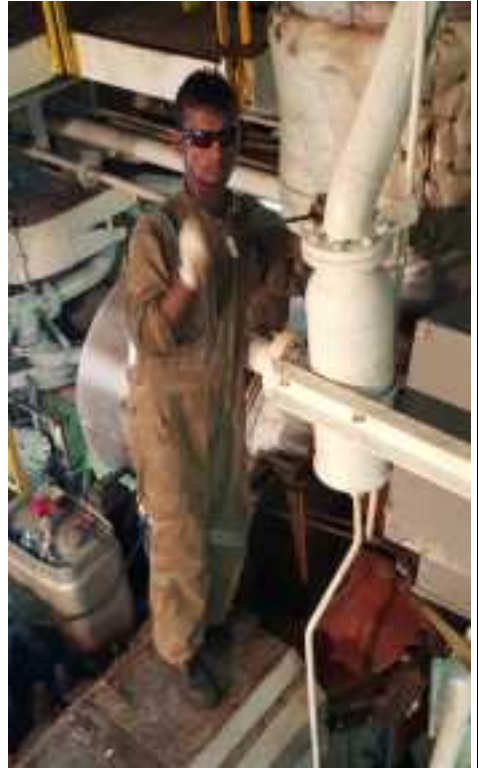
Pipe Removal

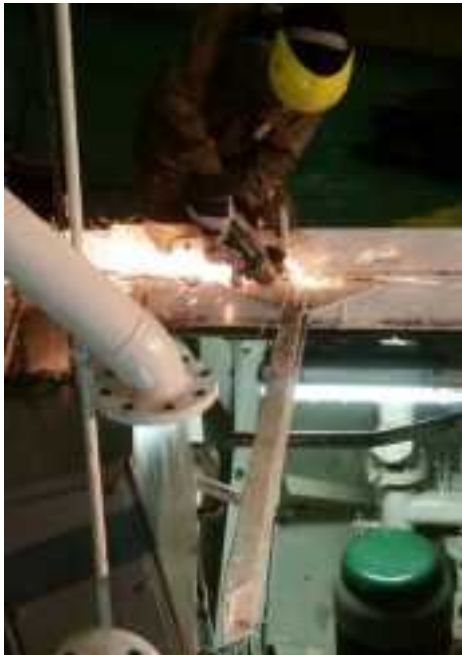
Grind cropping bracket structure

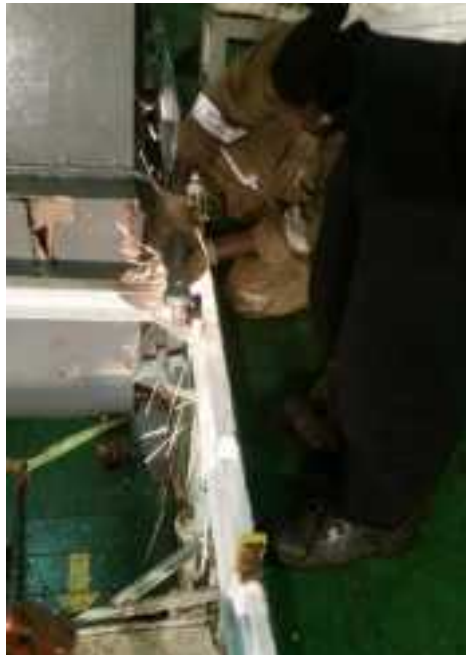
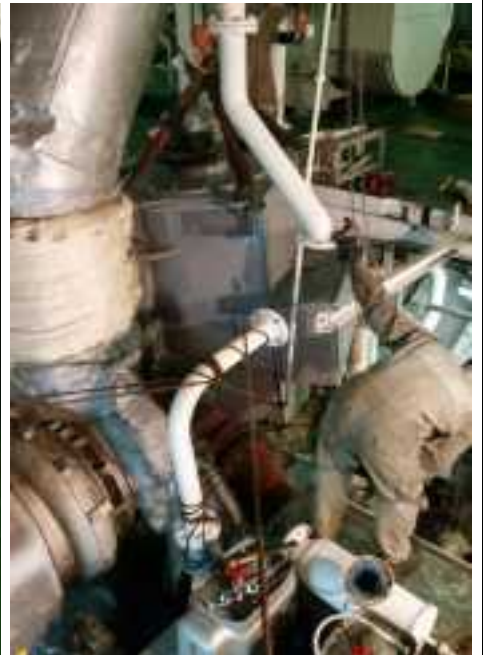
Pipe Removal

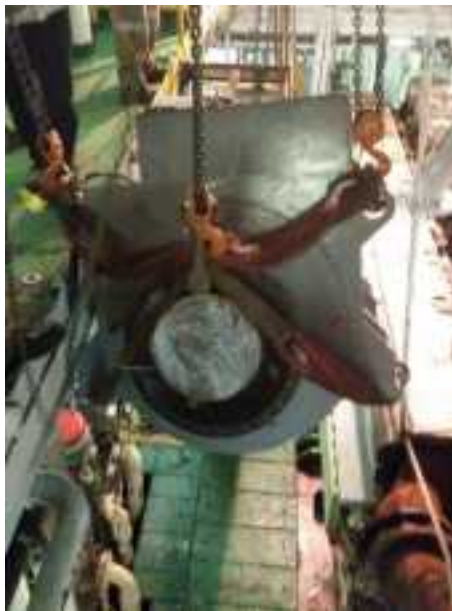
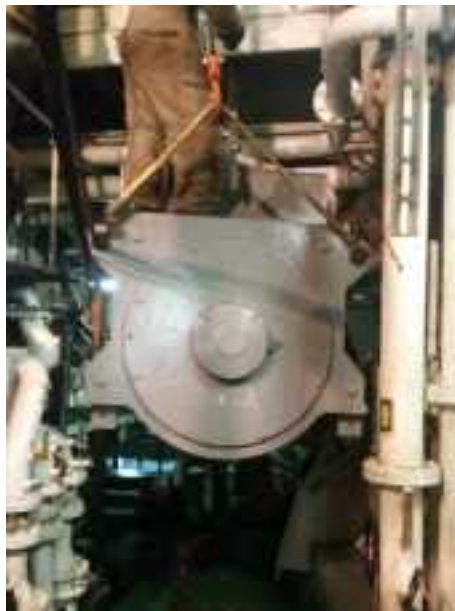
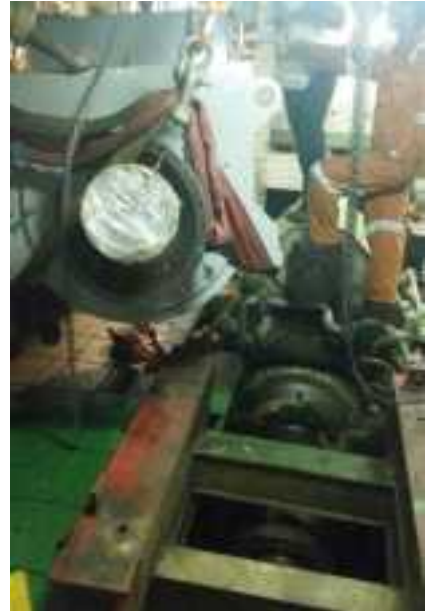
Shaft Generator were shifted into position at 0430hrs

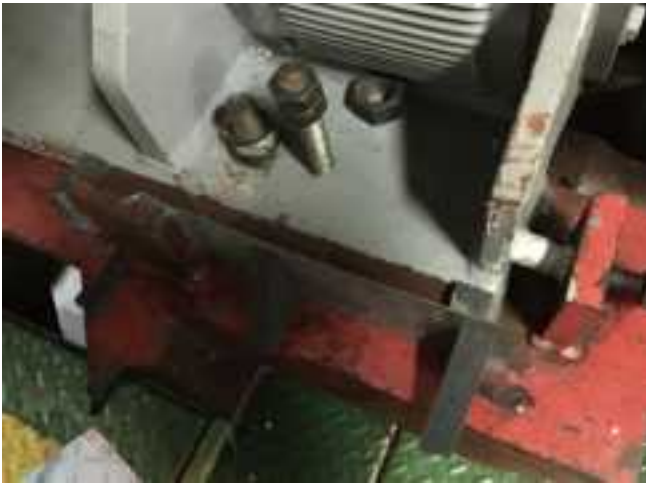
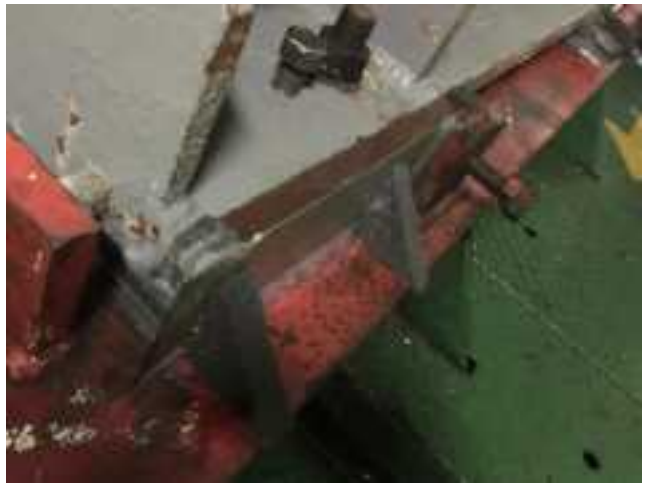
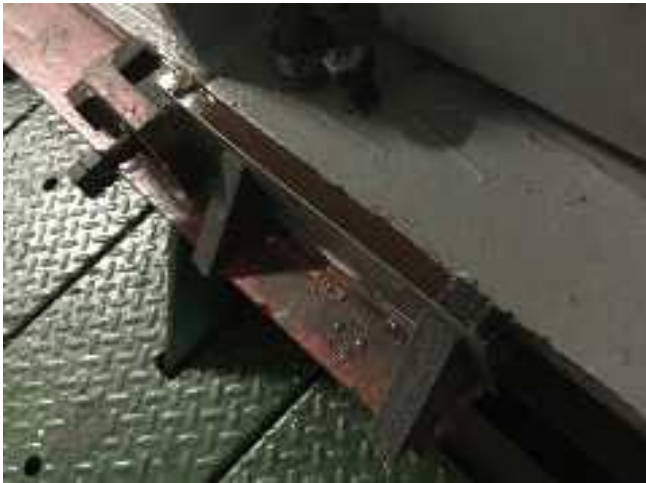
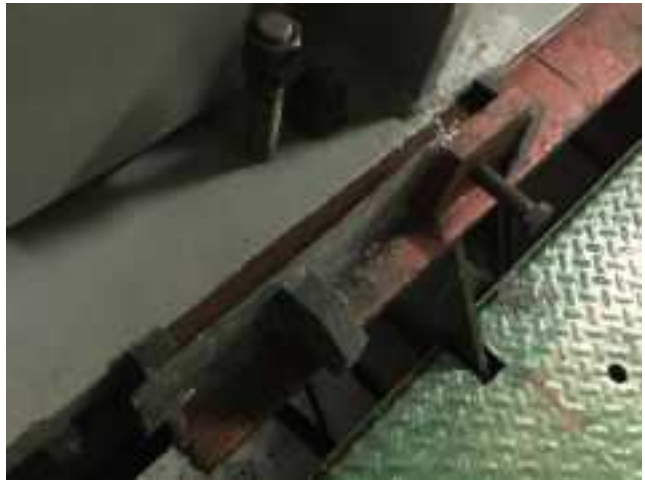
Chockfast material were then poured into coaming, as per photos shown below.

Chockfast hardening requires 18 to 24 hours, team to re-attend next day for final inspection, and final round of laser alignment.
